Tianda Uranium (Australia) Pty Ltd

Rehabilitation Report

Central Mount Project

EL 25694

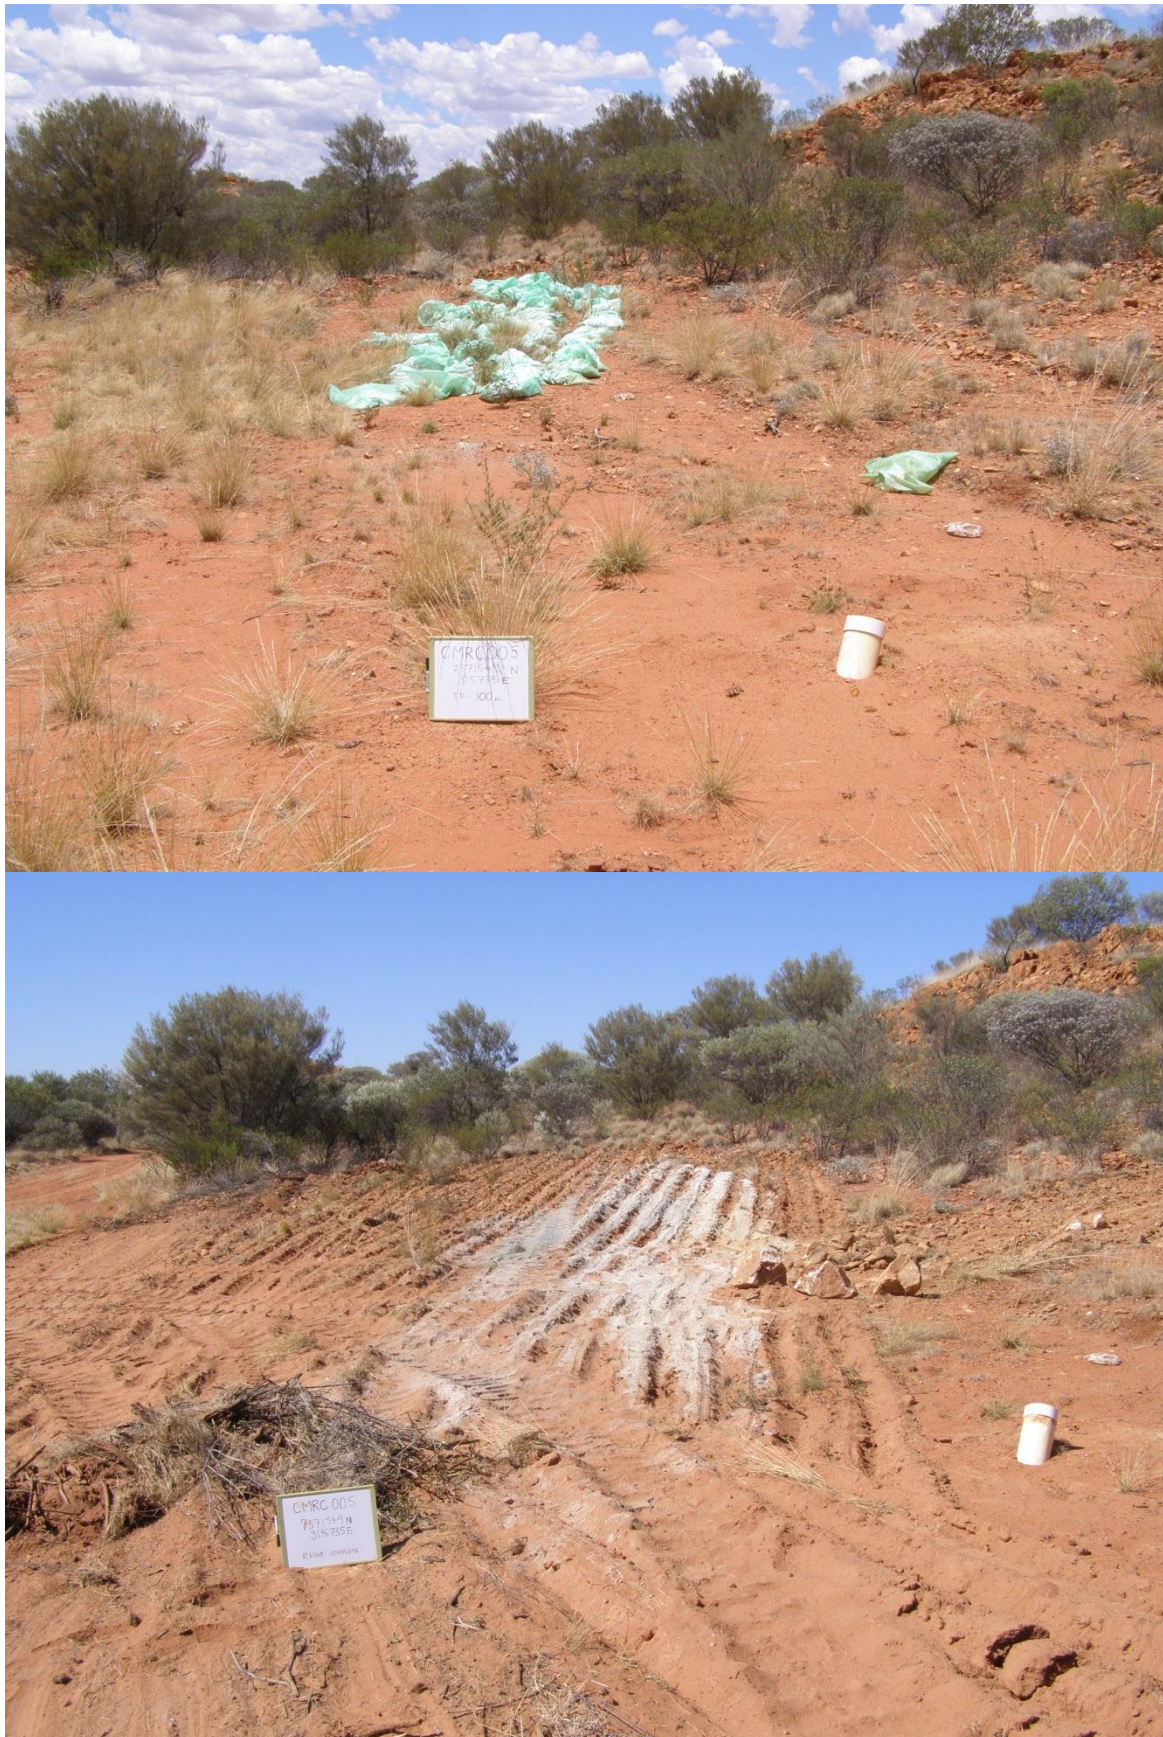
At request of the landowner three holes and access tracks to them were left available to become water bores for the stations cattle. They are CMRC005, 007 and 009 (figure 2). All remaining tracks were rehabilitated. The station owners contact details are given below:

Figure 7 – CMRC005 site, collar remains for water bore

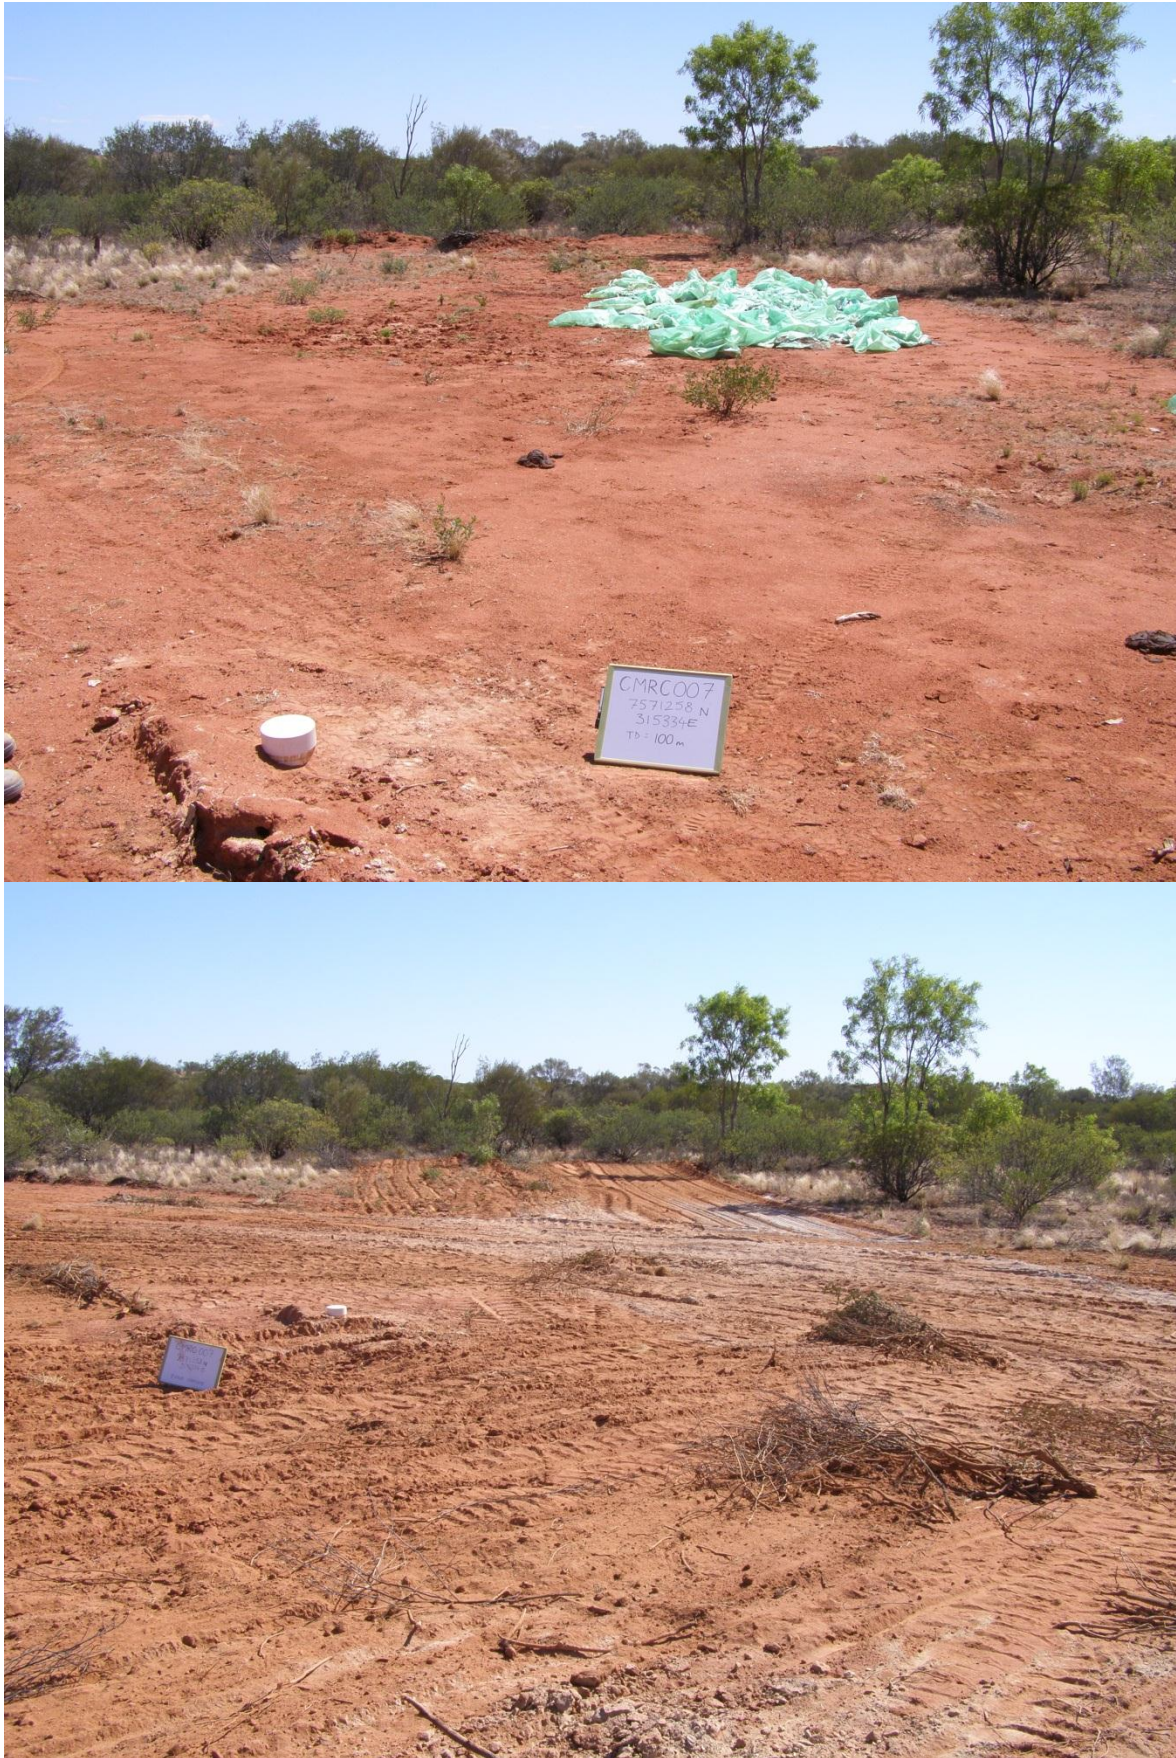
Figure 9 – CMRC007 site, collar remains for water bore

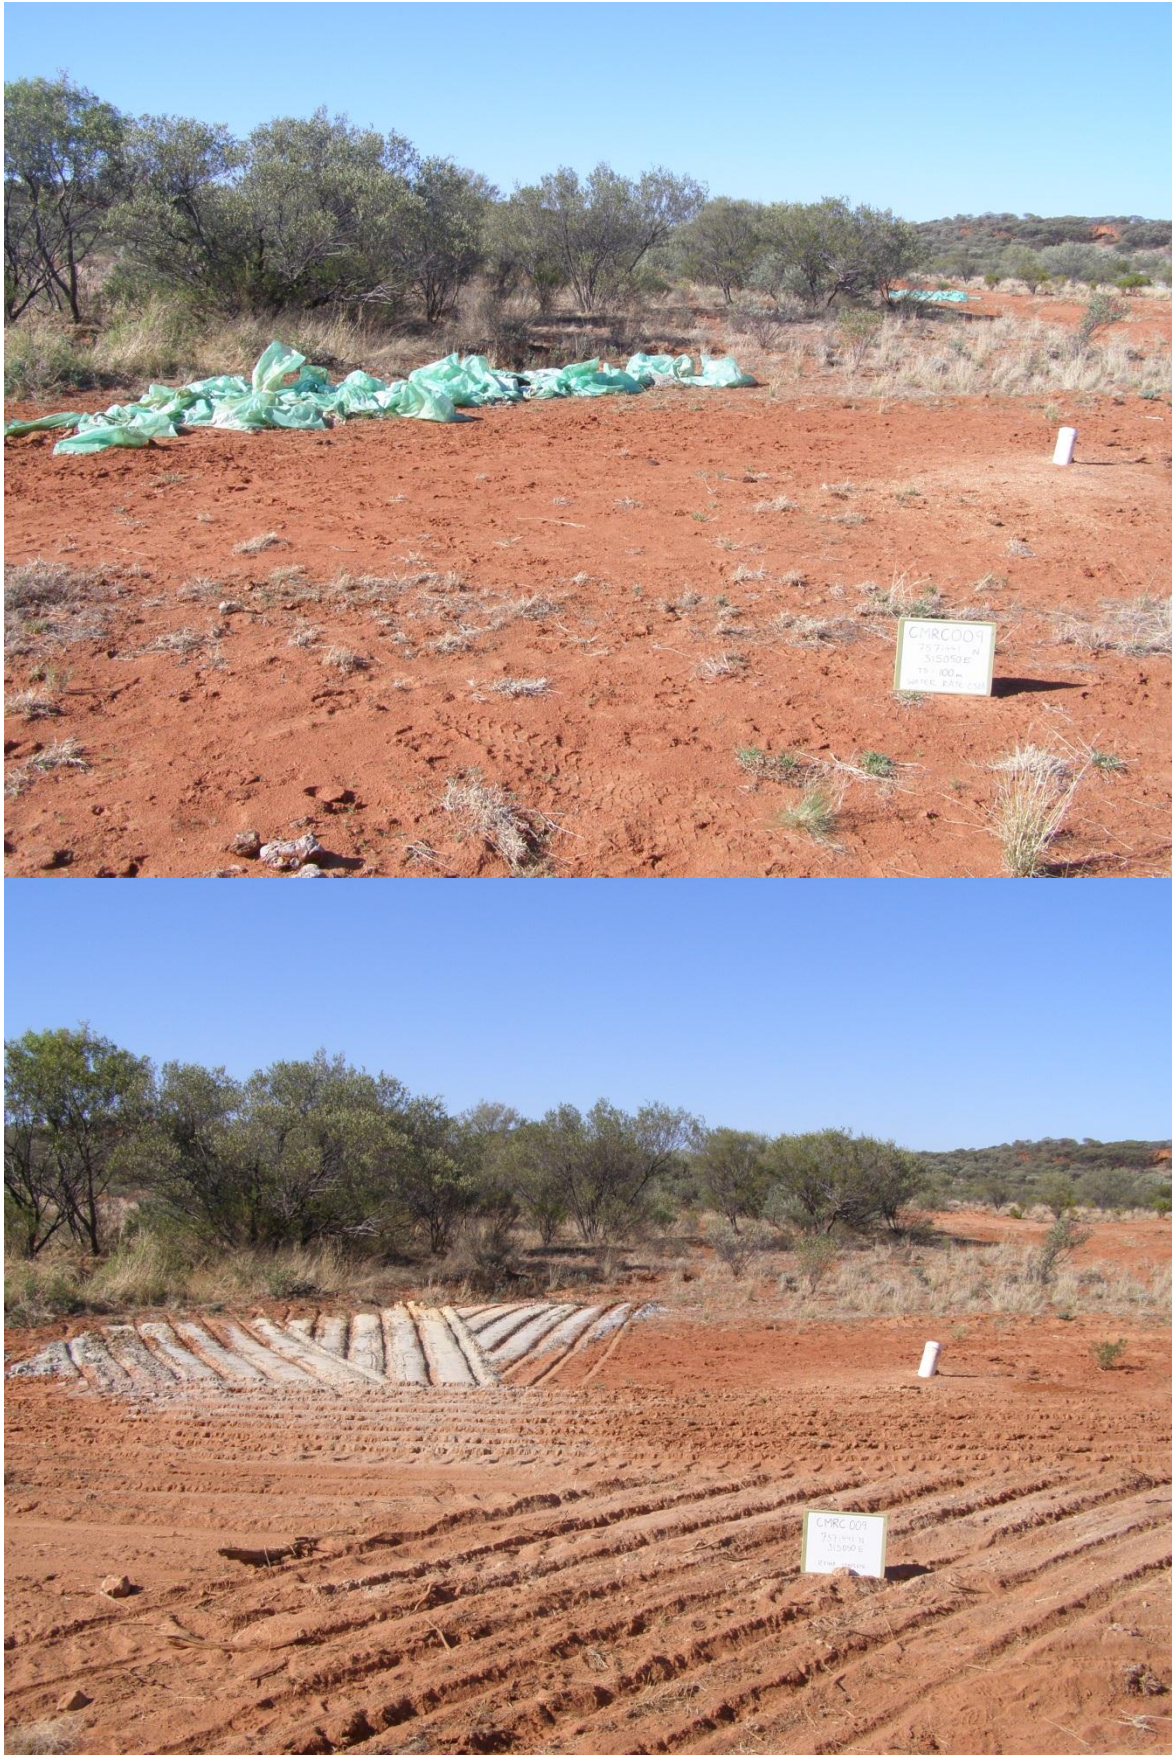
Figure 11 – CMRC009 site, collar remains for water bore
