## **EL23814, MLN 726 & MLN 727**

### **Bulman, Northern Territory**

## **Exploration Closure and Rehabilitation Report**

### **Completion of Drill Program**

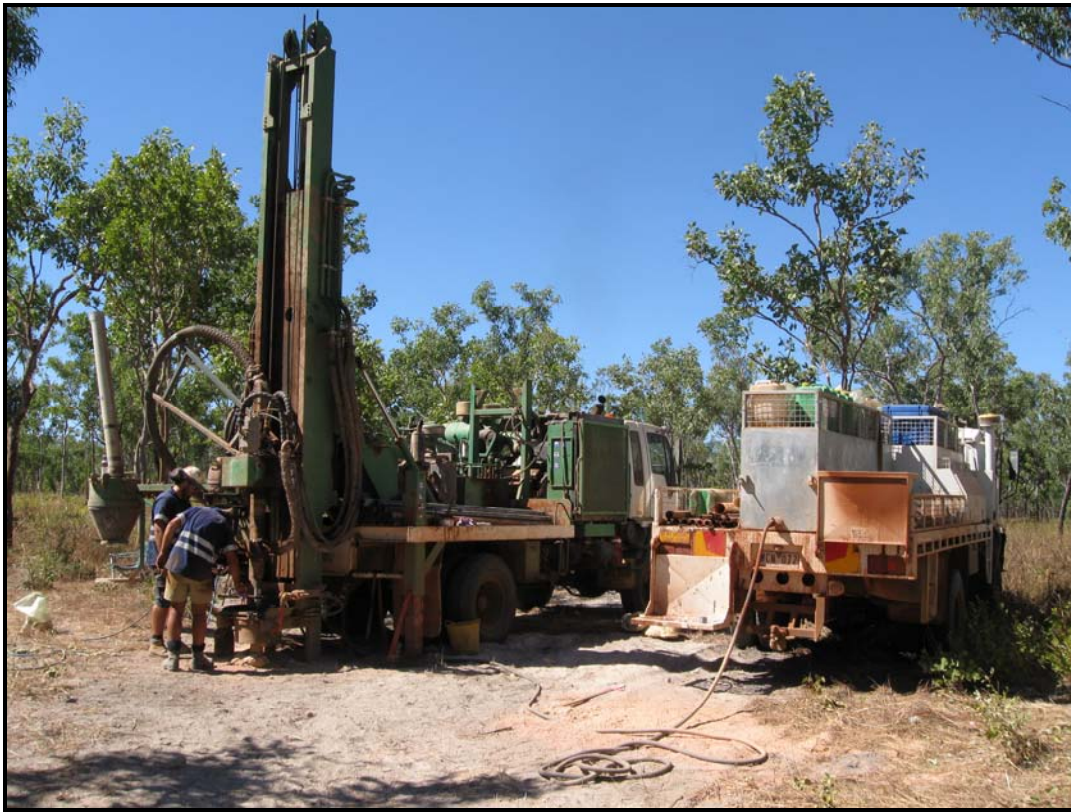
**Photo 1; Drilling on EL23814**

The drilling was carried out during June-July 2008 by Australian Mineral & Waterwell Drilling Pty Ltd (AMWD) using a 4x4 mounted Air-Core / Slim-Line RC Rig (Photo 1).

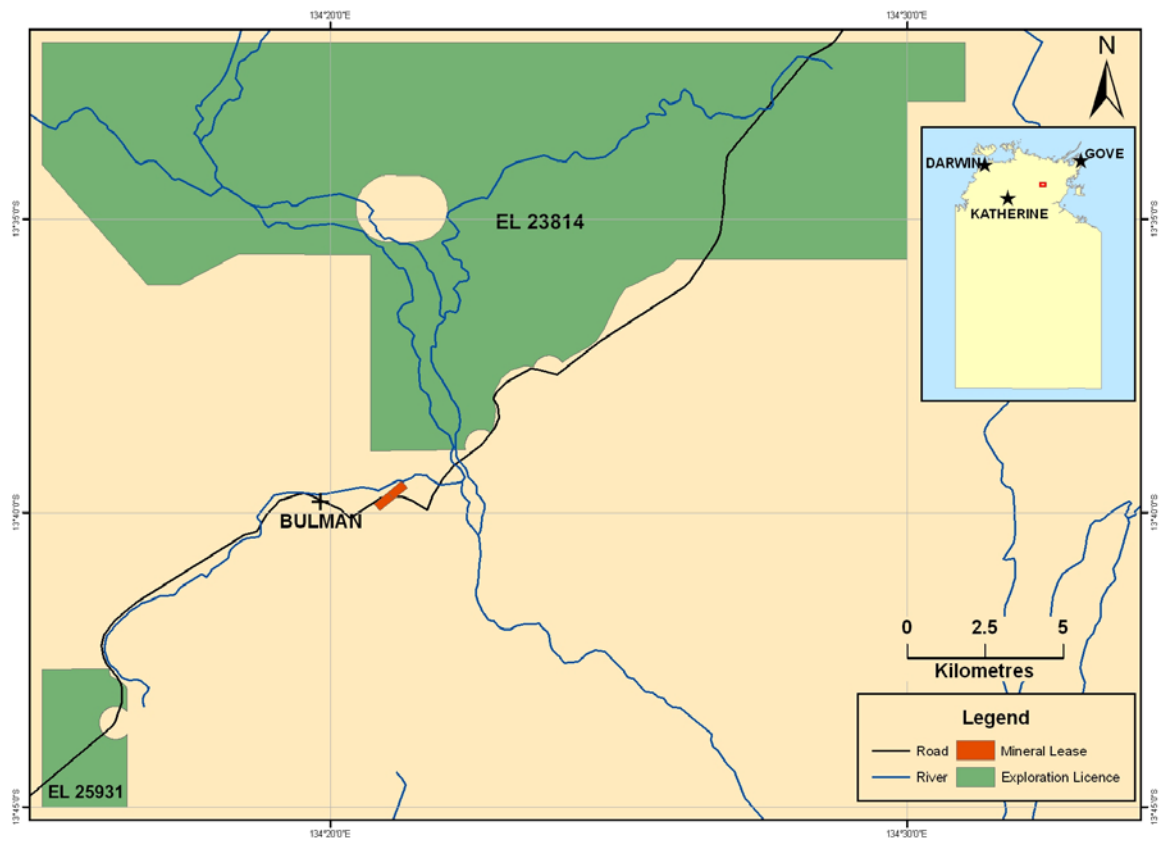
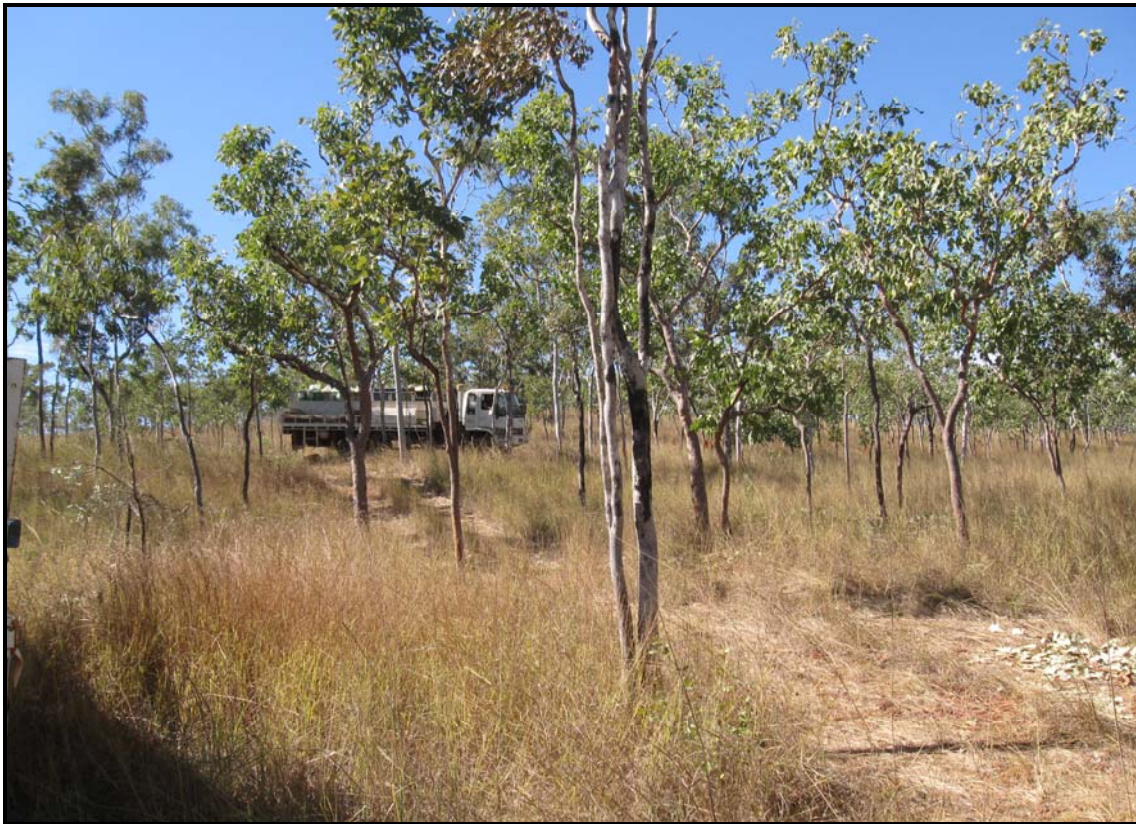
Tracks were manoeuvred through vegetation (Photo 2), only removing flora and termite bounds when no other reasonable option was left. No mature trees were removed at any stage, creating no threat to the natural environment. No water courses were filled although a few dry water courses have been crossed to get to the drill locations, minimal disturbance was made.

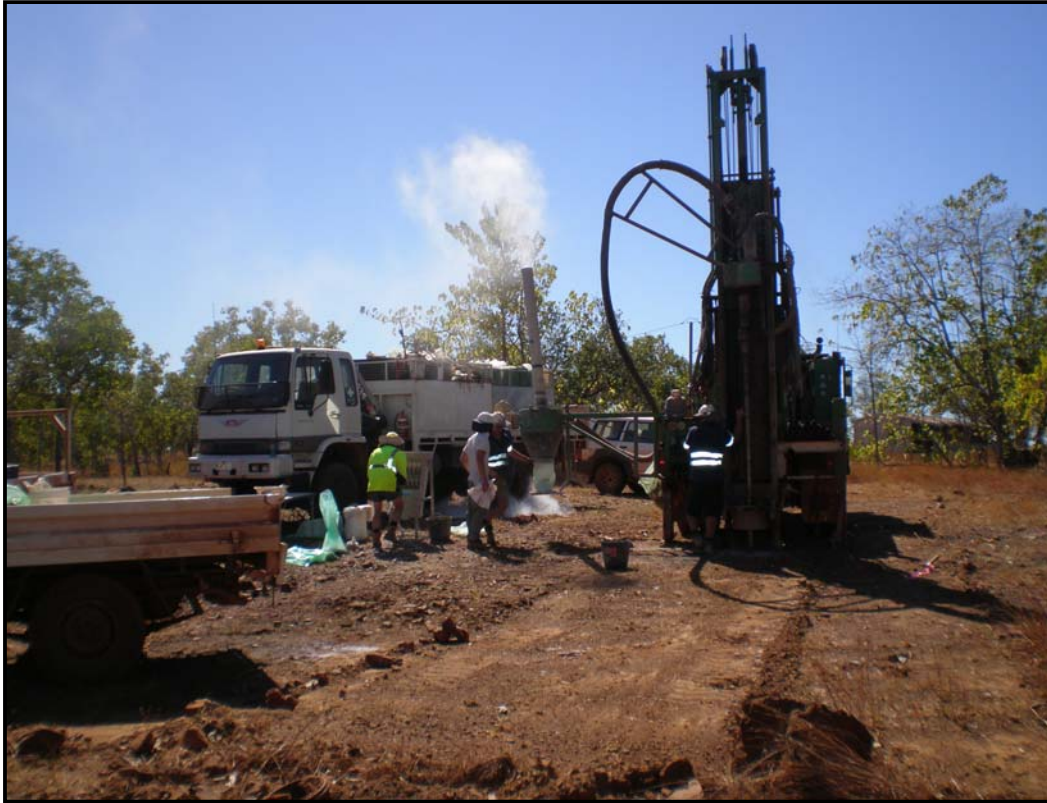
Drill pads were typically rectangle shape and rarely larger than 9m x 12m and all drill sites would cover a total area of 4400 m<sup>2</sup>. Each drill site equated to a minimum of 3 'bucket up' scrapings (as outlined in the drill pad /site departmental guidelines) in width and twice the length of the drill rig (refer to fig.2, fig.3) to minimise any impact. No scrapings were conducted to depth greater than ~15cm for levelling purposes. Assessment of the drill pads concluded that the minimal amount of disturbance was best rehabilitated by light infill of any divots by hand and then left to revegetate from moderately disturbed root stock and wind-blown seed during the high growth stormy season before the onset of the 'wet' season. Due to the high vegetation growth over the wet season little if any sign of the low impact drill sites would be evident.

**Photo 3; Drill pad 3x loader scrapings wide and twice drill rig length.**

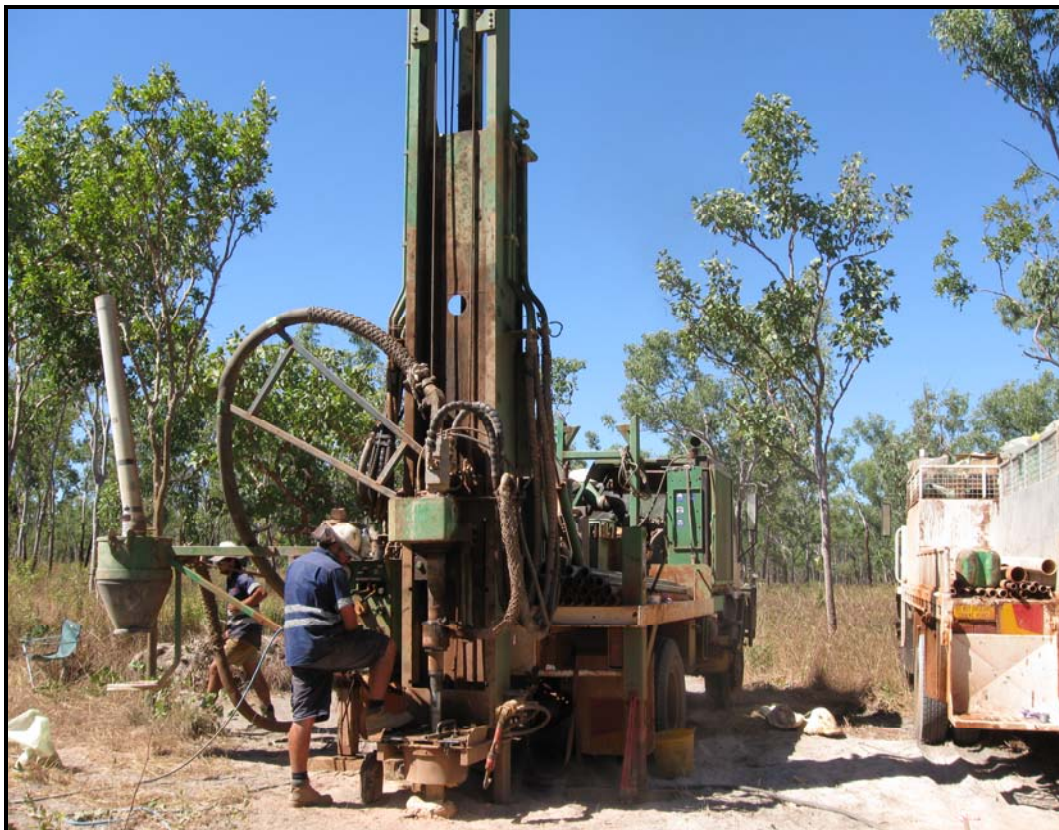
**Photo 4; Drill pad location selected between trees**

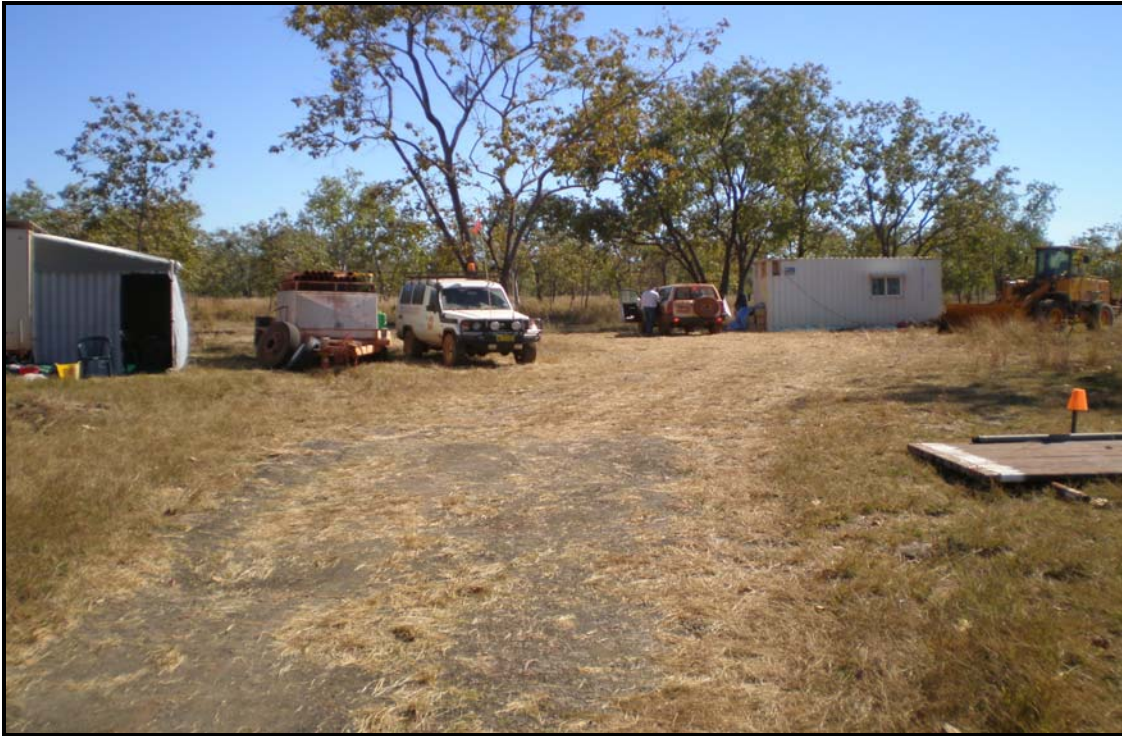
**Photo 6; camp site**

The camp site was chosen considering the environment, no trees were knocked down and little excavation was done to set up the camp (Photo 5). The camp site was chosen close to the main access road to avoid any more clearing.

All the trash was dumped in the nearest designated refuse disposal site located in Gulin Gulin (Bulman). No trash was left on the campsite and excavated soil re-spreading was done after the completion of the drill program.

All camp infrastructures were removed from the campsite on completion of the program.
