# **EXPLORATION ACTIVITIES SITE AUDIT**

Wonarah Phosphate Project

February 2012

CR 9014\_21\_v2

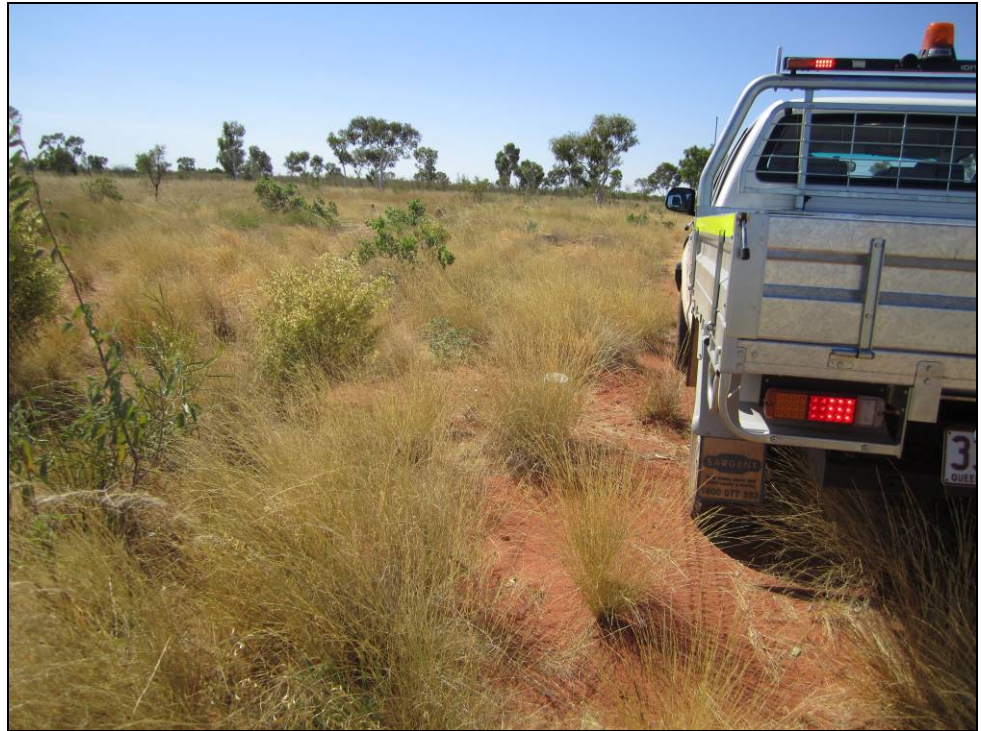
**Plate 4.1**

**Drillhole  
located close  
to exploration  
track.**

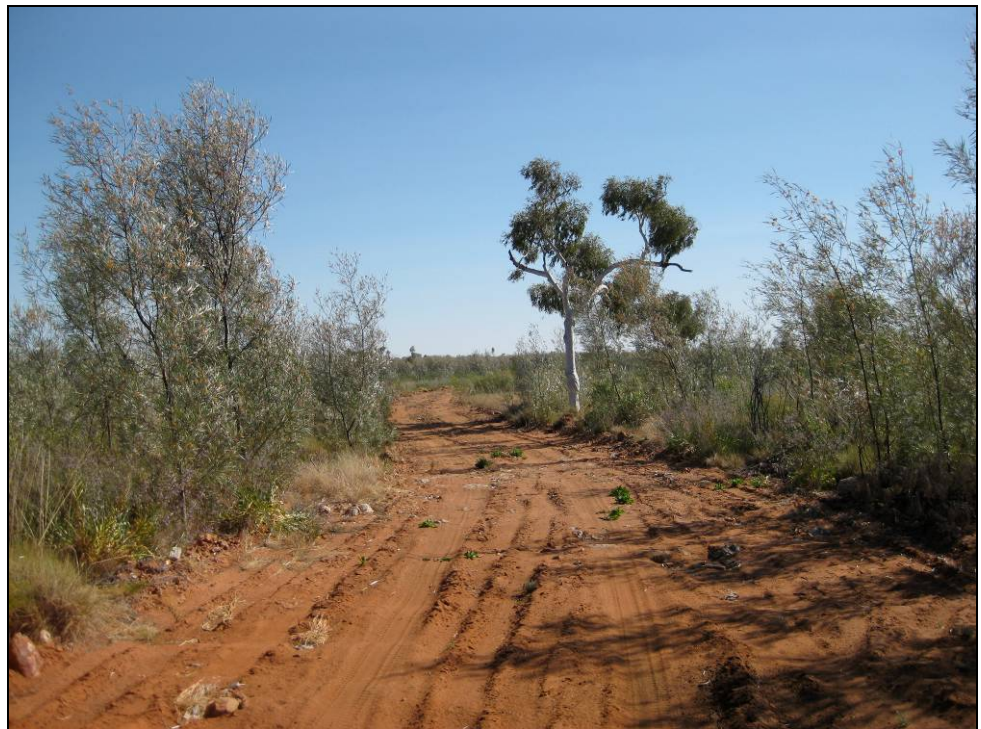
**Plate 4.2**

When constructing the exploration tracks, Minemakers advised the contractors to avoid large trees and termite mounds; evidence of this avoidance is shown in Plate 4.2. Tracks were also kept to minimum width, i.e., one vehicle width only, and maintained with minimal or no windrows evident (Plate 4.2). Vegetation, and topsoil where present, had been suitably stockpiled for reuse during rehabilitation activities.

**Large tree  
avoided in  
construction  
of exploration  
track.**

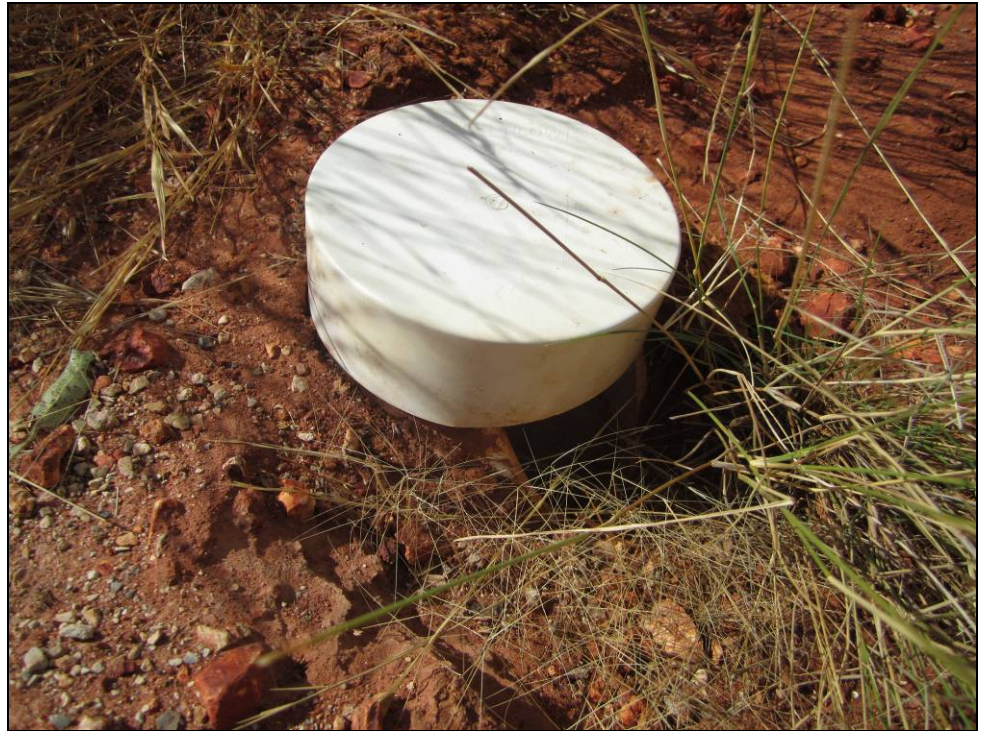
**Plate 4.3**

The majority of drill holes were capped immediately after completion and drill sites were left in a very clean and tidy state (Plate 4.3).

**Capped  
drillhole**

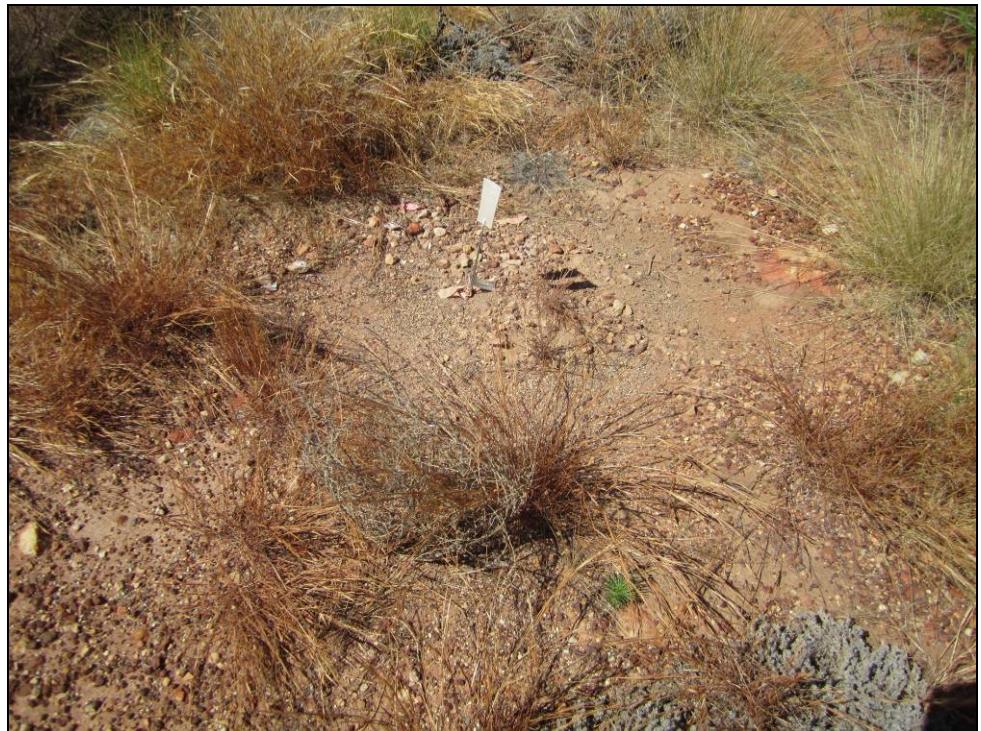
**Plate 4.4**

It was observed during the site visit that, with the assistance of good rainfall events in the area, many of the completed drill holes and old exploration tracks have naturally revegetated very well (Plates 4.4 and 4.5, 4.6). Indeed, in many instances it was not possible to positively identify historical access tracks, gridlines or rehabilitated drill pads due to the success of rehabilitation in these areas.

**Completed  
drill hole  
showing  
evidence of  
revegetation**

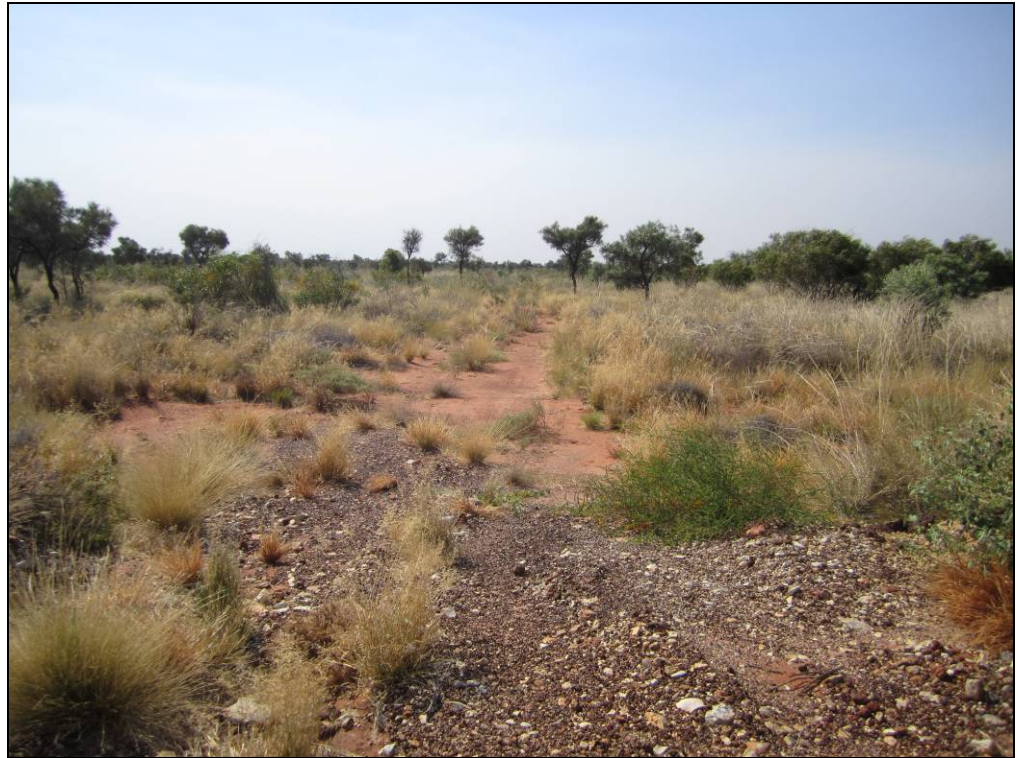
**Plate 4.5**

**Disused  
exploration  
track  
(constructed  
in 2008)  
showing  
evidence of  
revegetation**

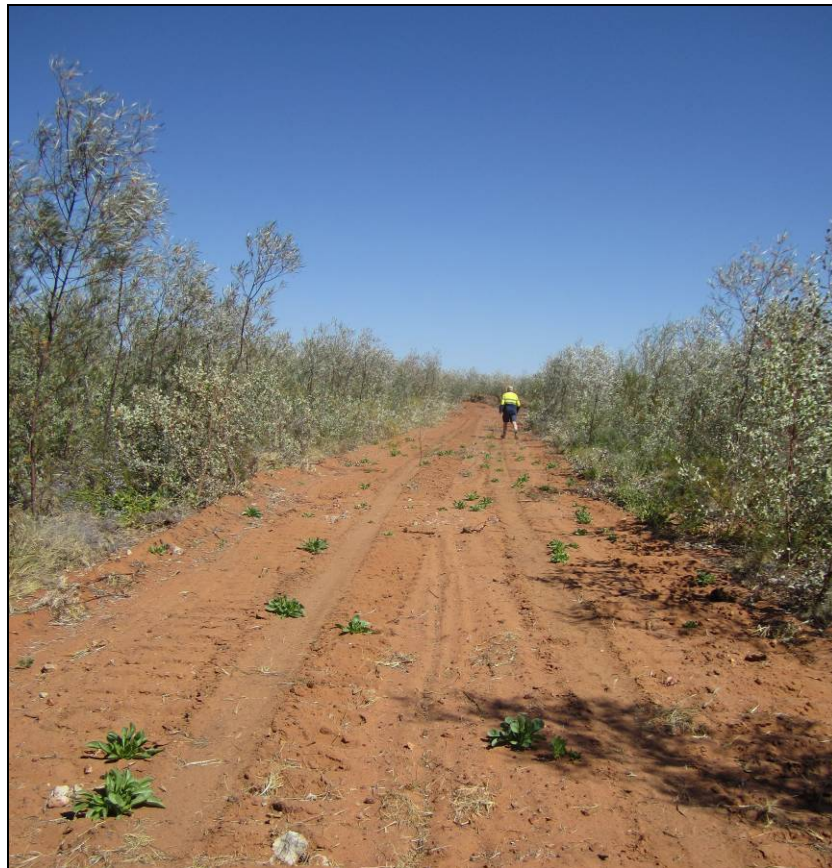
**Plate 4.6**

**Recently  
constructed  
excavation  
track (for  
comparison  
with Plate  
4.5 above)**

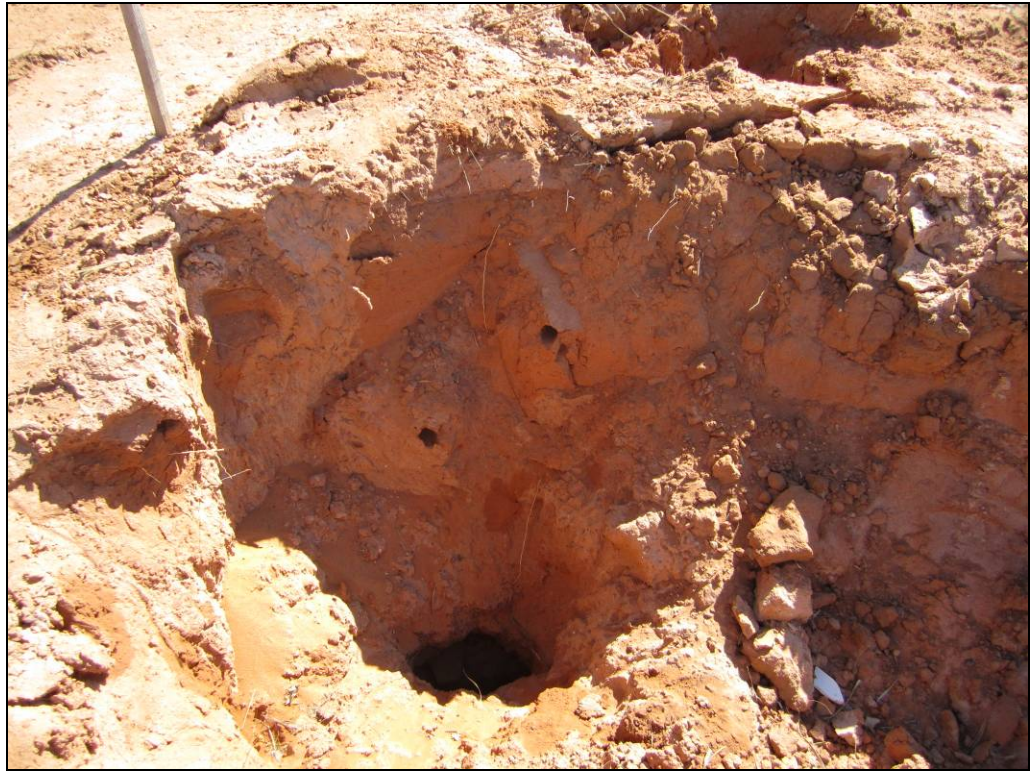
**Plate 4.7**

While the majority of the drill holes were capped and rehabilitation commenced and/or completed, some open drill holes were observed in the SEL26451 lease north of the Barkly Highway (Plates 4.7 and 4.8). In one instance, this open hole poses a risk to native fauna, stock and possibly vehicles using the track.

**Uncapped  
drill hole  
observed  
in  
SEL26451.**

Minemakers is currently engaging with the Arunga Land Protectors to have caps placed on these drill holes to rectify the problem.

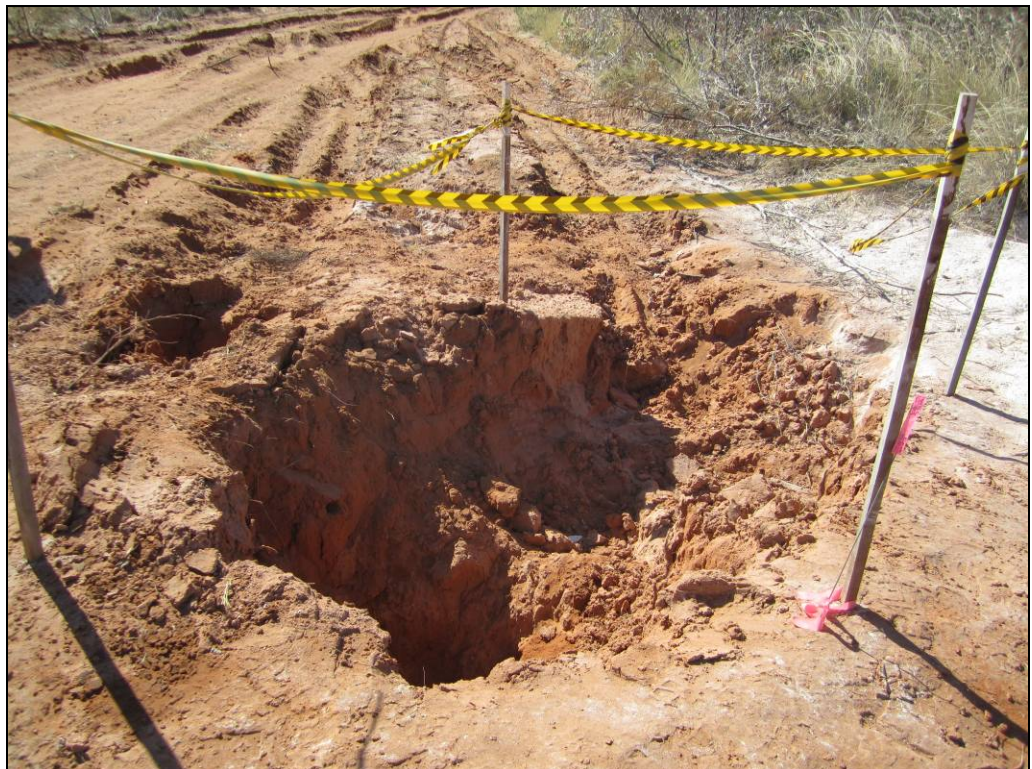
**Plate 4.8  
Uncapped  
drill hole  
observed  
in  
SEL26451.**

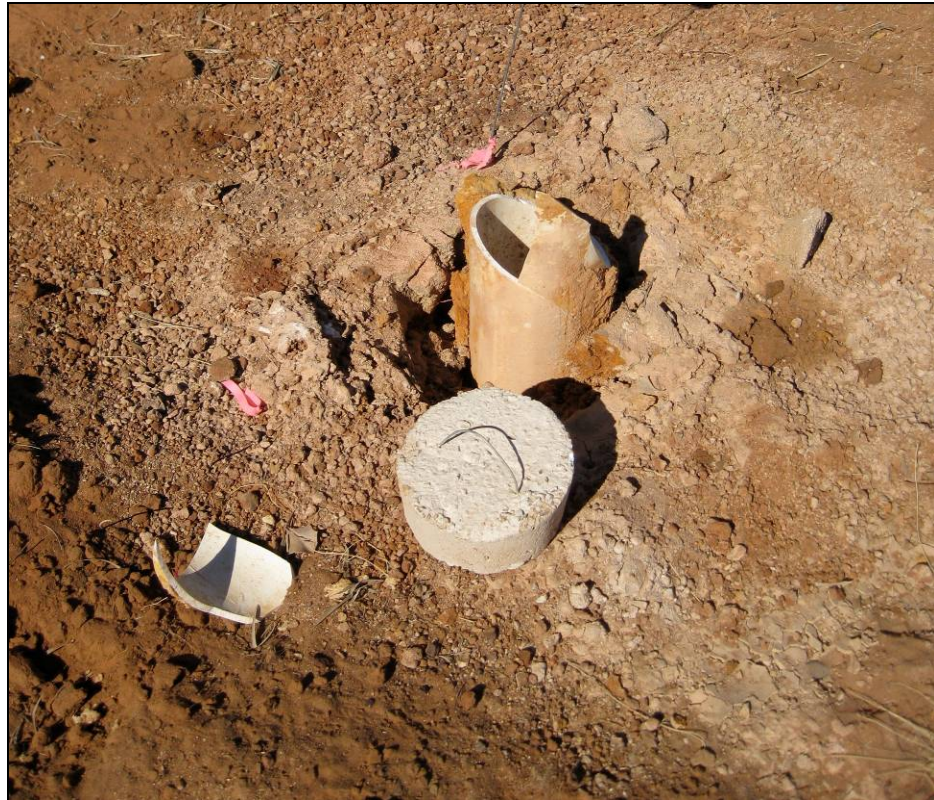
**Plate 4.9**

Some holes have only received temporary capping as there is the potential for these holes to be re-investigated. However, it was noted in some instances that the temporary capping has either been damaged or not used correctly, or been dislodged (Plates 4.9 and 4.10). There is the potential for small mammals and reptiles to crawl into the holes seeking shelter, which could prove to be fatal.

**Damaged cap  
on drill hole.**

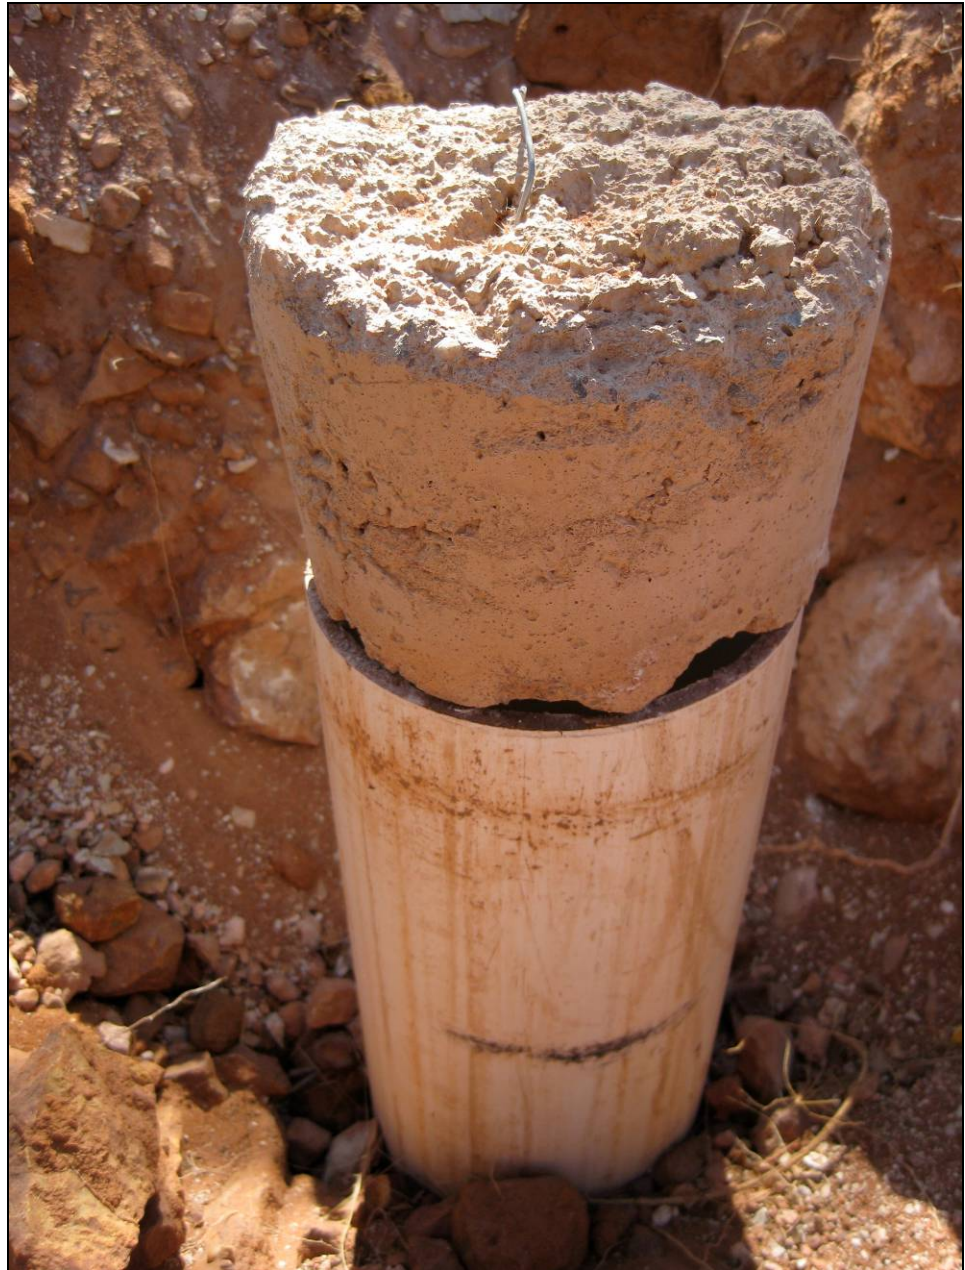
**Plate 4.10**  
**Inappropriate**  
**cap on drill**  
**hole.**

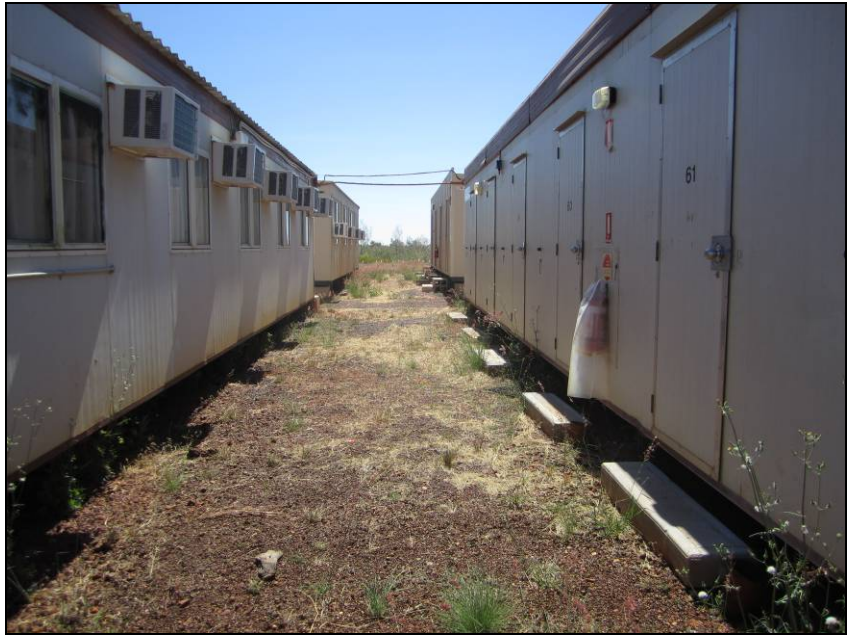
**Plate 4.11**

A number of weed species were observed around the site office (Plate 4.11), occasionally on access tracks and particularly at the Arruwurra lay down area (although it is acknowledged that activities in this area are not exploration activities). The implementation of documentation to verify washdown and a procedure for the early identification and management of newly-established weed infestations could prevent further transmission and establishment of weed species within the site.

Several weed species were evident associated with exploration activities. The majority of sightings were at the main camp site (Plate 4.11) and the Arruwurra camp. Minemakers is in the process of contracting a local environmental management group, Arunga Land Protectors, to carry out weed management on site. This is scheduled to take place within the month of August 2011.

**Weeds evident at  
camp site.**

As mentioned previously, for future on site activities, Minemakers will implement a machinery wash down and inspection procedure that will assist in the prevention of importing weeds to the site. In addition, cattle activity (tracks and droppings) was observed during the audit. It is possible that cattle are a source of weed transmission around the site.
