McCarthy Hill Rehabilitation Progress Report (EL22440) – Feb 2012

February 2012

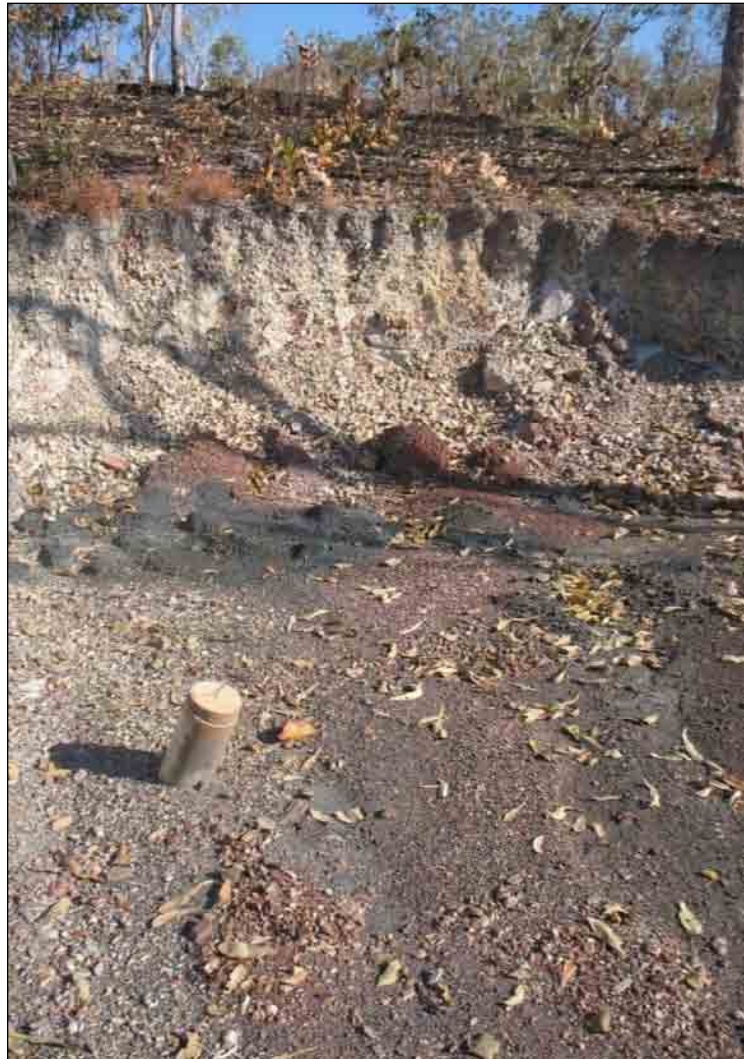
As per protocol for drill holes all PVC collars are temporarily plugged with concrete plugs (Figure 1). There is no waste present on site, as all sample bags and general waste have been removed. Some star picket survey poles remain throughout the area that will be removed upon completion of all works on site.

Figure 4 Plugged PVC Collar at MHRC 014

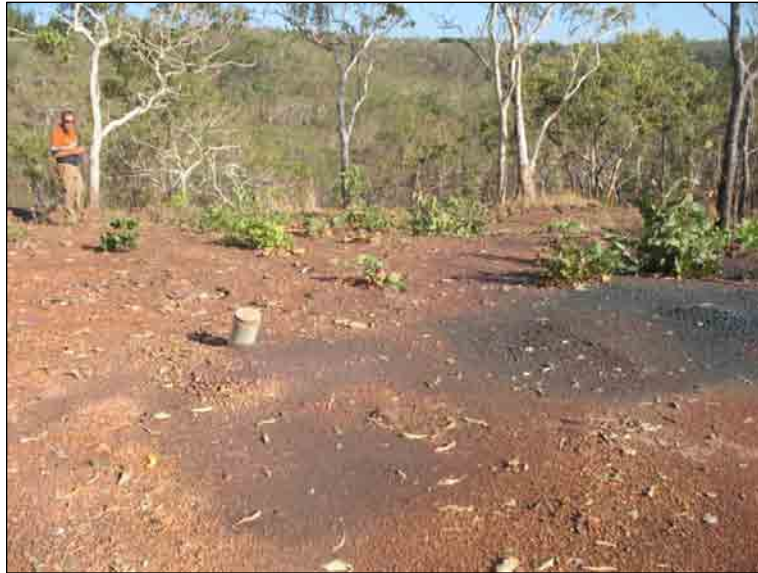
A small amount of natural bush regeneration was noted on several drill pads, particularly MHRC 017 and MHRC 009, in addition to some of the access tracks (Figure 2). Observations during site visit indicated that there are no weeds in the area.

Figure 5: Vegetation Regrowth at MHRC 017

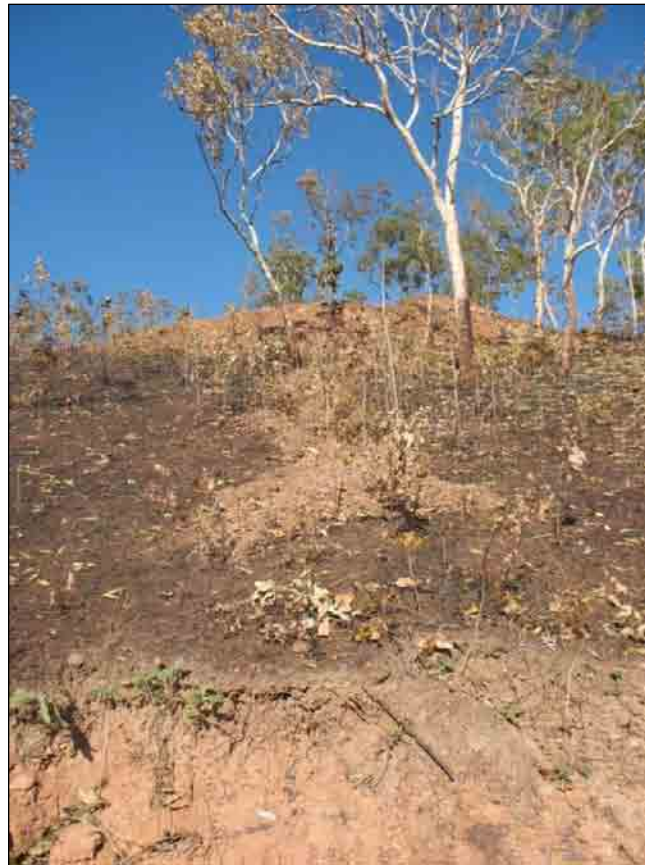
Erosion gullies had formed downhill from several of the drill pads during heavy rain in early 2011, the largest of which is above drill hole MHRC 012 (Figure 3 and Figure 4). The erosion was restricted to a small number of drill pads; however it was noted as a potential issue for the coming wet season and therefore required consideration during rehabilitation.

Figure 6: Erosion gully uphill from MHRC 012

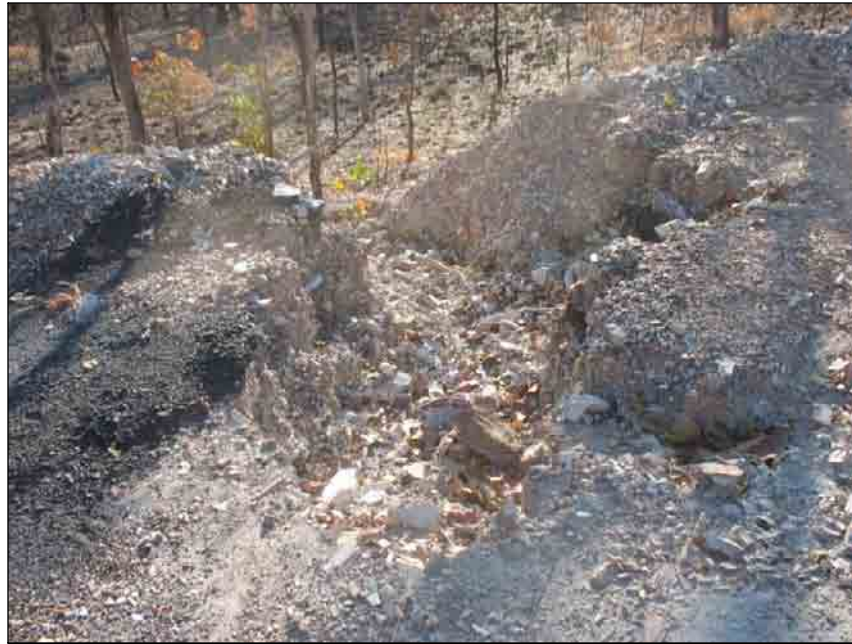
Figure 7: Erosion Gully at MHRC 024

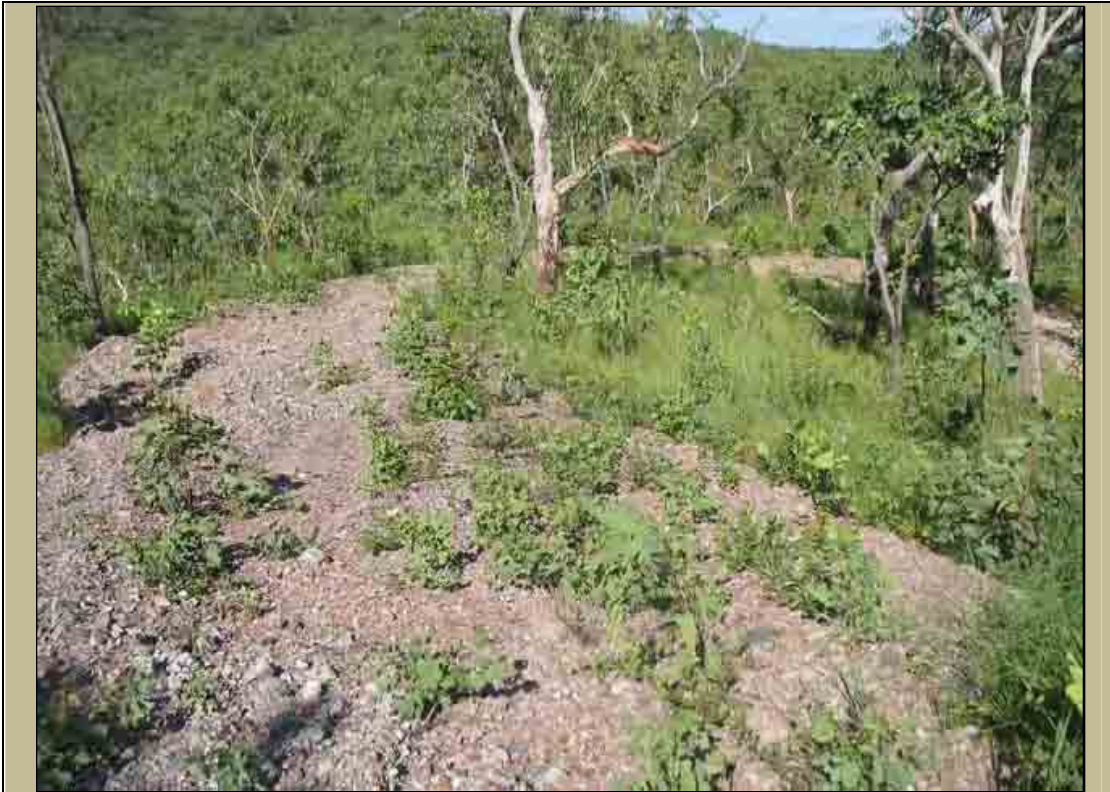
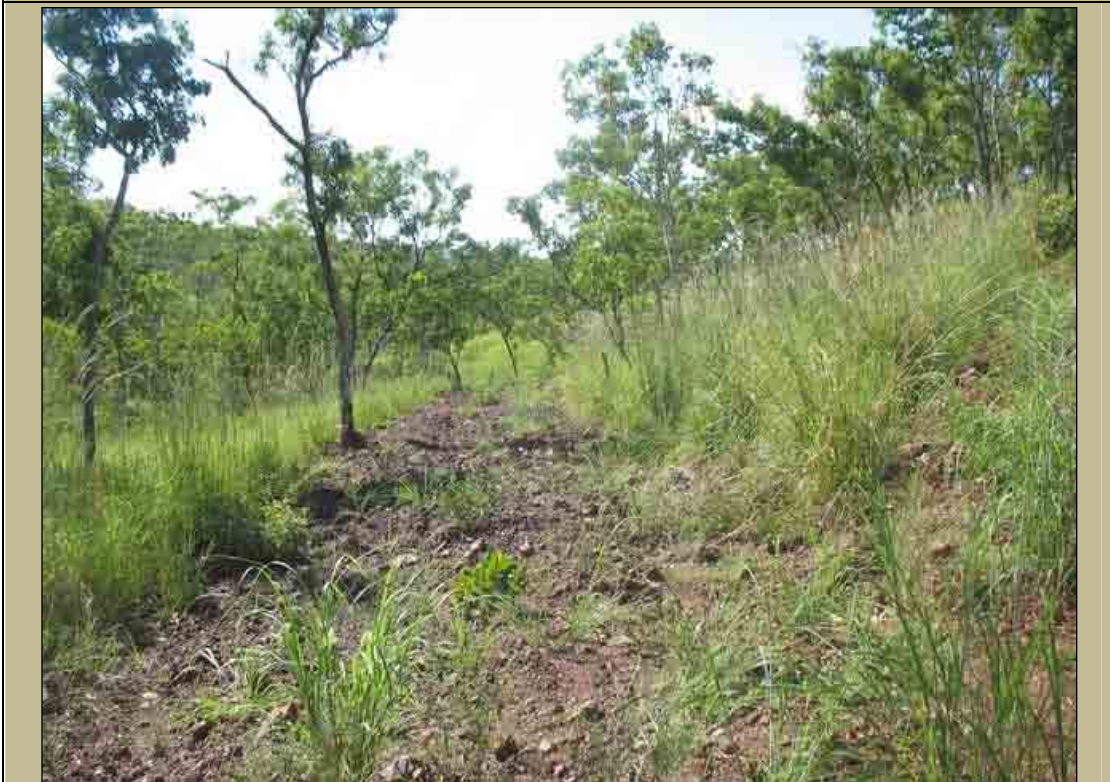
Above/Below: Natural regrowth on recontoured access tracks – Zone B.

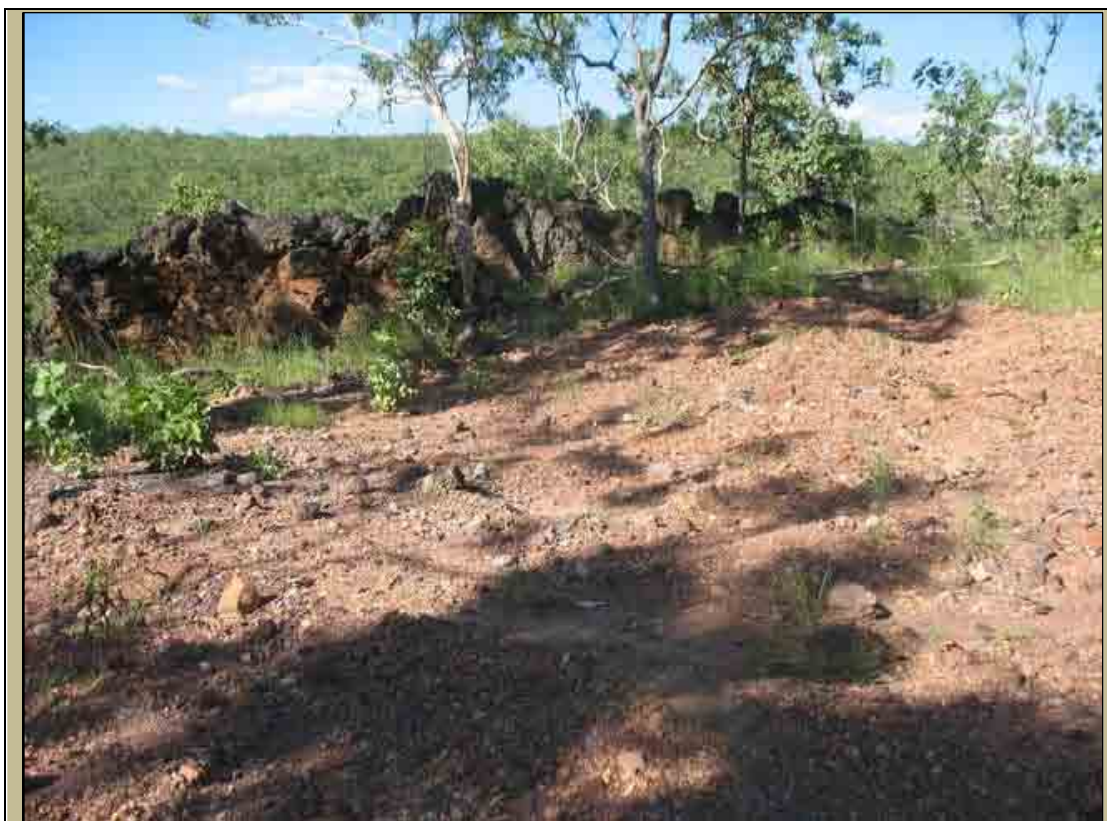
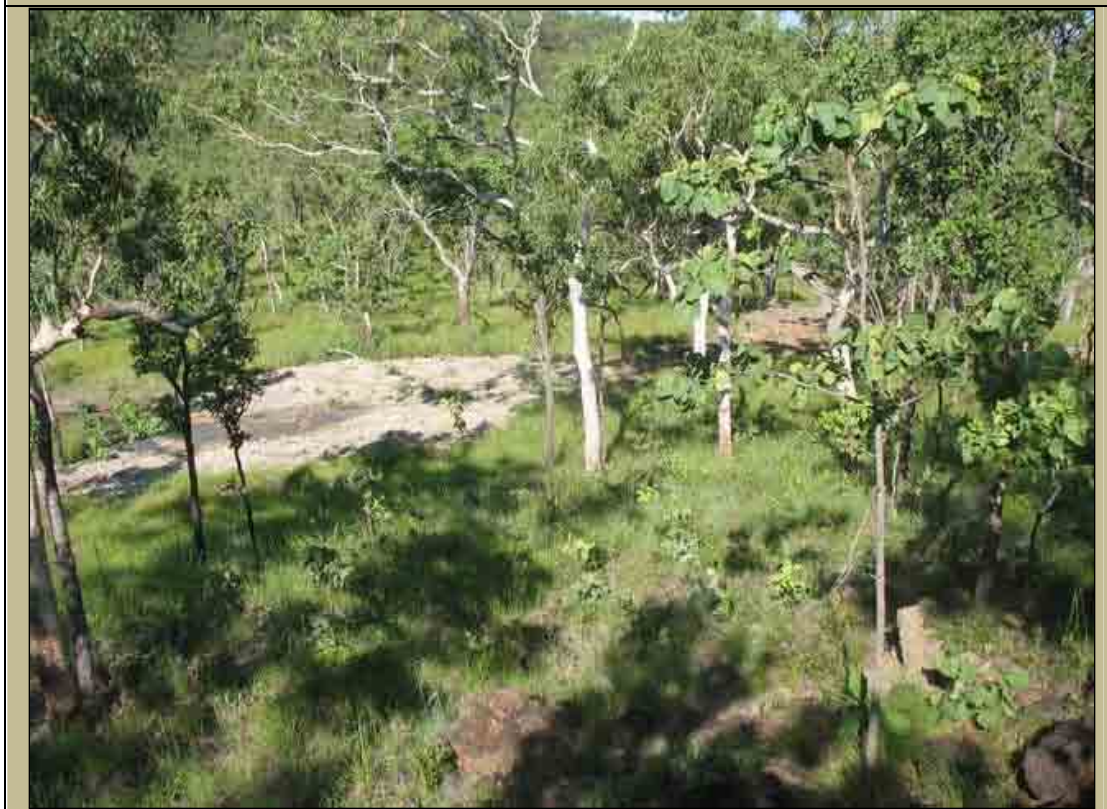
Above/Below: Recontoured drill pads – Rehabilitation Zone A.

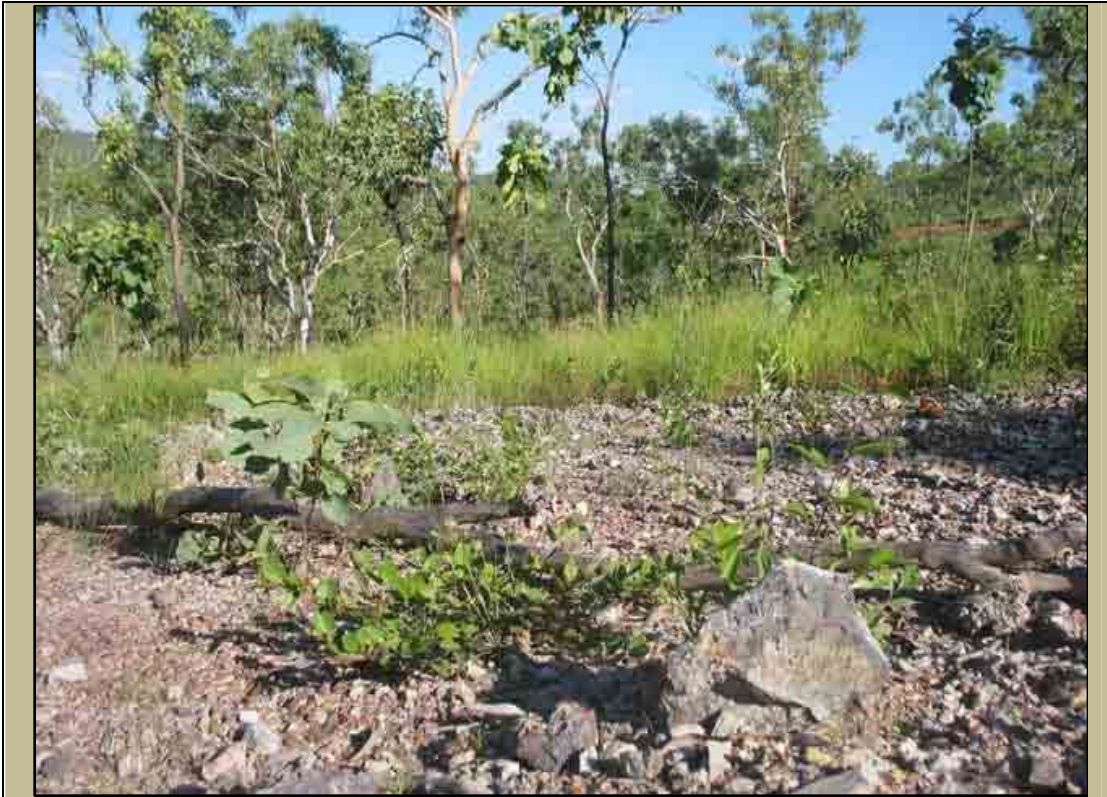
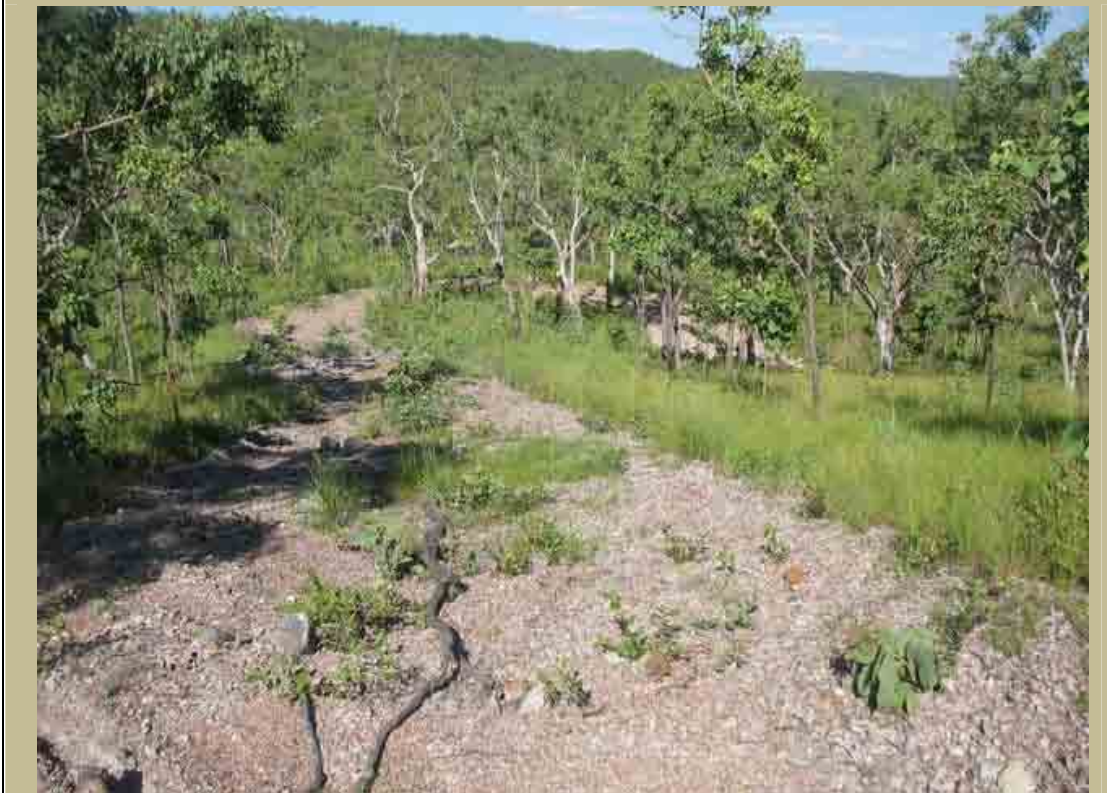
Above/Below: Natural and seeded regeneration – Rehabilitation Zone B

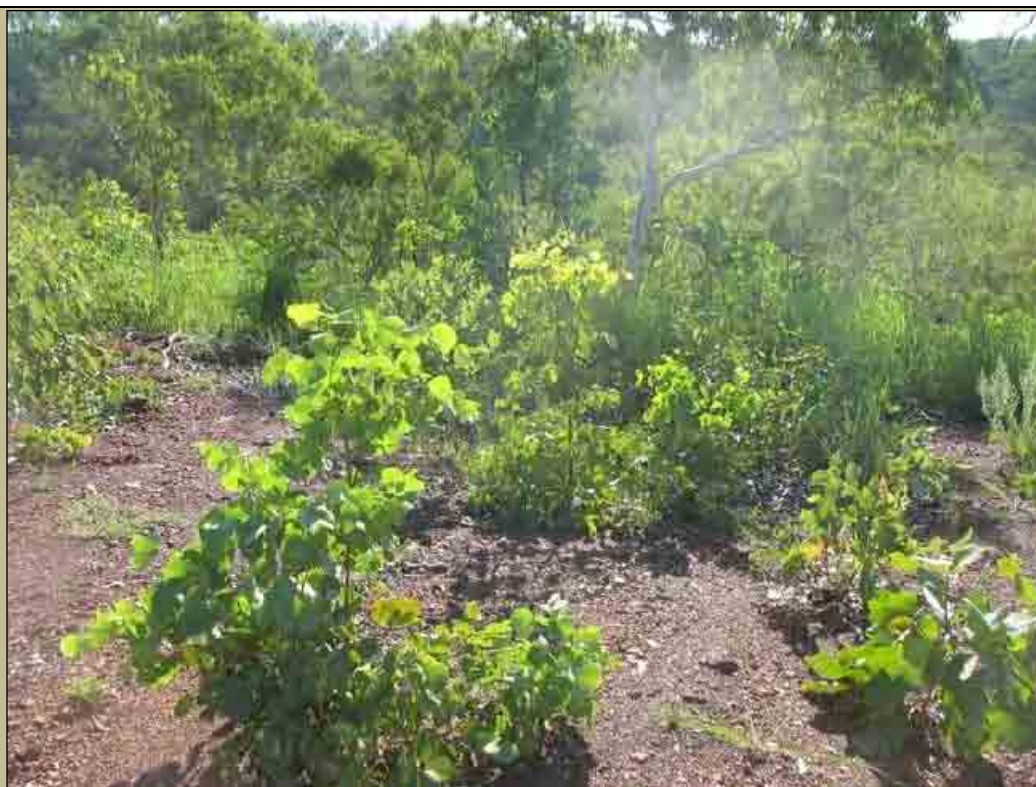
Above: Natural regeneration – Zone B.
Below: Recontoured access track – Zone B

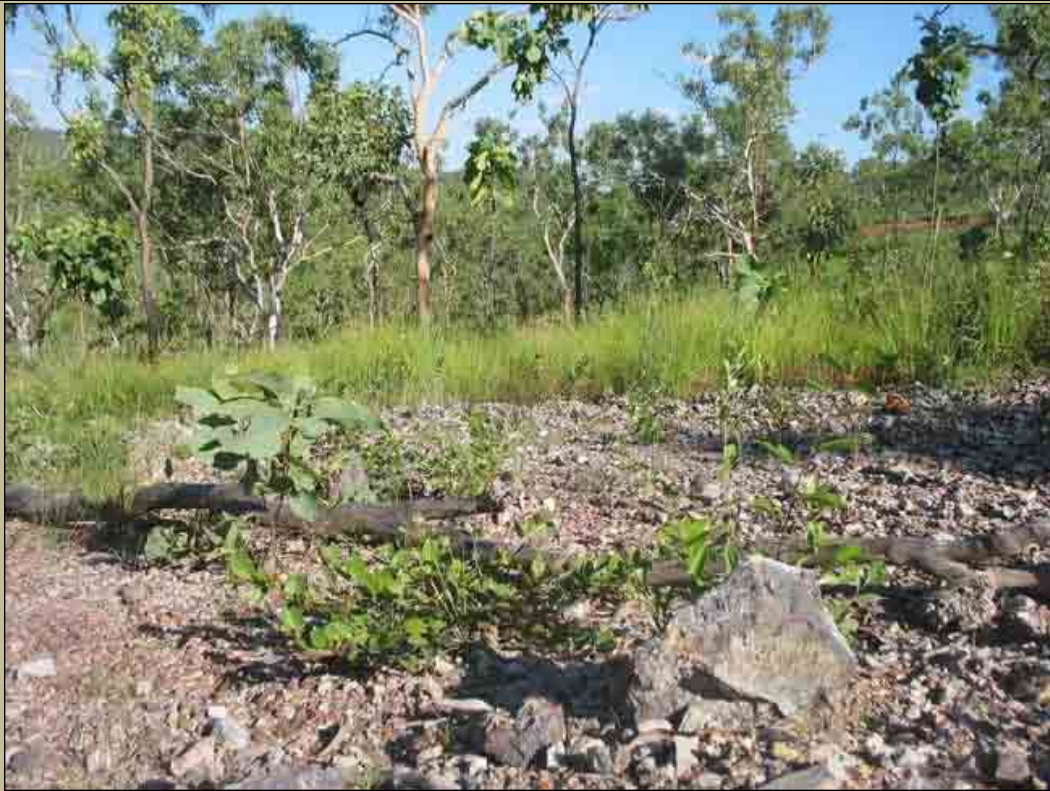
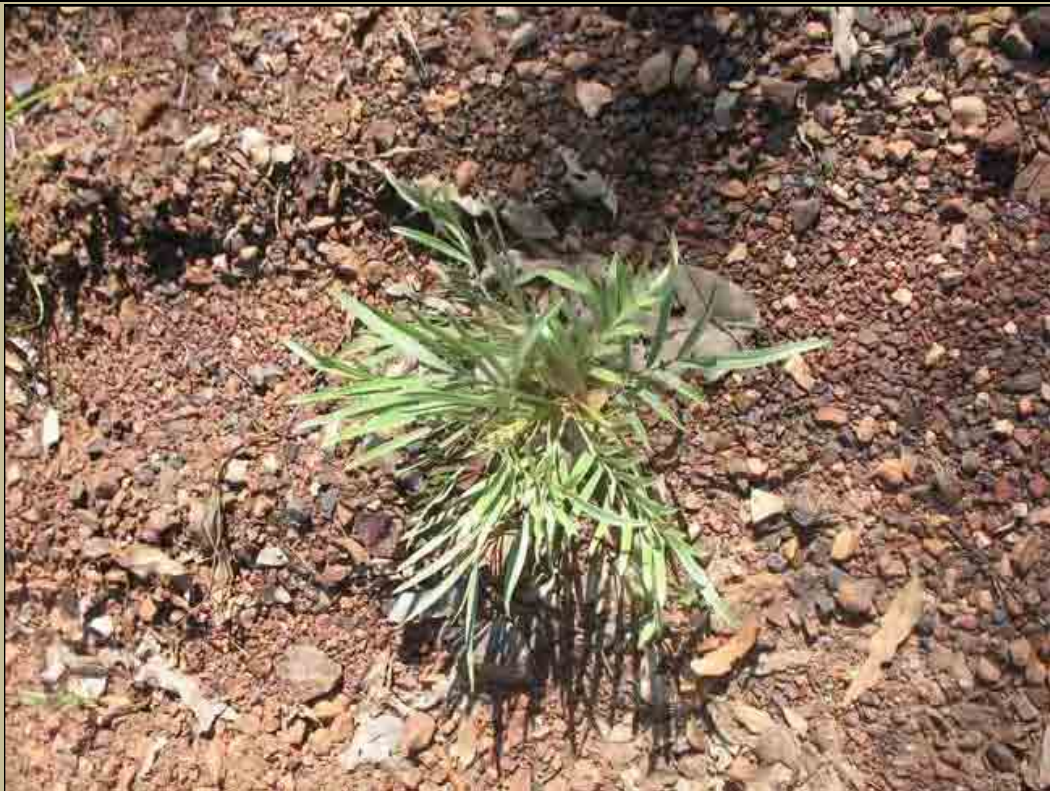
Above/Below: Natural regeneration – Zone B.

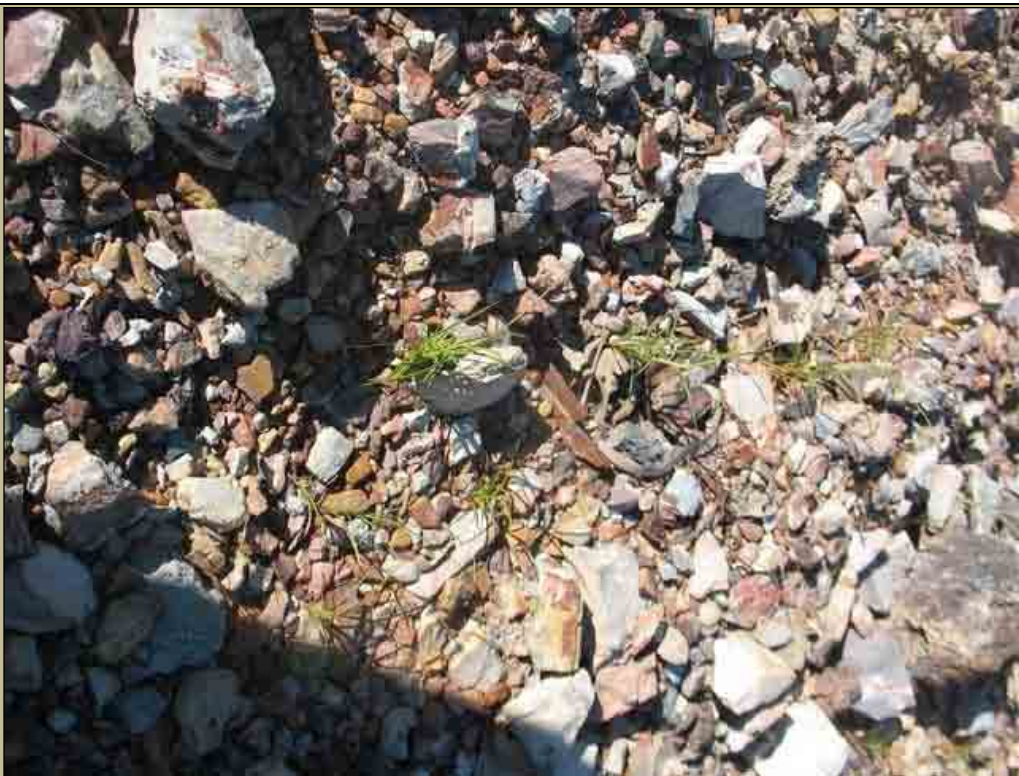
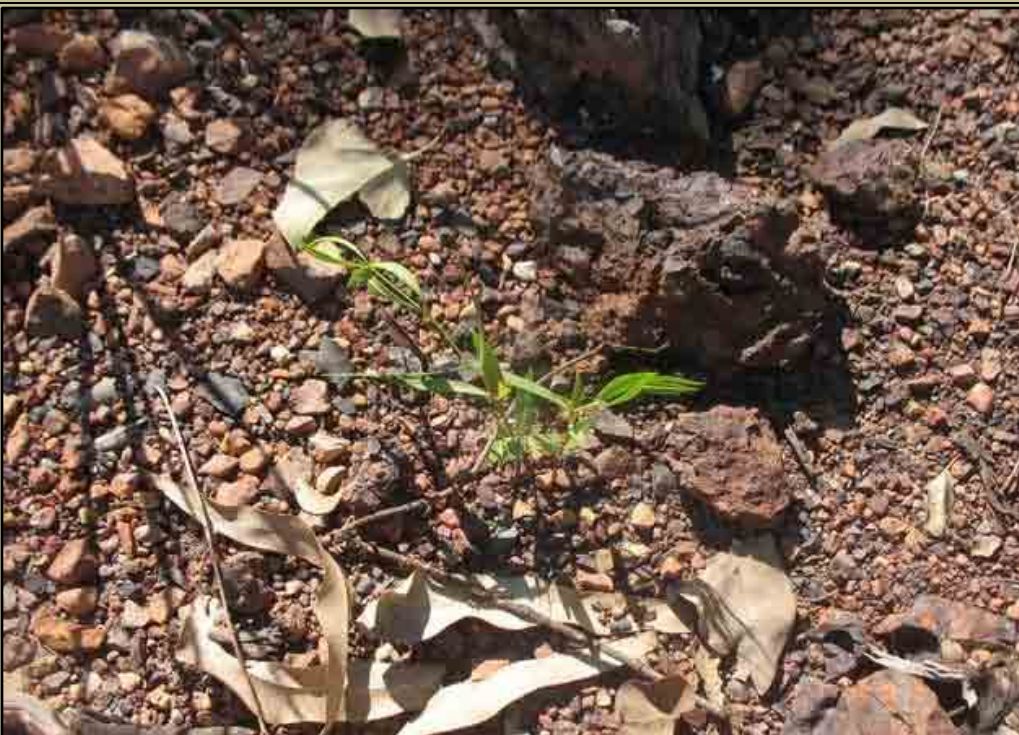
Above/Below: Seeded Regeneration – Zone A
