McCarthy Hill Rehabilitation Progress Report (EL22440) – Feb 2013

TERRITORY
IRON

February 2013

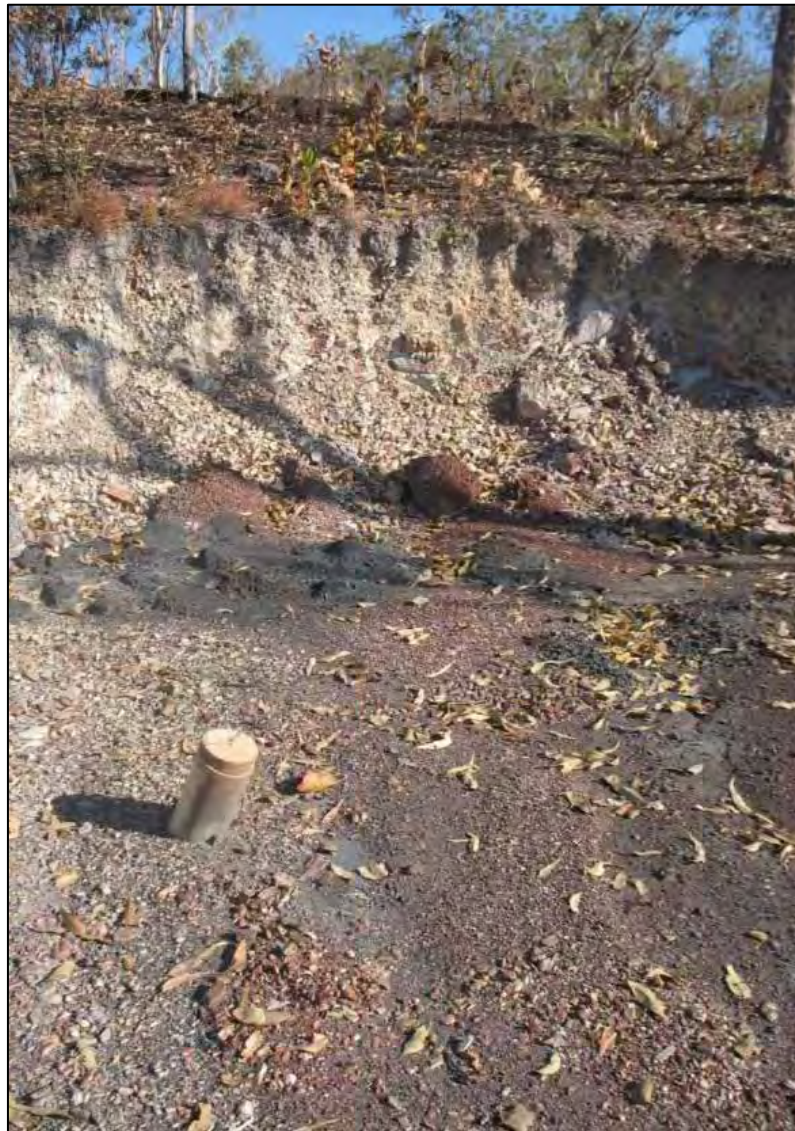
Figure 4 Plugged PVC Collar at MHRC 014

As per protocol for drill holes all PVC collars are temporarily plugged with concrete plugs (Figure 1). There is no waste present on site, as all sample bags and general waste have been removed. Some star picket survey poles remain throughout the area that will be removed upon completion of all works on site.

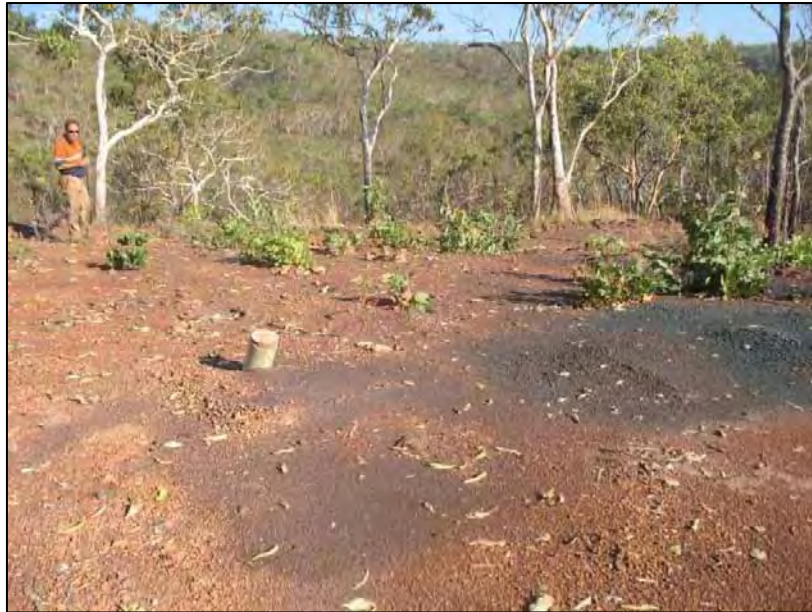
Figure 5: Vegetation Regrowth at MHRC 017

A small amount of natural bush regeneration was noted on several drill pads, particularly MHRC 017 and MHRC 009, in addition to some of the access tracks (Figure 2). Observations during site visit indicated that there are no weeds in the area.

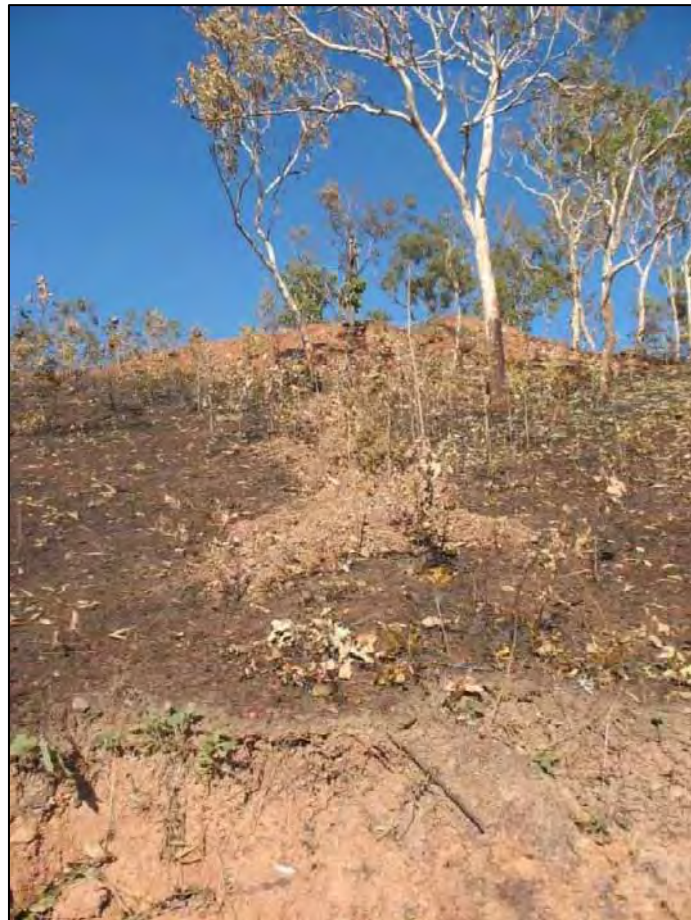
Figure 6: Erosion gully uphill from MHRC 012

Erosion gullies had formed downhill from several of the drill pads during heavy rain in early 2011, the largest of which is above drill hole MHRC 012 (Figure 3 and Figure 4). The erosion was restricted to a small number of drill pads; however it was noted as a potential issue for the coming wet season and therefore required consideration during rehabilitation.

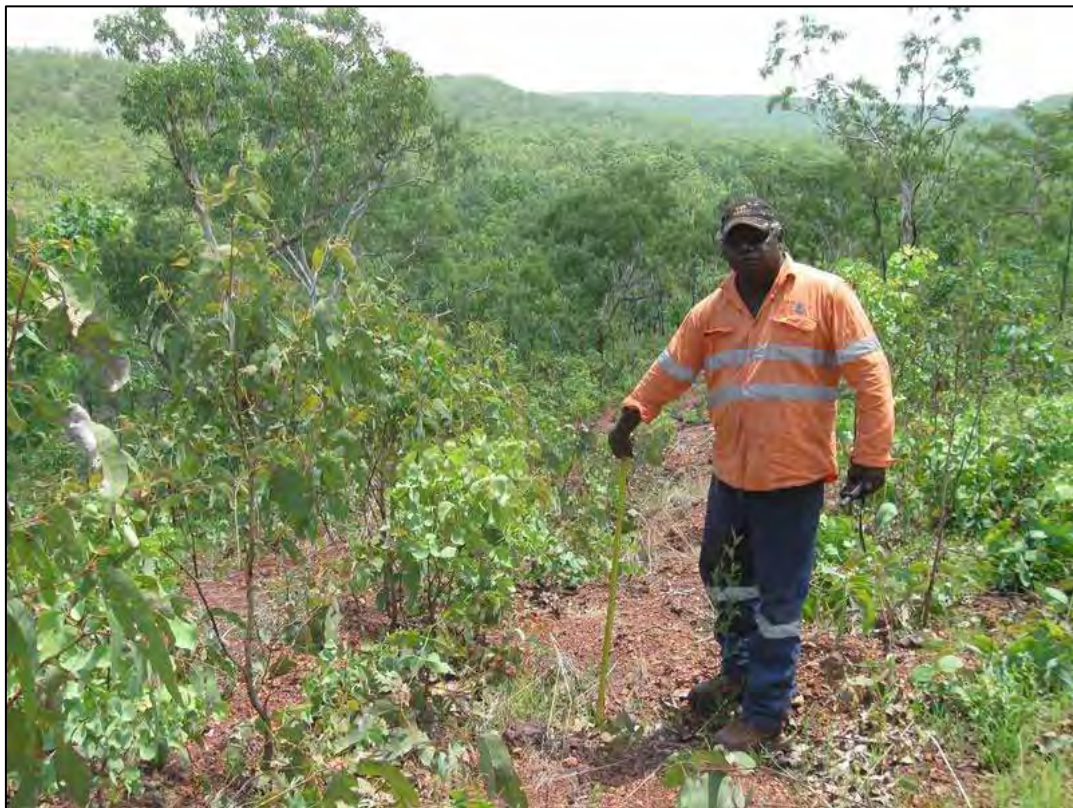
Figure 8: Drill Pad Rehabilitation (Zone C) – December 5 2012

As presented in Figures 8 - 11, revegetation growth has generally been sporadic over the past 12 months. Whilst this is not unexpected, the low levels of seed germination were perhaps owed to the density of seeds spread, coupled with the late timing of initial seeding. Typically, revegetation is slow to establish within the first 12 months with more rapid plant growth during 12-24 month period once plant root systems become established and seeds that have lain dormant germinate.

Erosion and sediment loss appeared to minimal and not dissimilar to natural runoff patterns.

To assist with accelerating rehabilitation at the site, infill seeding was undertaken by Traditional Owners during mid-December 2012.

Seeding used a mixture of species outlined in Appendix 1 and hand spread at a rate of approximately 5kg/ha.

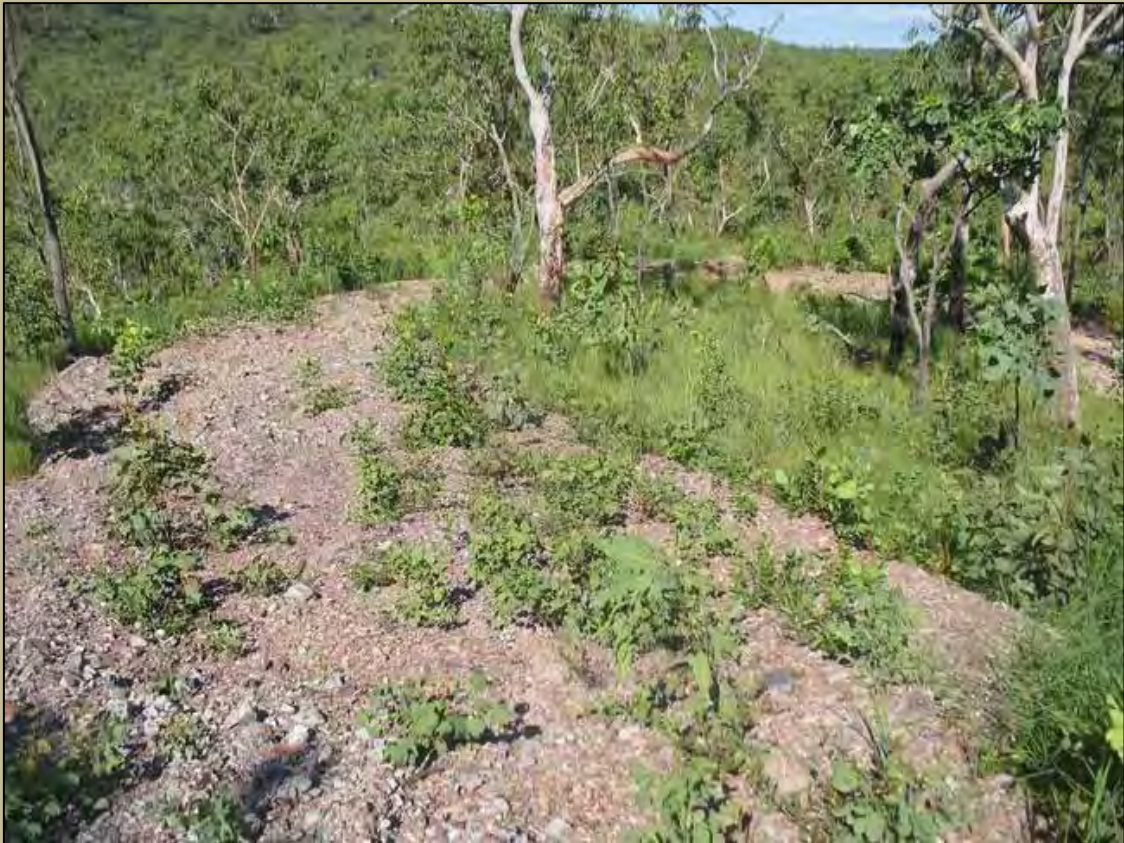
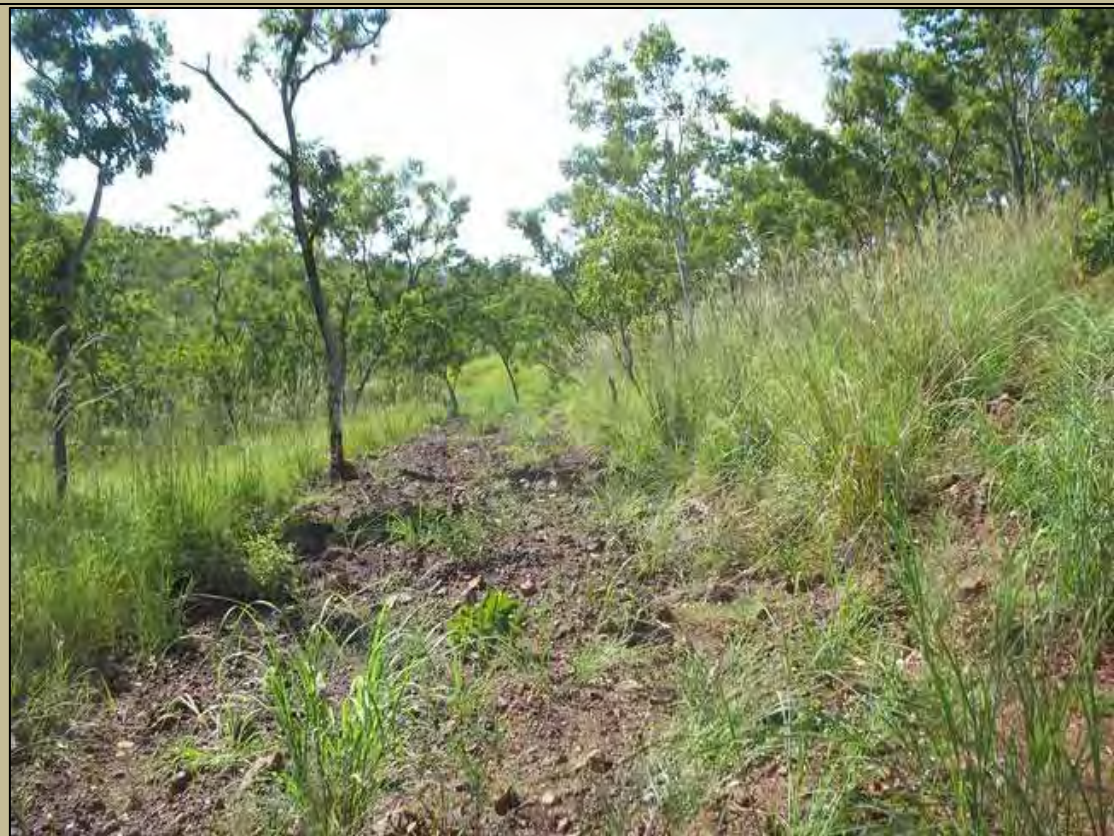
Above/Below: Natural regrowth on re-contoured access tracks – Zone B.

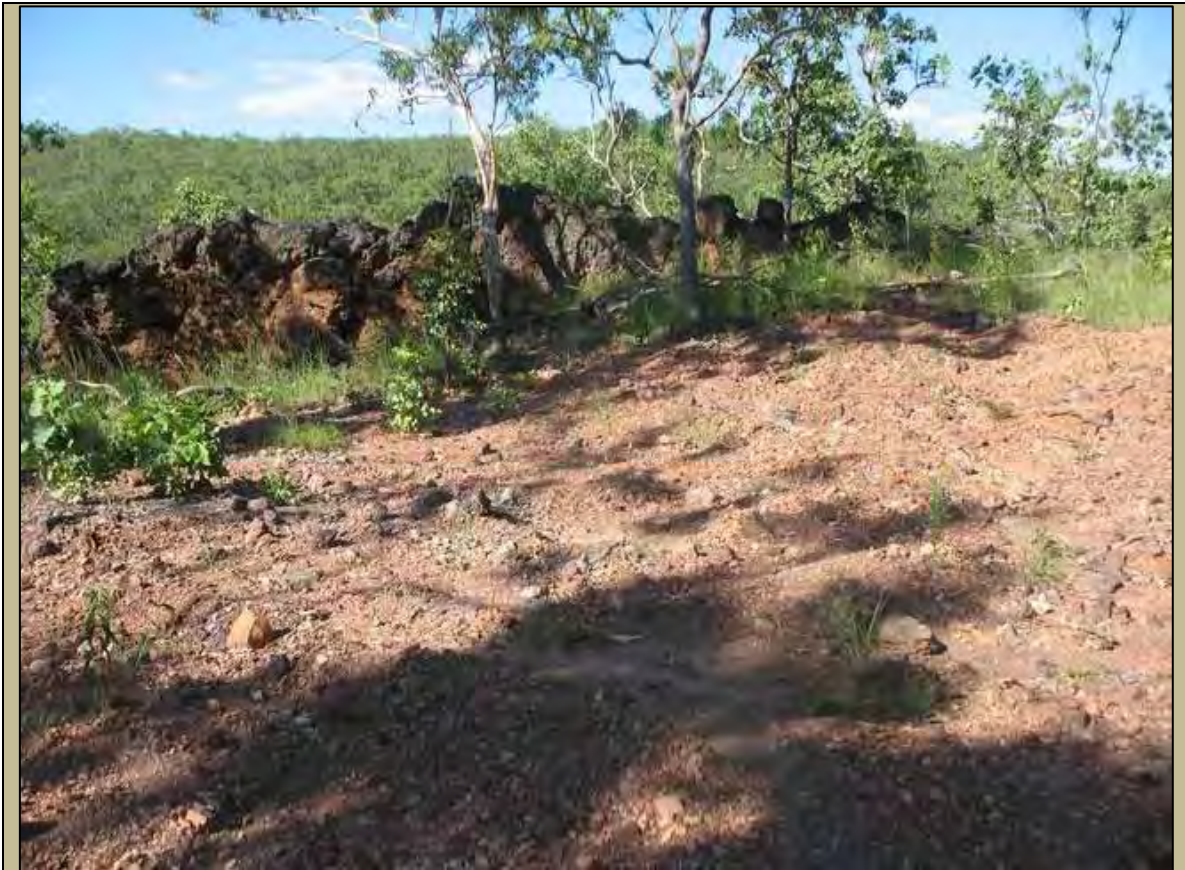
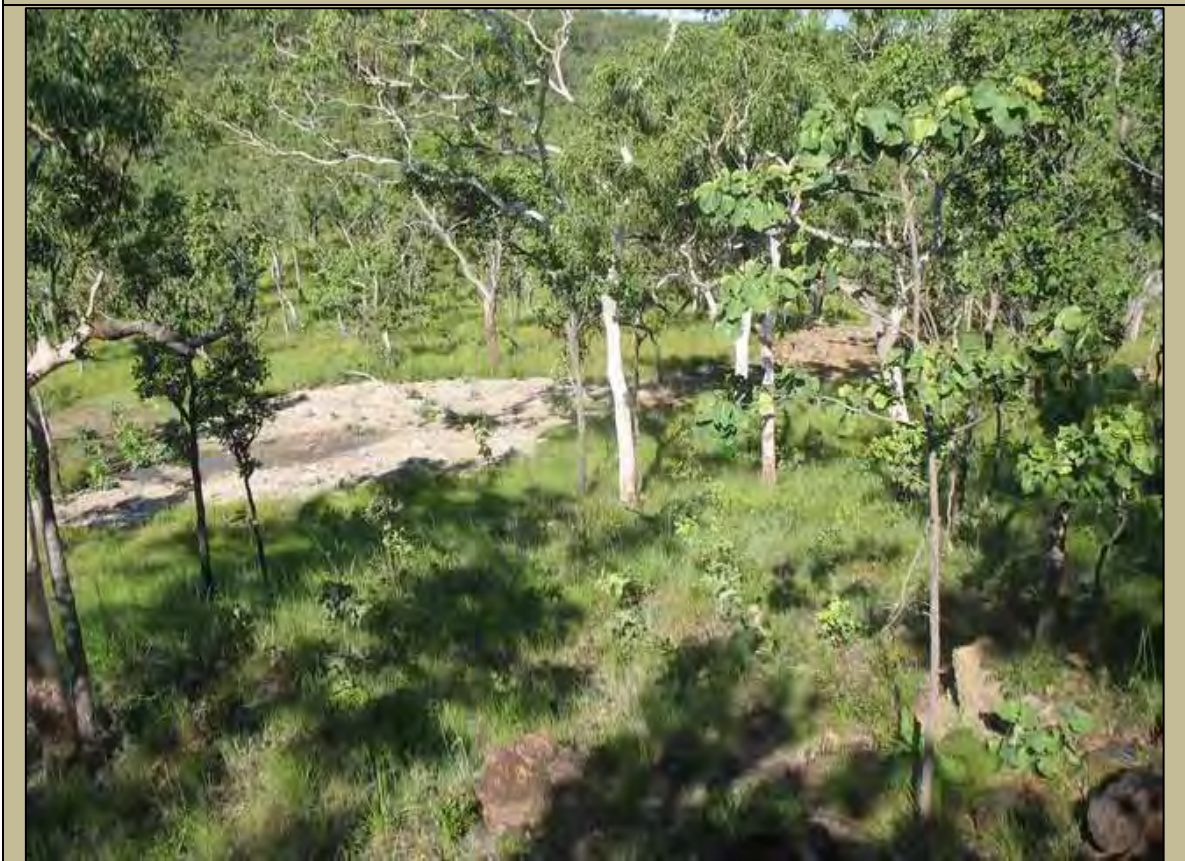
Above/Below: Re-contoured drill pads – Rehabilitation Zone A.

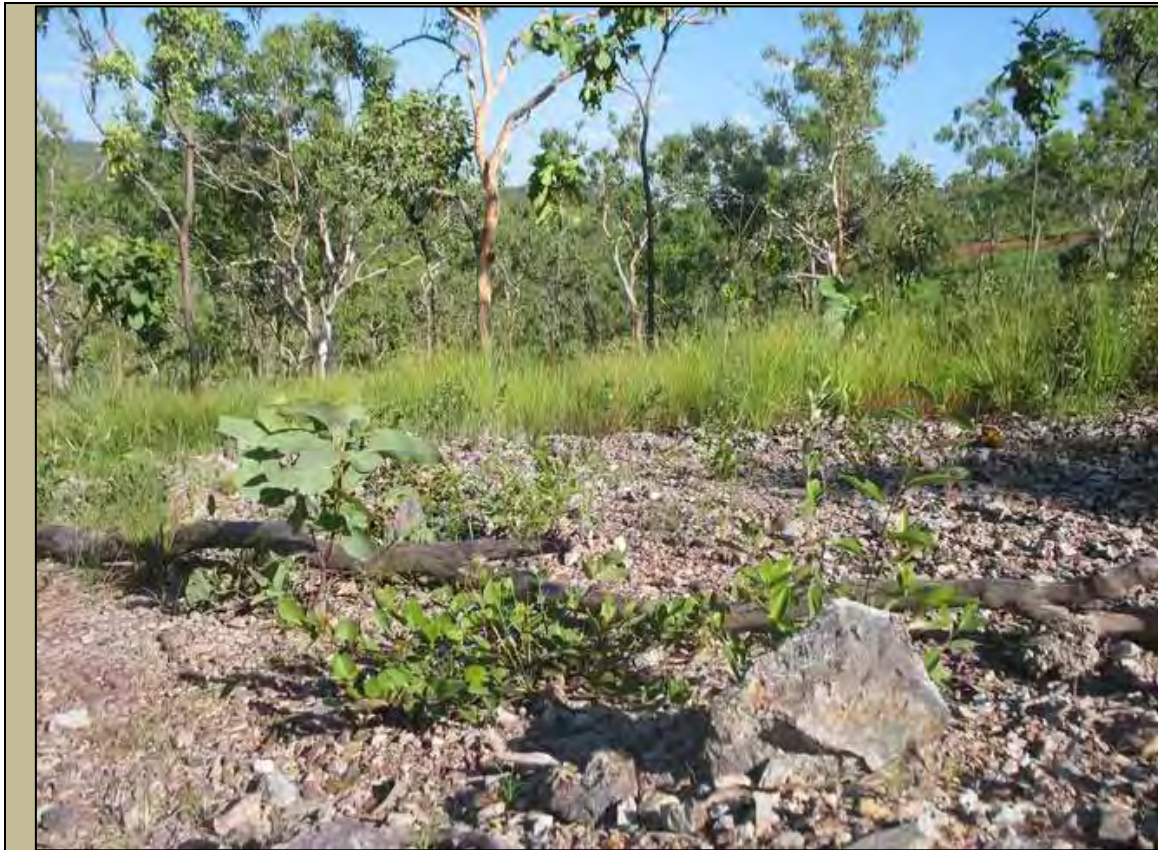
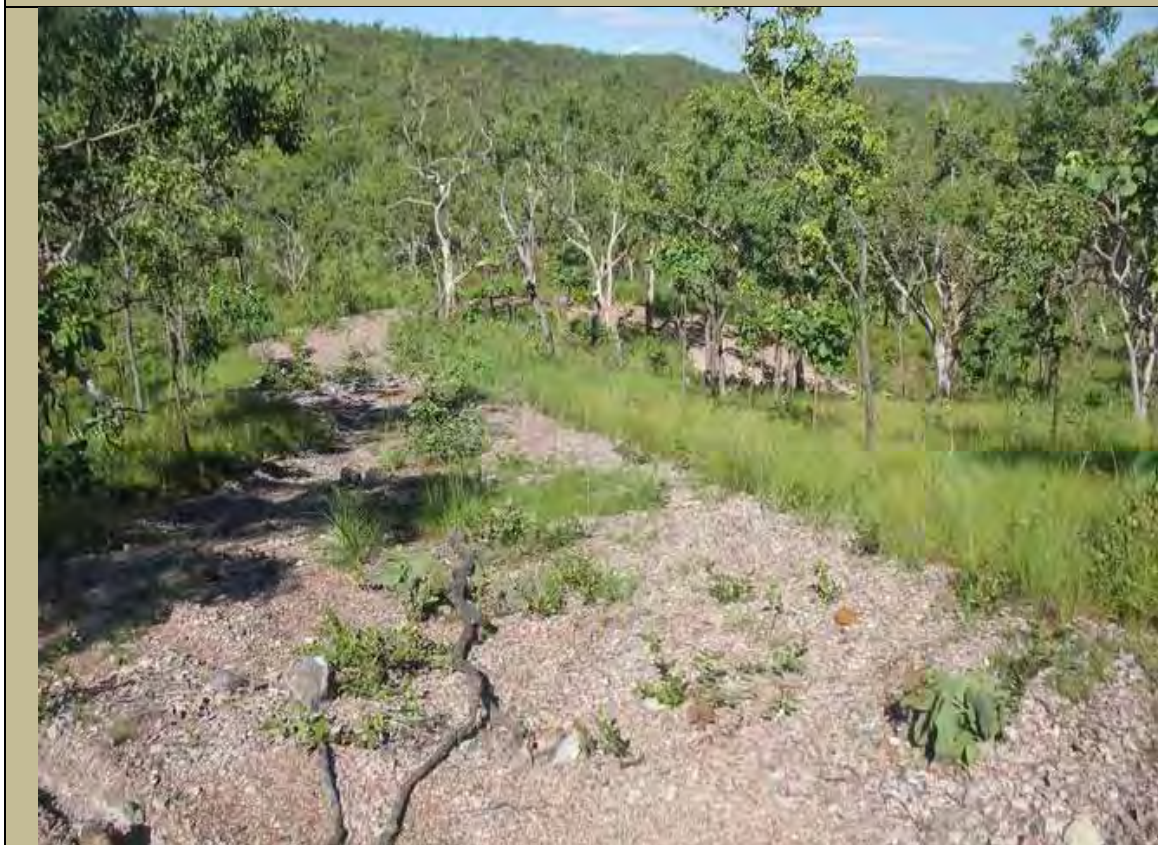
Above/Below: Natural and seeded regeneration – Rehabilitation Zone B

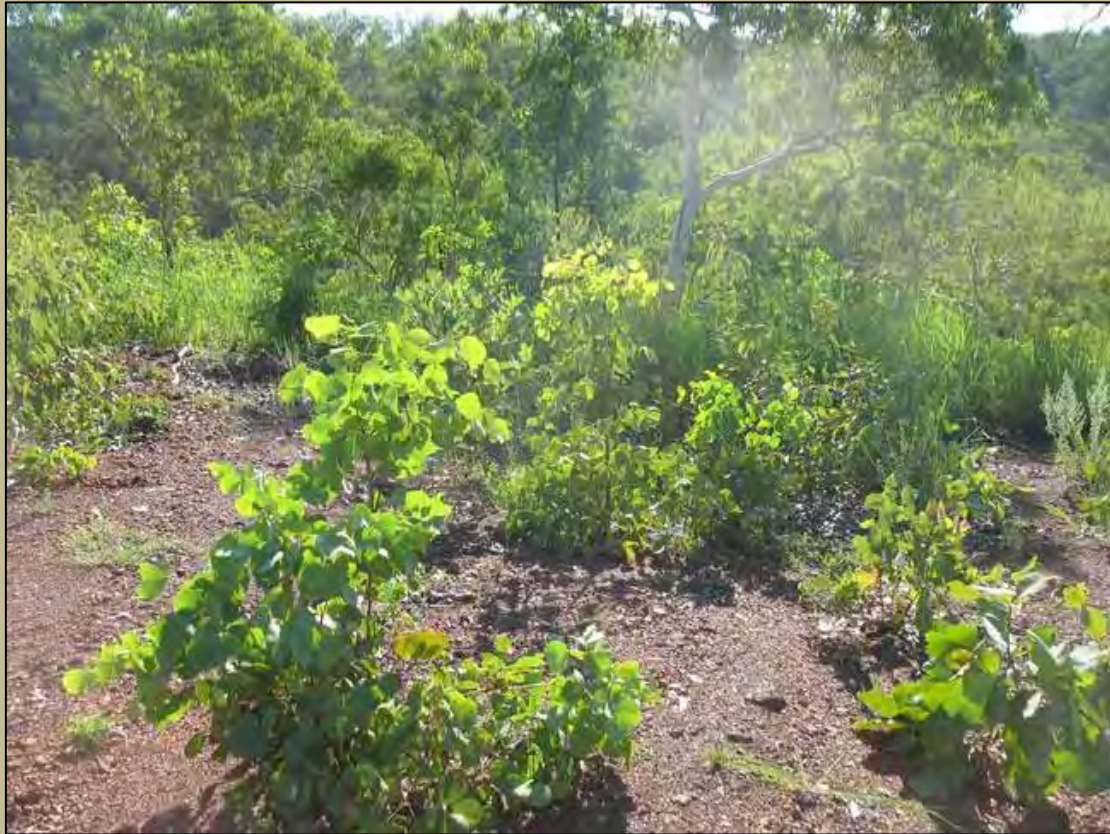
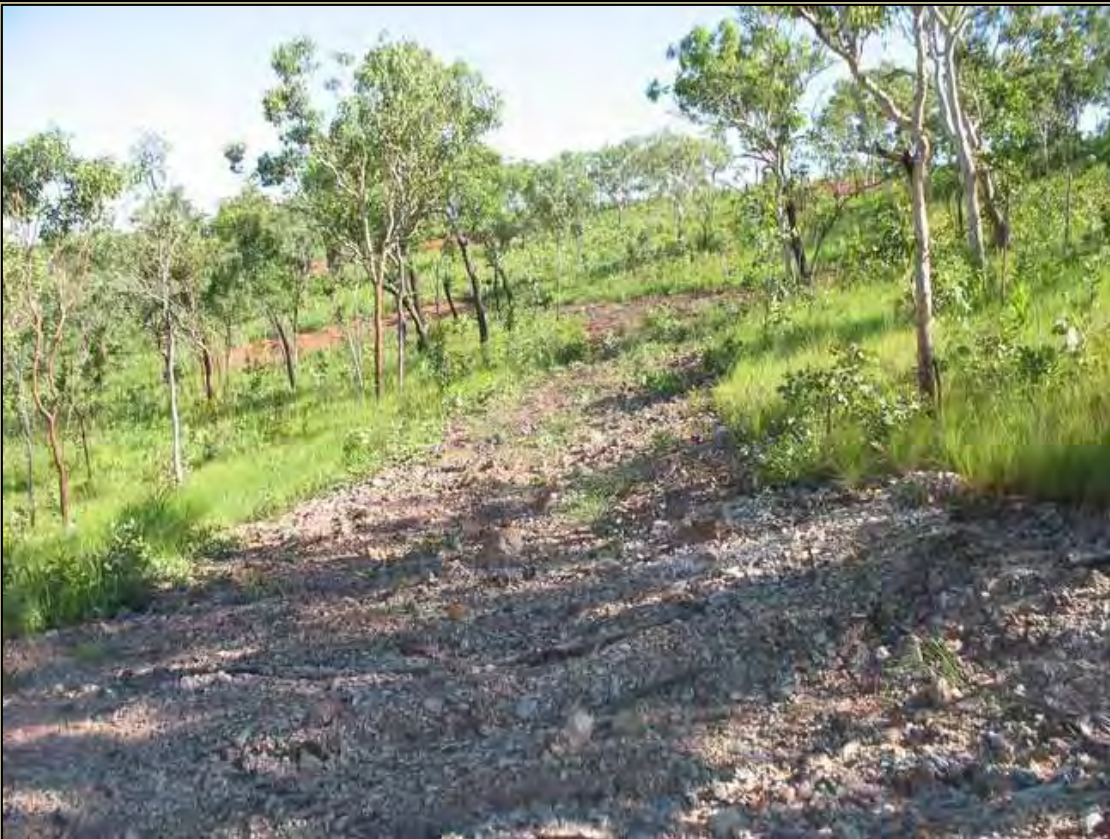
Above: Natural regeneration – Zone B.
Below: Re-contoured access track – Zone B

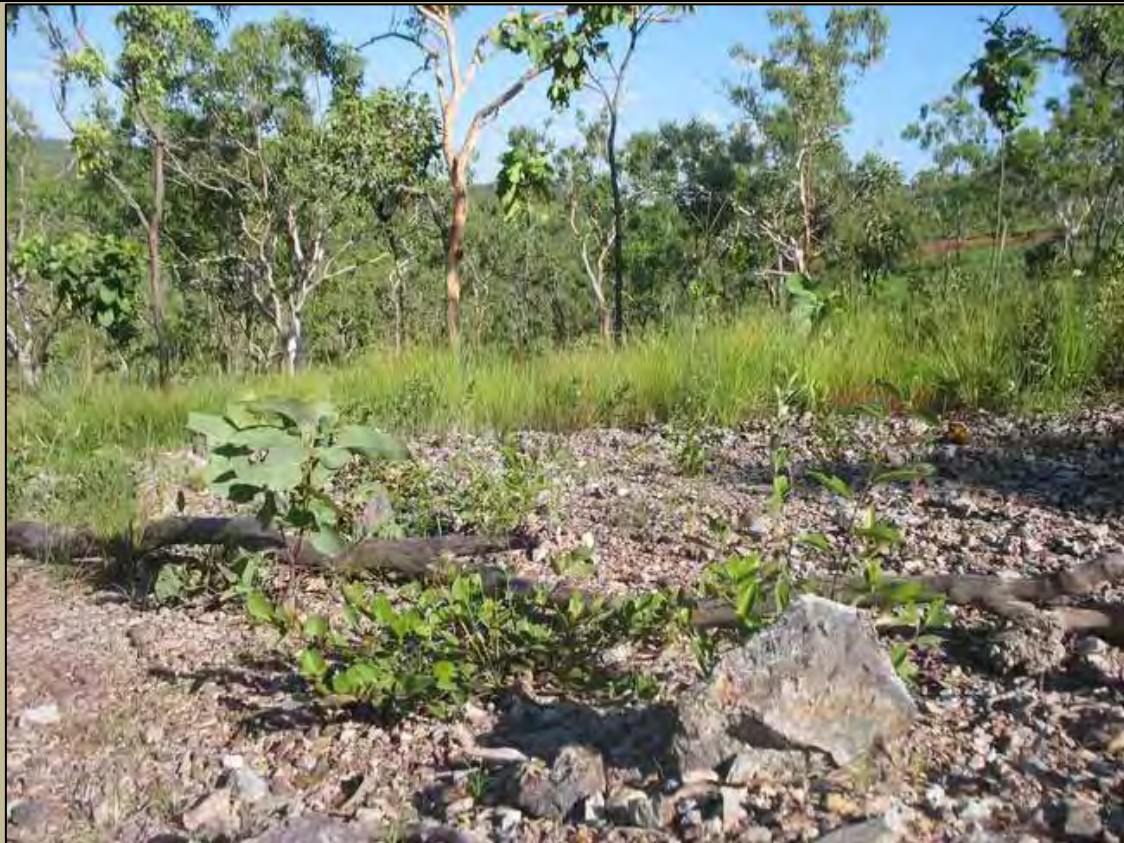
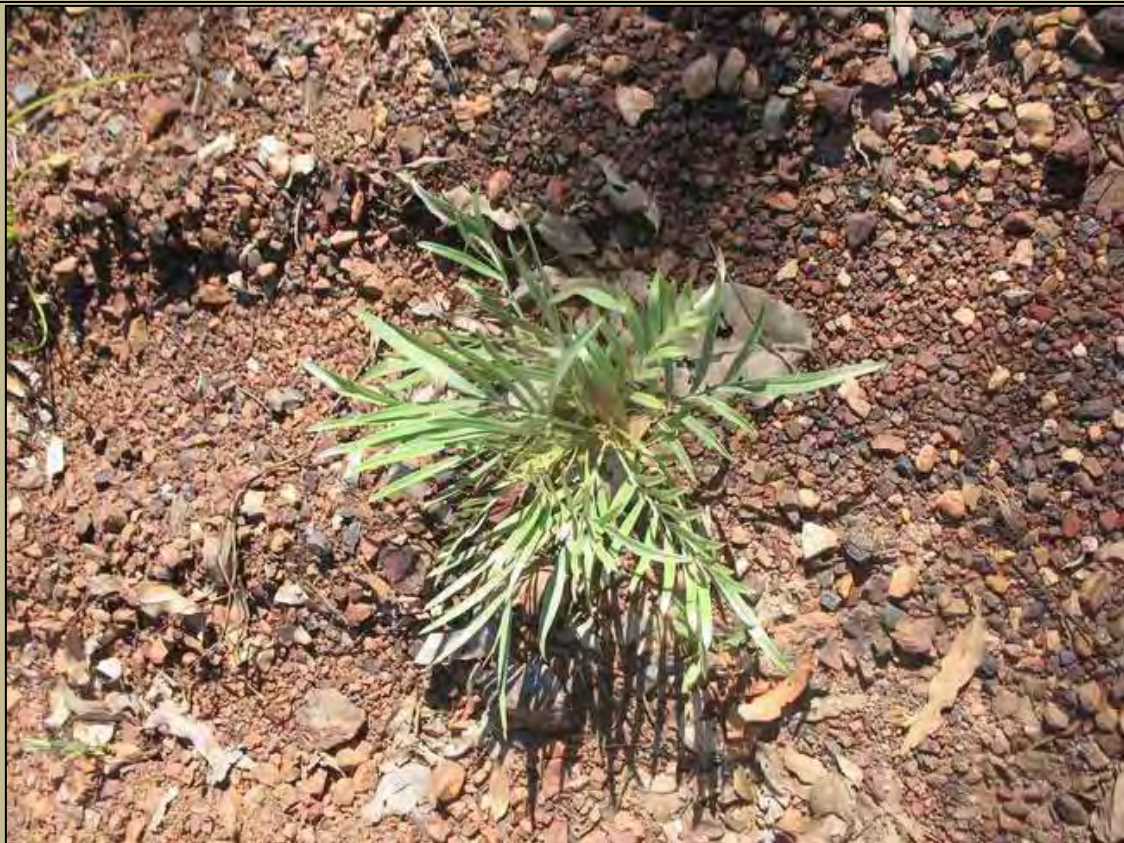
Above/Below: Natural regeneration – Zone B.

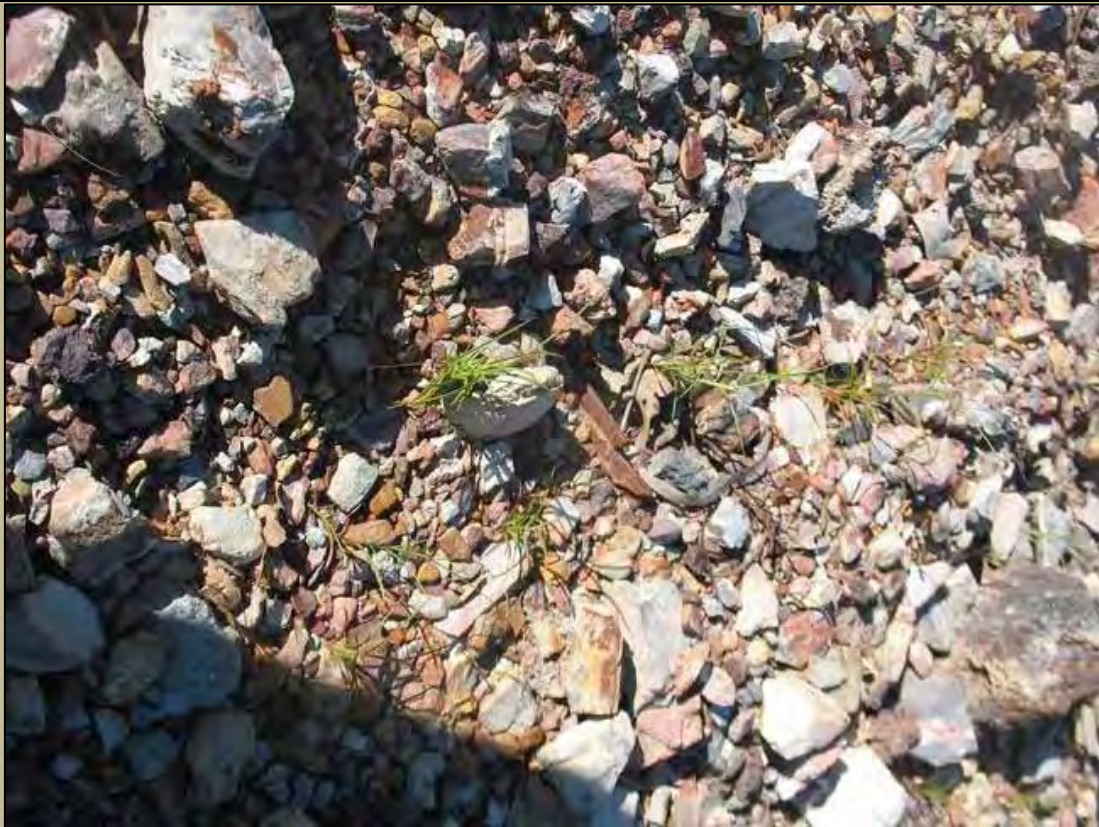
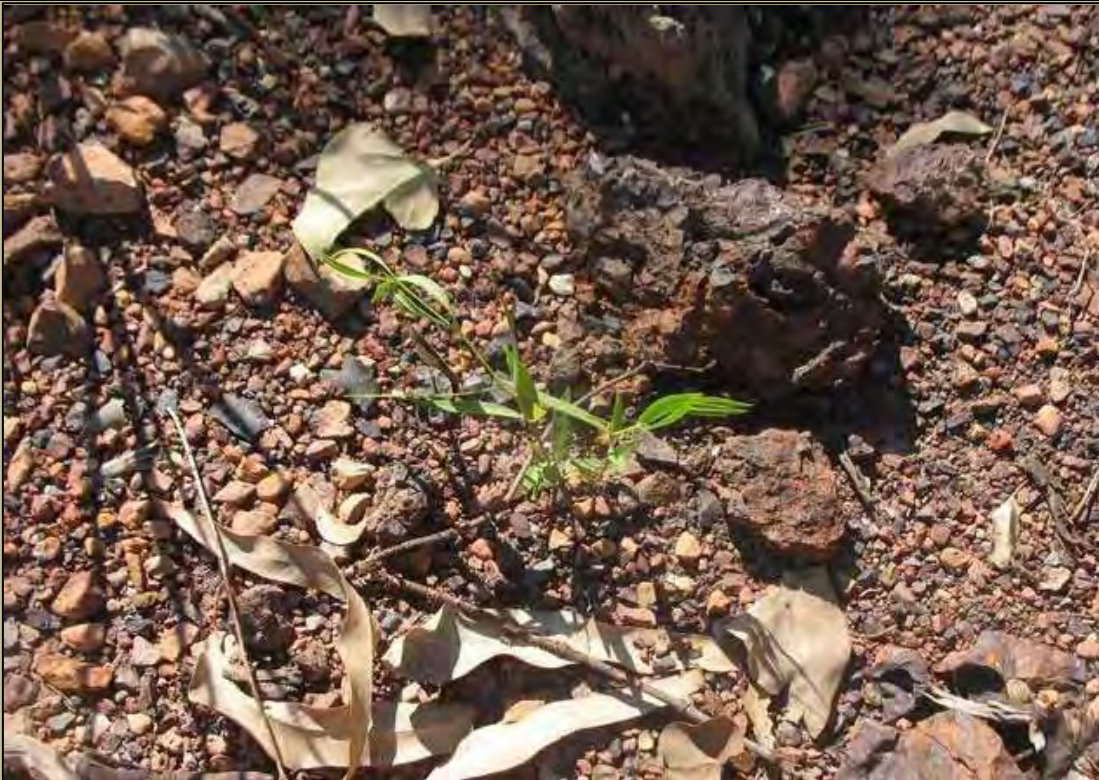
Above/Below: Seeded re-vegetation – Zone A
