Merlin Diamonds Limited

SURRENDER REPORT FOR EXPLORATION LICENCE 24082 "AQUA PROJECT"

For The Period 17th October 2005 to 16th October 2015

REPORT TITLE: Surrender Report for EL24082 "Aqua Project"

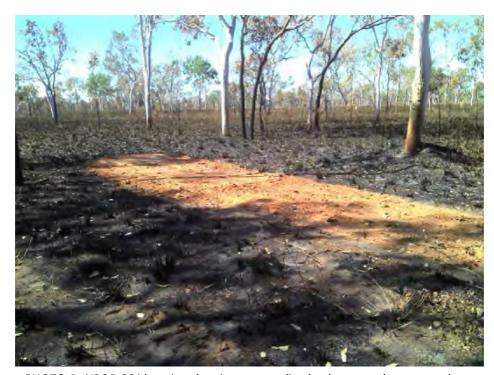
PHOTO 4: NBOR-004 location showing surrounding landscape and recent works to return site to close to original topography (28th May 2012)

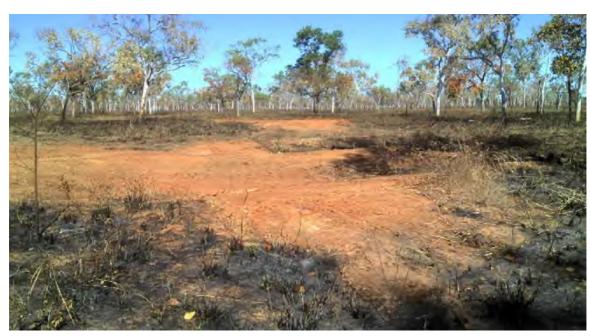
PHOTO 5: NBOR-005 location showing surrounding landscape and recent works to return site to close to original topography (28th May 2012)

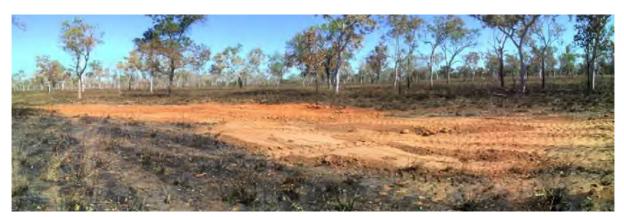
PHOTO 6: NBOR-006 location showing surrounding landscape and recent works to return site to close to original topography (28th May 2012)

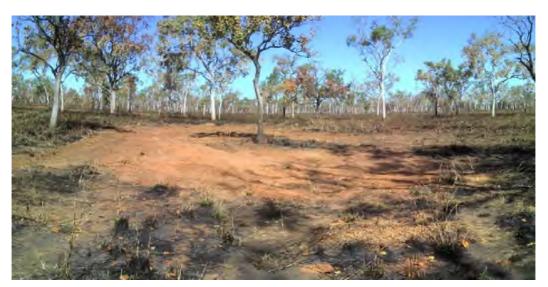
PHOTO 7: NBOR-007 location showing surrounding landscape and recent works to return site to close to original topography (28th May 2012)

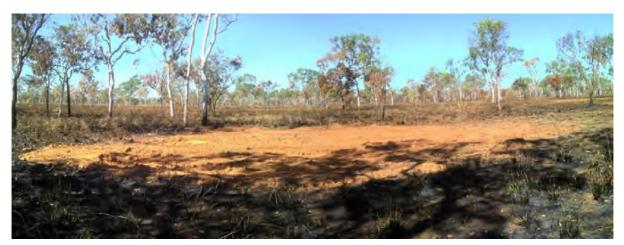
PHOTO 8: NBOR-008 location showing surrounding landscape and recent works to return site to close to original topography (28th May 2012)

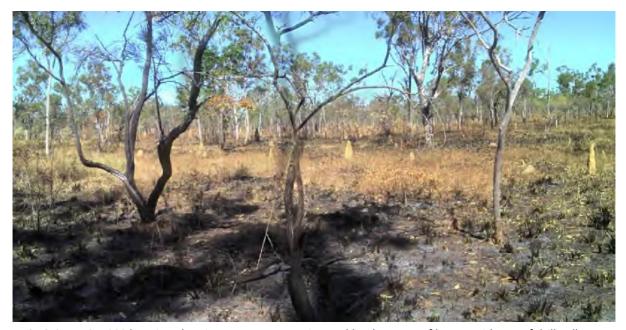
PHOTO 9: NBOR-009 location showing current vegetation and landscape profile. No evidence of drill collar or subsidence was observed (28th May 2012)

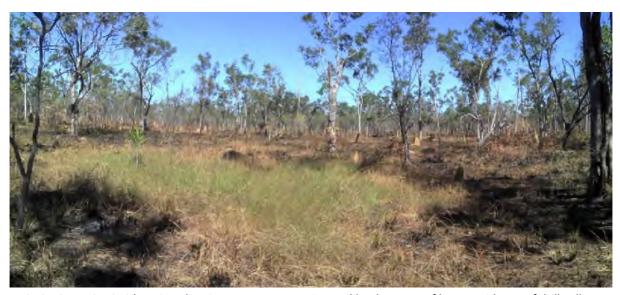
PHOTO 10: NBOR-010 location showing current vegetation and landscape profile. No evidence of drill collar or subsidence was observed (28th May 2012)

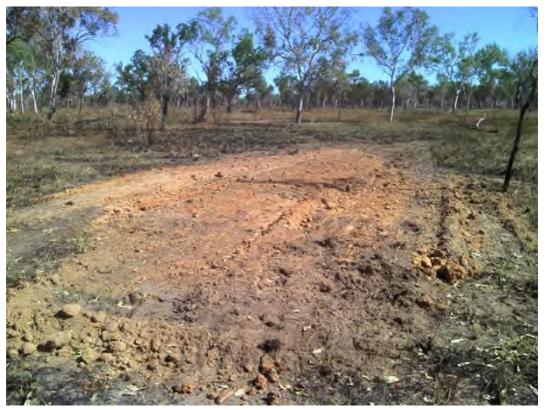
PHOTO 11: NBOR-011 location showing surrounding landscape and recent works to return site to close to original topography (28^{th} May 2012)

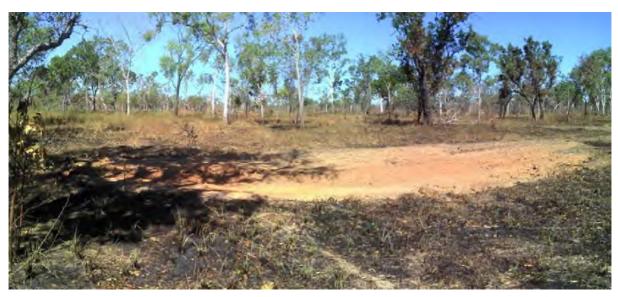
PHOTO 12: NBOR-012 location showing surrounding landscape and recent works to return site to close to original topography (28th May 2012)

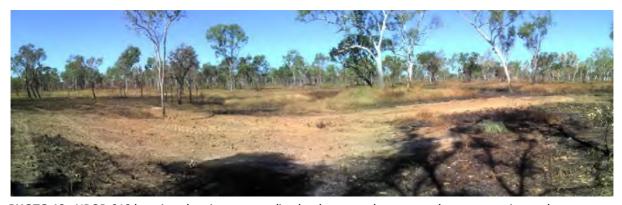
PHOTO 13: NBOR-013 location showing surrounding landscape and recent works to return site to close to original topography (28th May 2012)

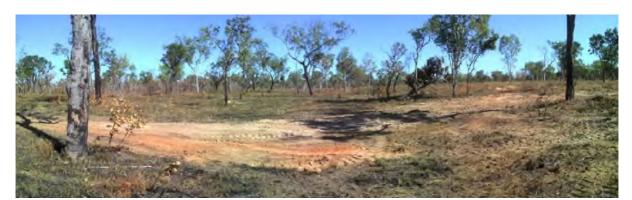
PHOTO 14: NBOR-014 location showing surrounding landscape and recent works to return site to close to original topography (28th May 2012)

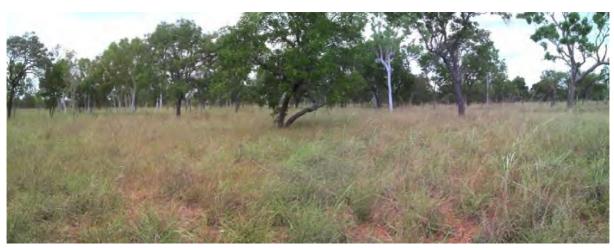
PHOTO 15: NBOR-015 location showing current vegetation and landscape profile. No evidence of drill collar or subsidence was observed (28th May 2012)
