NORTHERN TERRITORY GEOLOGICAL SURVEY

REPORT GS 79/9

REPORT ON THE FEASIBILITY OF A DAM
ON THE TODD RIVER

B. WEBER & C. HORSFALL

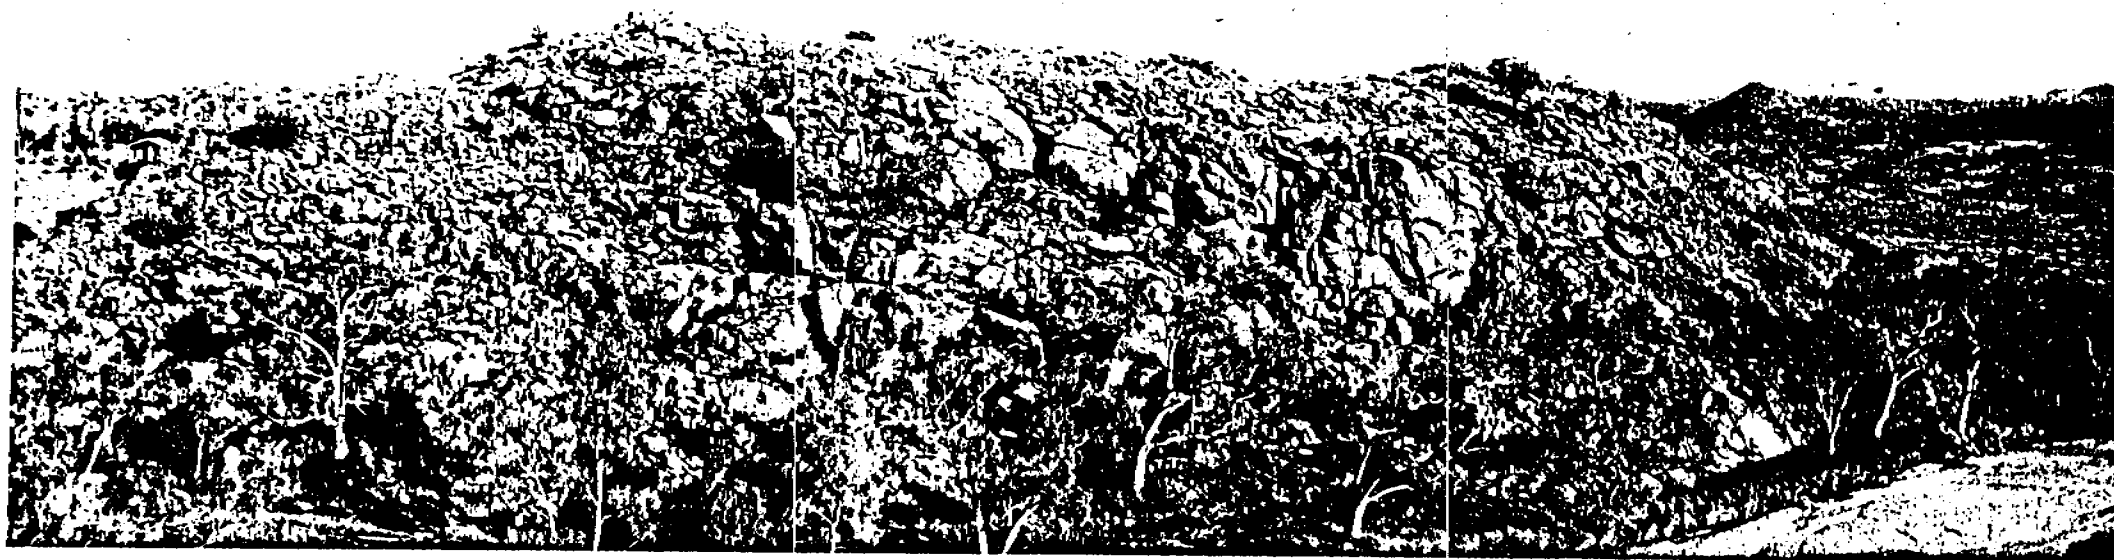
Fig. 2. TOTAL VIEW OF RIGHT ABUTMENT

At least four faults (A1, A2, B1, B2, on Plate 12) intersect the right abutment; of the faults B1 and B2 may be continuous with faults observed in boreholes DDH 3A and DDH 7. In DDH 3A the fault cuts a thin dolerite dyke. Their intersection with master joints could explain the high permeability (>100 Lugeons over the fault in DDH 3A) recorded in this area.

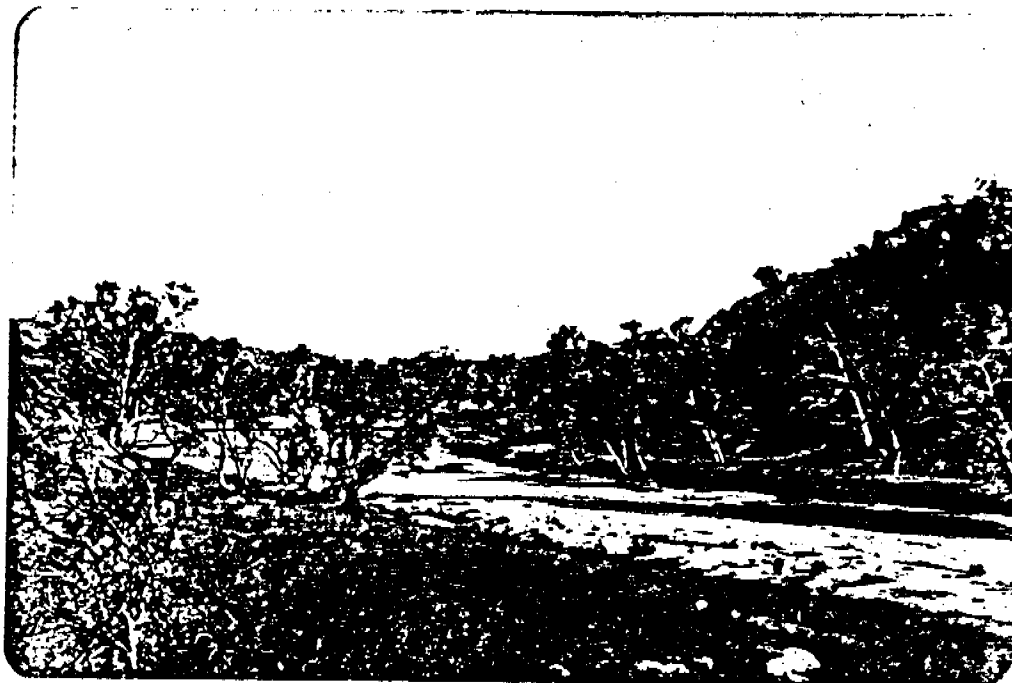
Fig. 3. RIVER SECTION, TODD RIVER DAM SITE

defined floodplains on either side of the channel. The channel alluvium has already been described and is a maximum of 5.5 m thick. The entire alluvial section will require dewatering and excavation to the level shown in the geological cross-section (Plate 13) for the foundation of the plinth. The necessity for excavating the entire alluvial section below rockfill has not been investigated and will largely depend on the in-site density.

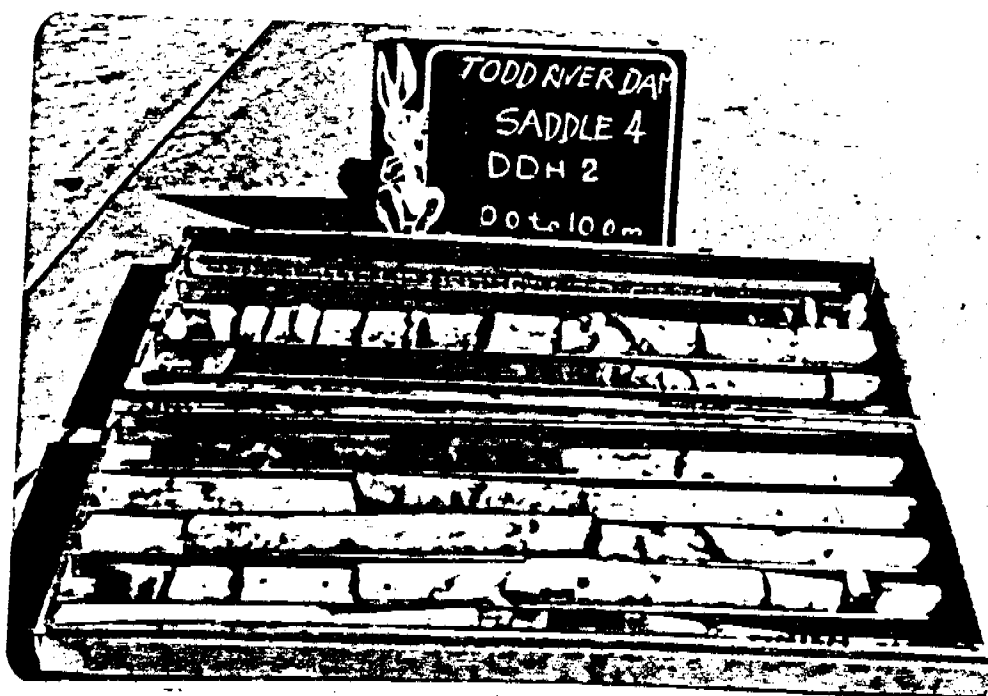
Fig. 6. CORE OF DDH2, SADDLE 4

NOTE: DARK COLOURED SECTION CAUSED BY GREASE FILM
