NORTHERN TERRITORY GEOLOGICAL SURVEY

REPORT GS 79/10

GEOLOGICAL REPORT ON THE FEASIBILITY OF A DAM ON THE HUGH RIVER AT BIRTHDAY GAP (Hermannsburg 1:250 000 Sheet SF 53-13)

DEPARTMENT OF MINES & ENERGY (October 1979)

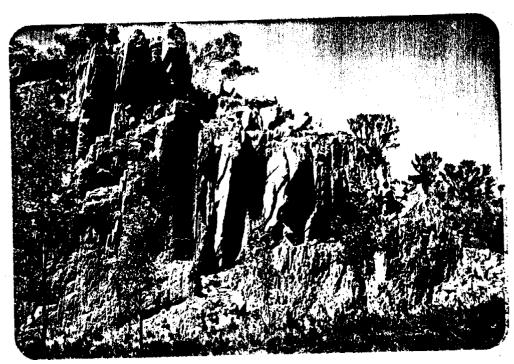
PLATE 2

The faults parallel to joint set J1 and the dam axis are strike slip faults with minor vertical movement (refer Pls. 2 and 10) and contain up to 1 m of recemented breccia.

A minor 'overthrust' fault on the left abutment has been displaced by movement along a fault parallel to the J1 joint set (P1. 2). This 'overthrust' fault may be a minor potential leakage path.

VIEW OF LEFT ABUTMENT
SHOWING WELL DEVELOPED J1 JOINTS &
OVERTHRUST FAULT DISPLACED BY STRIKE SLIP FAULT.

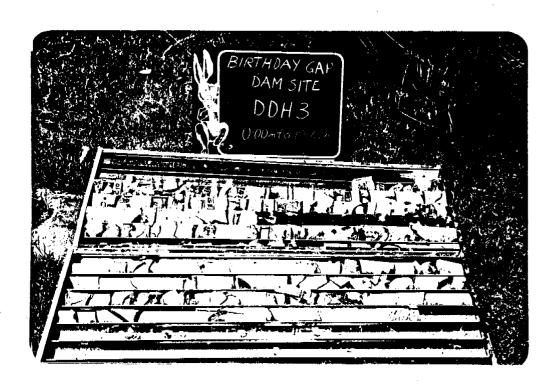
PLATE 5
CORE OF DDH3, BIRTHDAY GAP DAM SITE
RIVER SECTION

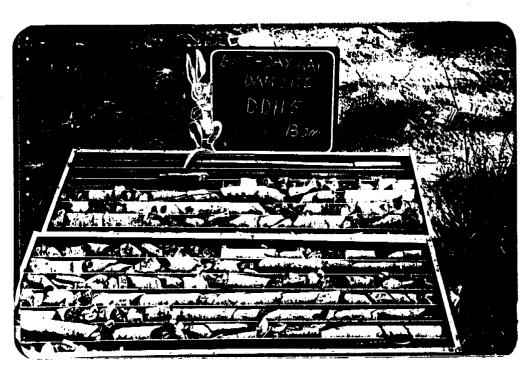
PLATE 6
CORE OF DDH5, BIRTHDAY GAP DAM SITE
LEFT ABUTMENT

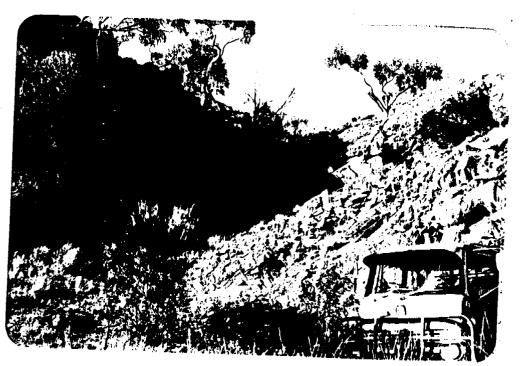
PLATE 9

Faults parallel to joint set 4 also have a horizontal displacement with the western side being displaced north. The fault controlled gully on the left abutment (Pl. 9) has a displacement of only one metre but a large fault, 400 m from the river, on the right abutment, has a horizontal displacement of 70 metres.
