CRA EXPLORATION PTY LIMITED

MCN 1720, 1721, 1722 MATHESON CREEK, NT

FINAL REPORT FOR PERIOD ENDING 8th MARCH 1993

REPORT NO. : 18843

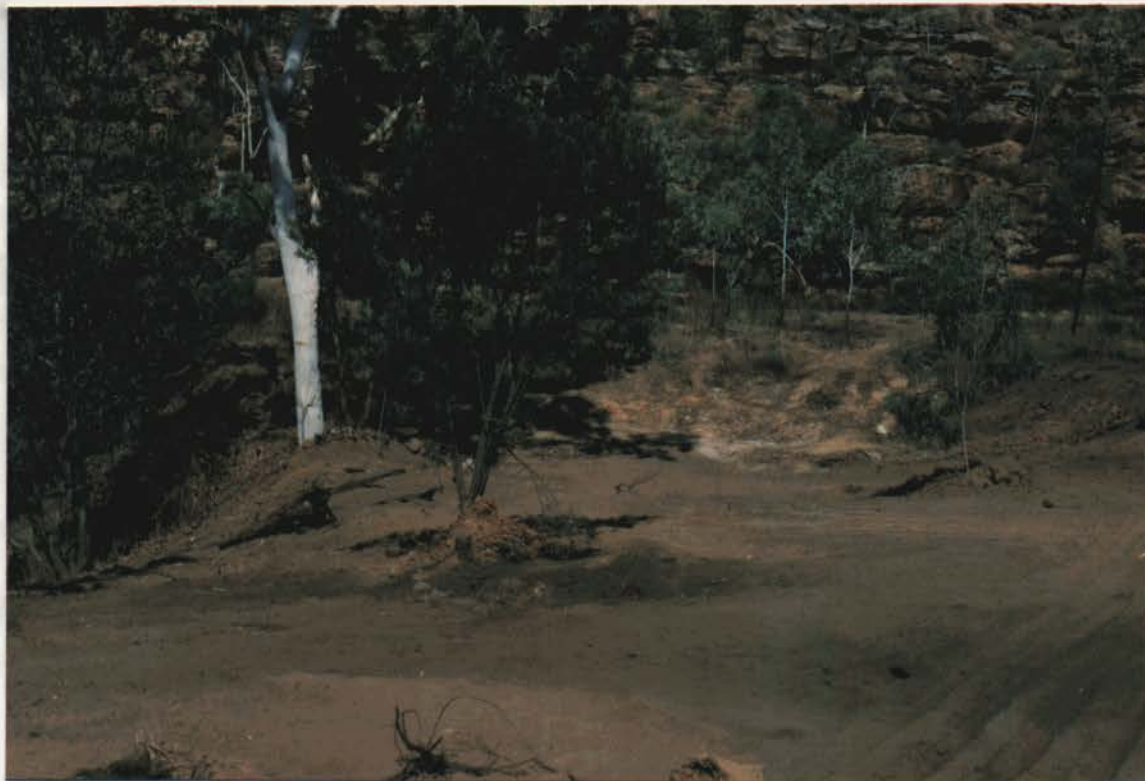
PHOTO 1 View looking west at site E1E showing reinstated bank profile and contoured costean/mullock sites.

- E1E Push heaps into excavated area. Reinstate bank profile. Reinstating of bank profile is the priority.
- E2A Remove heap A to o.g.l. place material in deepest part of costean. Do not touch heap B.

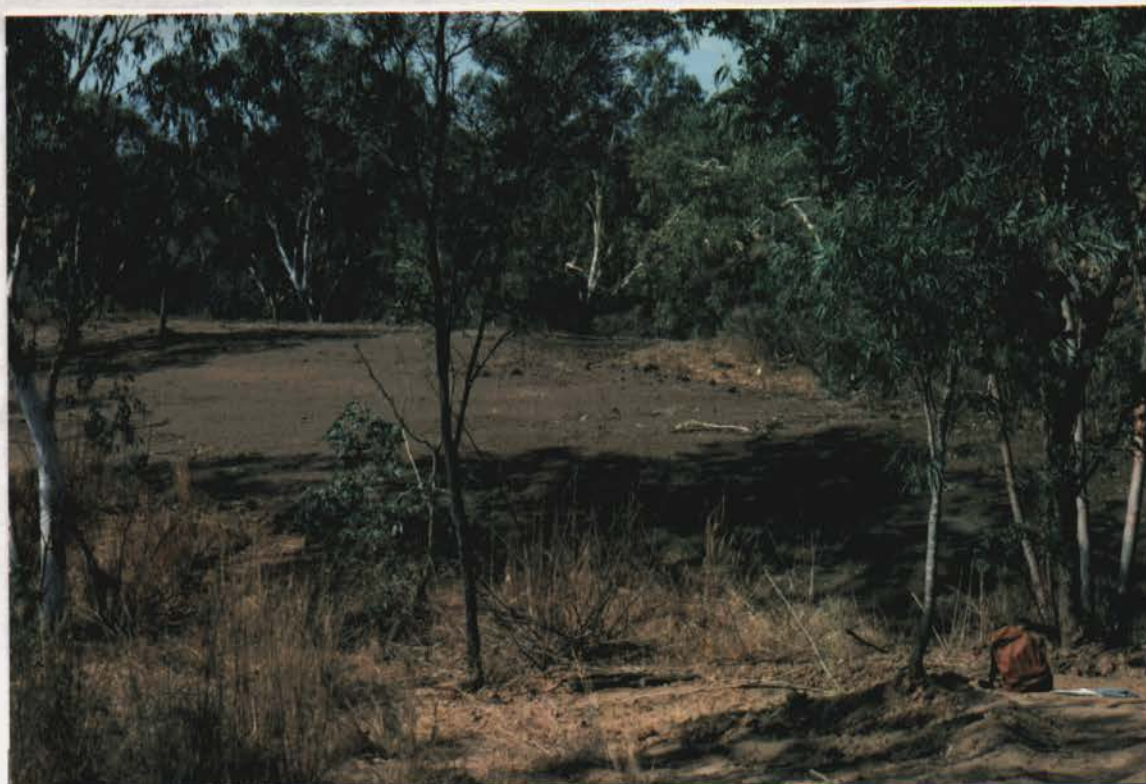
PHOTO 2 View looking southwest at site E1E showing levelled and filled mullock/costean site, now contoured with topsoil.

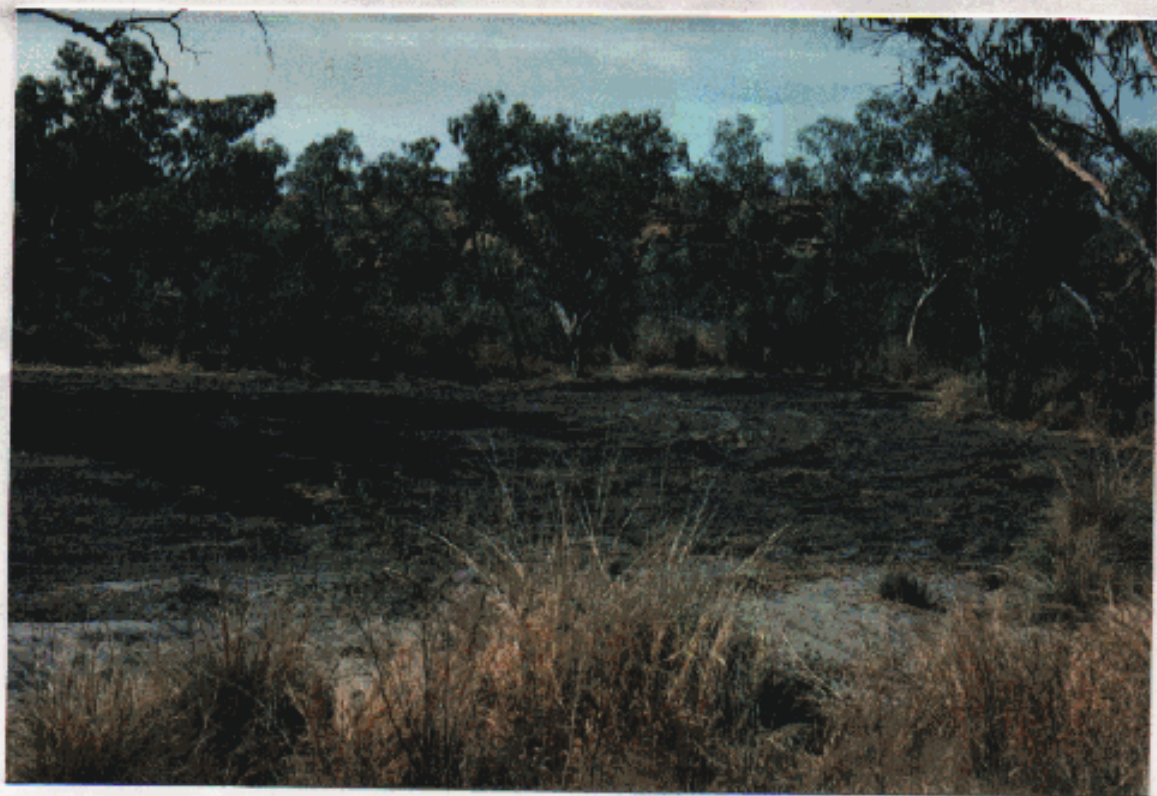
PHOTO 3 View looking south at site E1A, showing levelled and filled mullock/costean site, contoured with topsoil to drainage line (foreground).

- E1A Push mullock heaps into excavated area battered off to drainage line profile.
- E1B As for E1A
- E1C As for E1A
- E1D Push heaps into excavated area and track cutting. Restore track cutting to original ground level first. If there is insufficient material leave a depression in the excavated area.

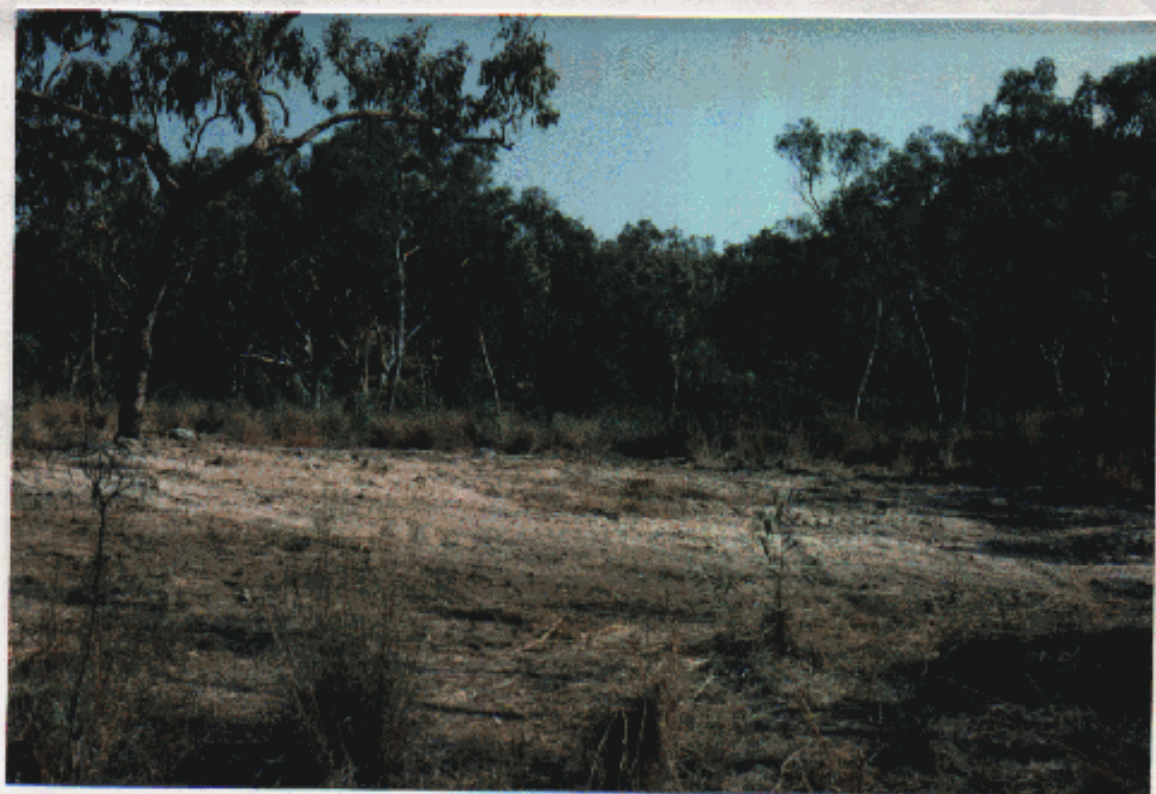
PHOTO 4 View looking north at site E1D, showing levelled and filled mullock/costean site, contoured with topsoil to old ground level.

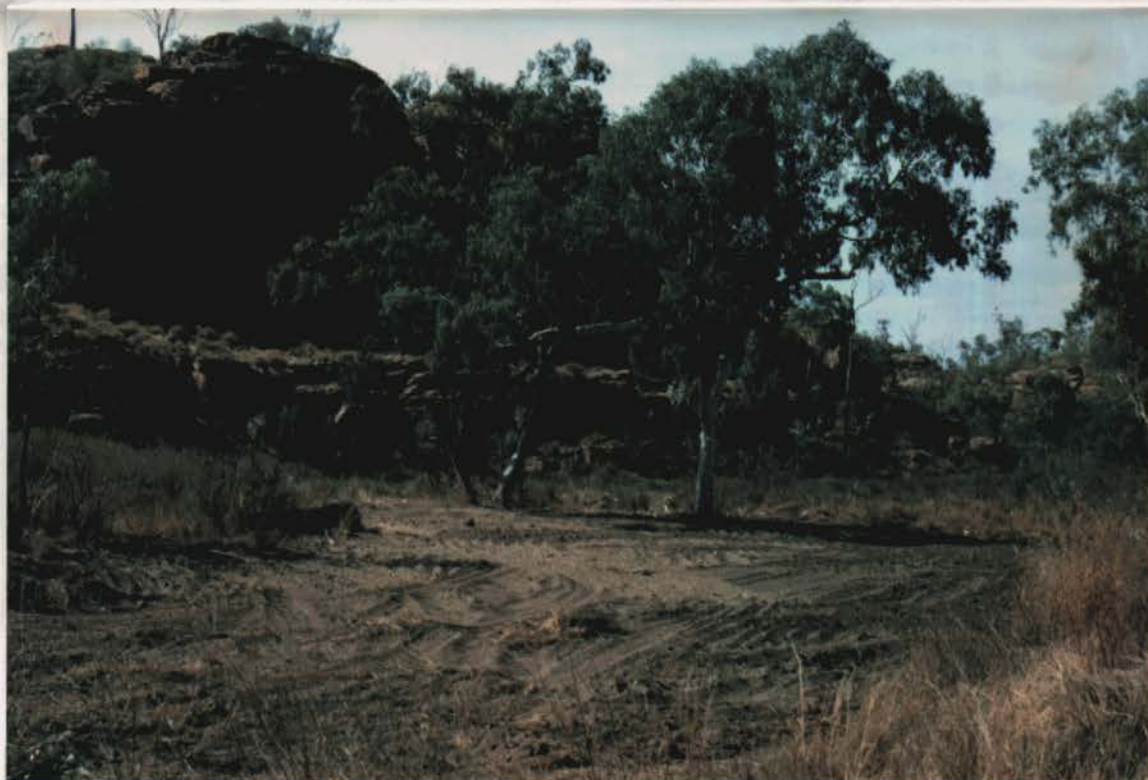
PHOTO 5 View looking southeast at site E1C, showing levelled and filled mullock/costean site, contoured with topsoil.

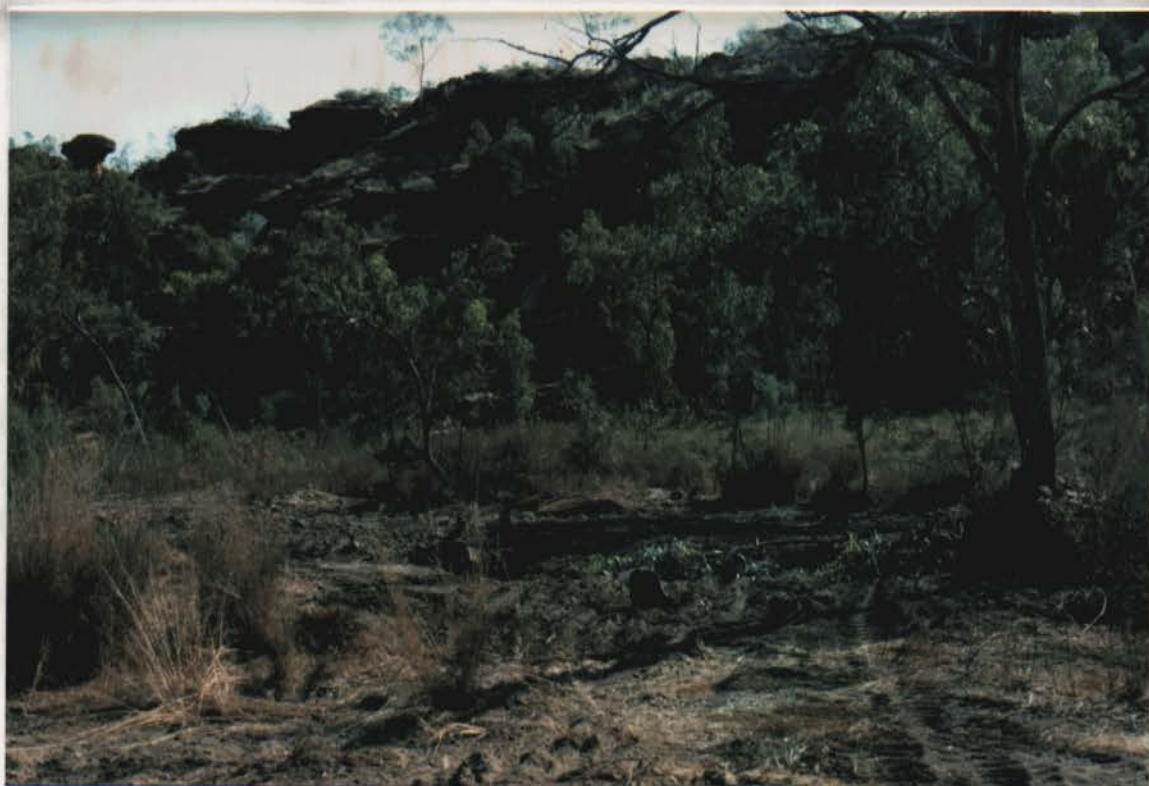
PHOTO 6 View looking north at site E1B, filled and levelled mullock/costean site.

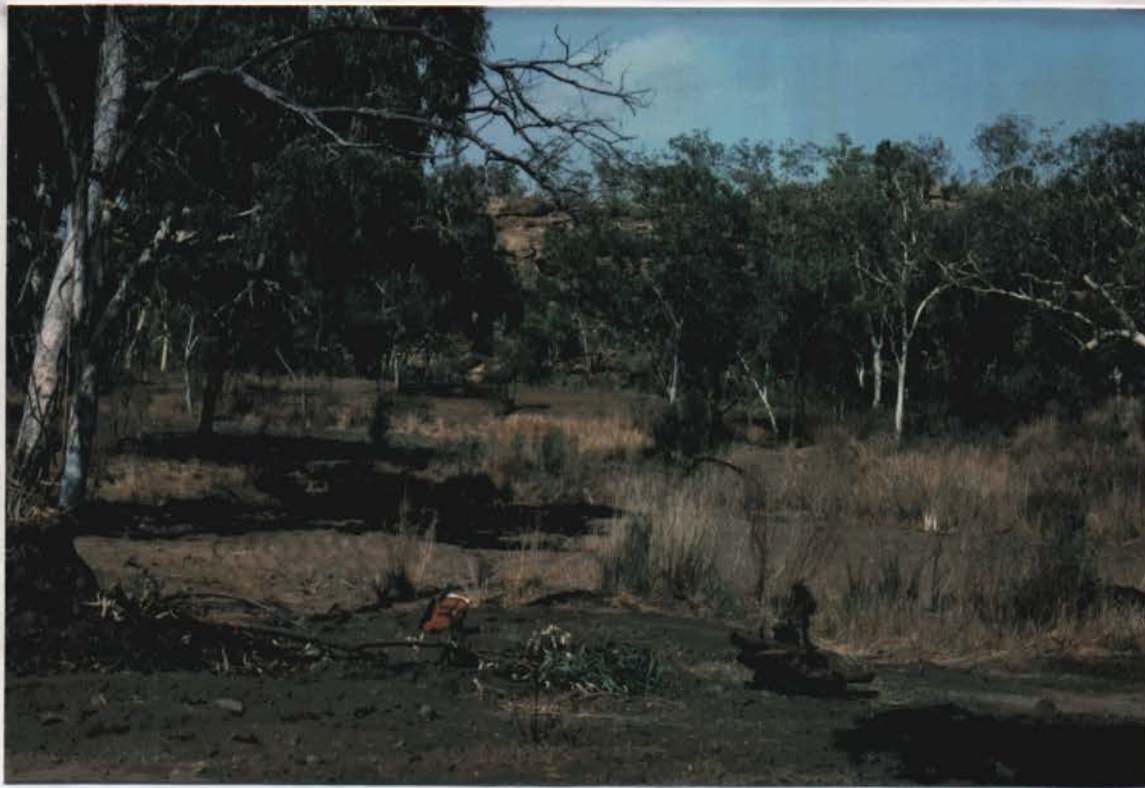
PHOTO 7 View looking west-southwest showing contoured sites E1B, E1C, E1A and E1E.

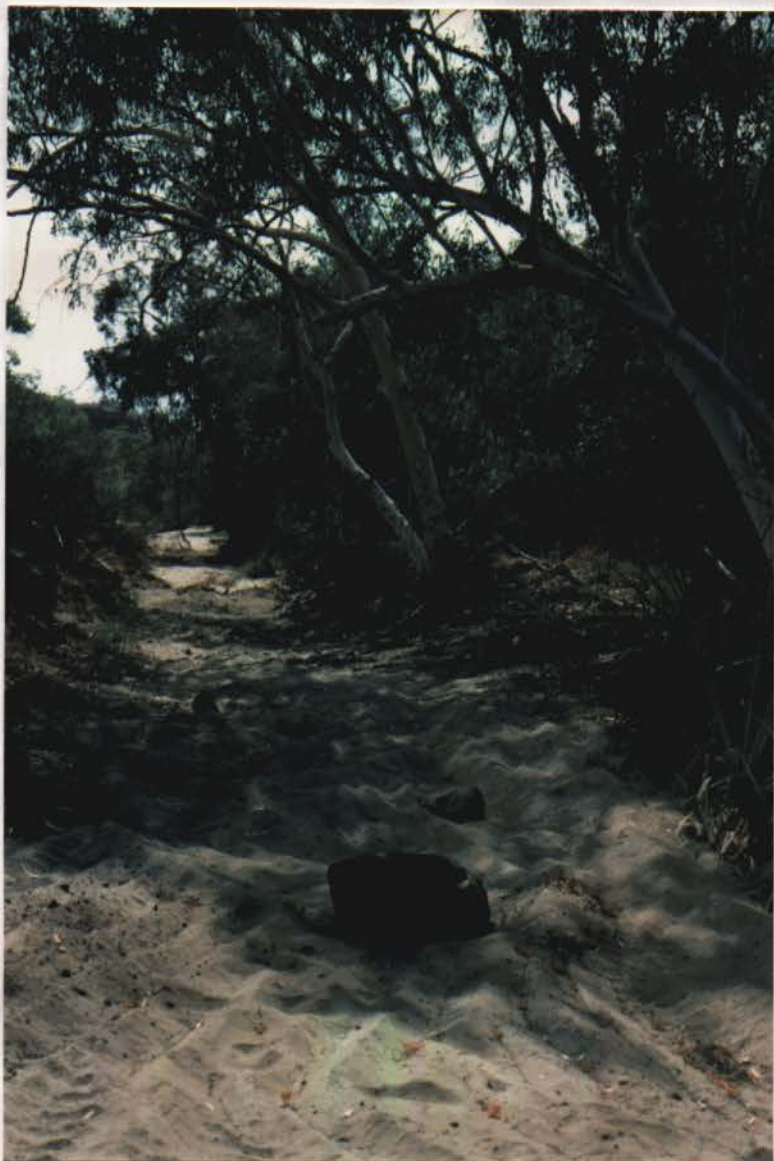
PHOTO 8

View looking east showing rehabilitated road cuttings and back bladed windrow used to restore vegetated creek bank (RHS) at Area B.

- Area B Incised road cutting. There is one tree in this area that is having its roots undermined. It is suggested that material from the windrow in this area be used to nearly fill the hole. The hole should then be capped with 3 or 4 buckets of heavy material from the mullock heap at costean E1E. The windrow should be back bladed at spacings of approximately 5 metres. This spacing should be determined onsite and depends on the amount of vegetative regrowth.

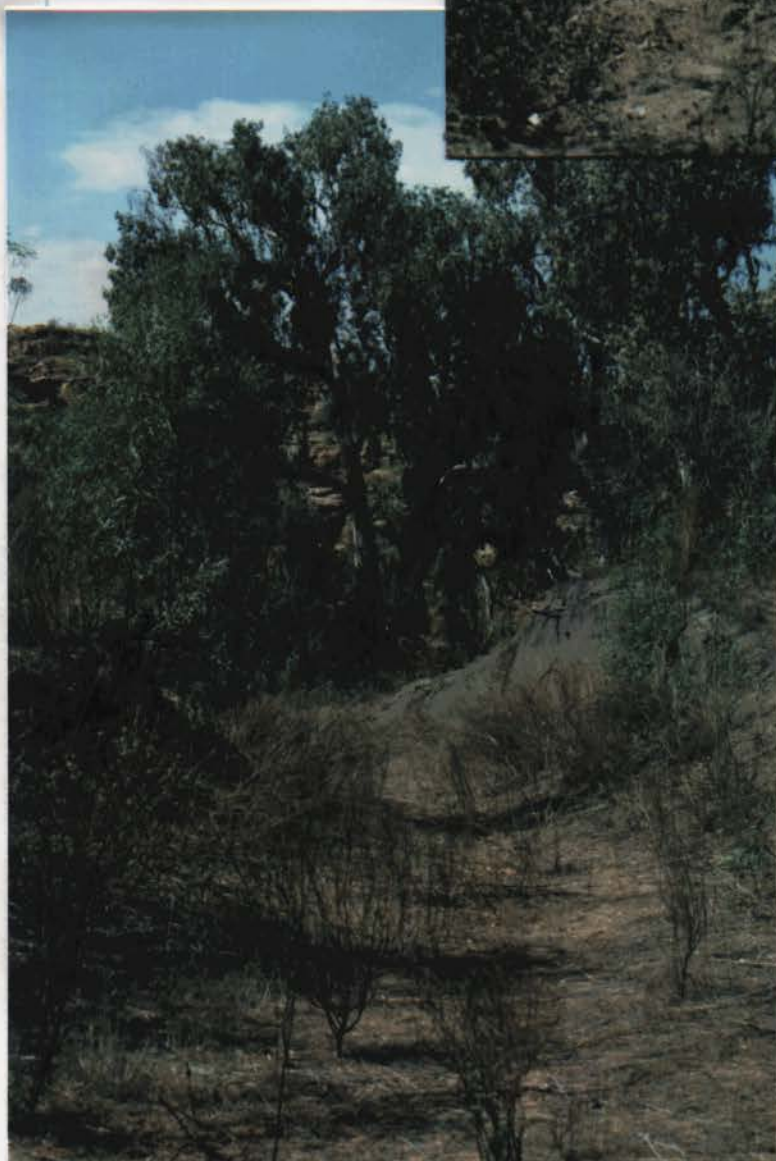
PHOTO 10

View looking at site E2A. Mullock "B" left as directed.

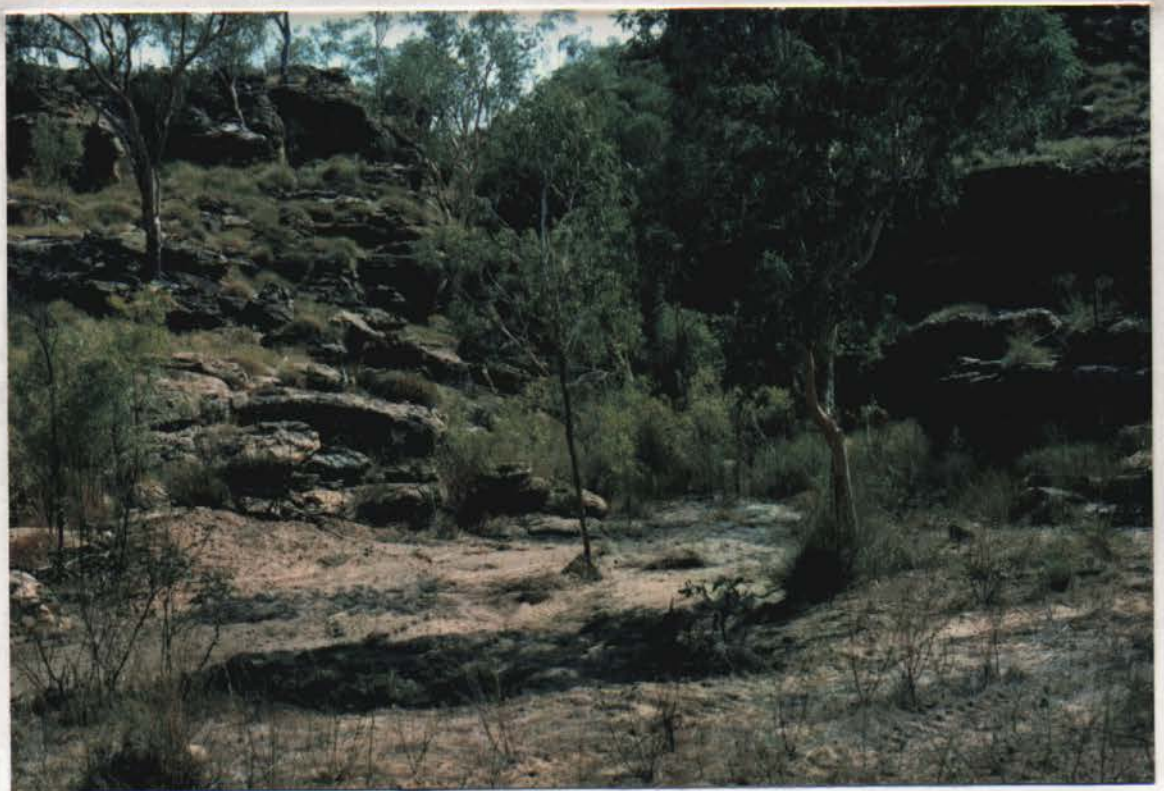
PHOTO 12

View looking northeast at site E2C showing restored stream channel (centre), filled costean with spread mullock/topsoil cover.

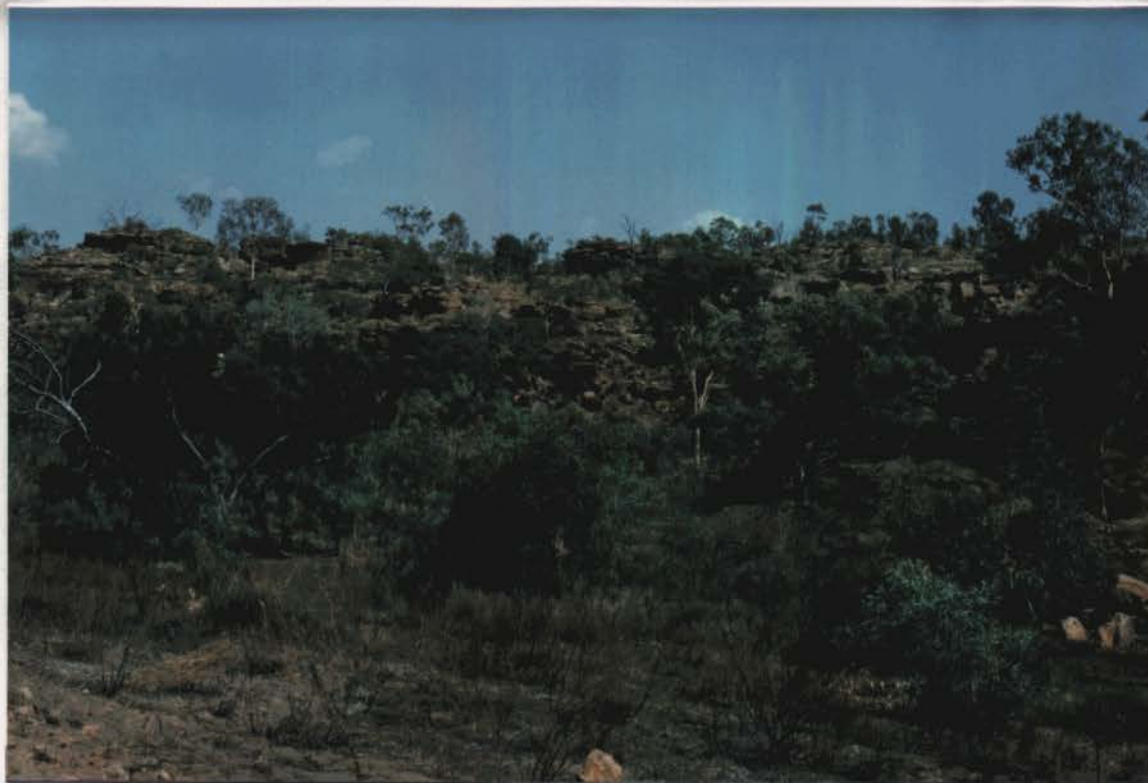
PHOTO 13 View looking northwest across EMU-2 showing vegetation regrowth and minimised surface disturbance.

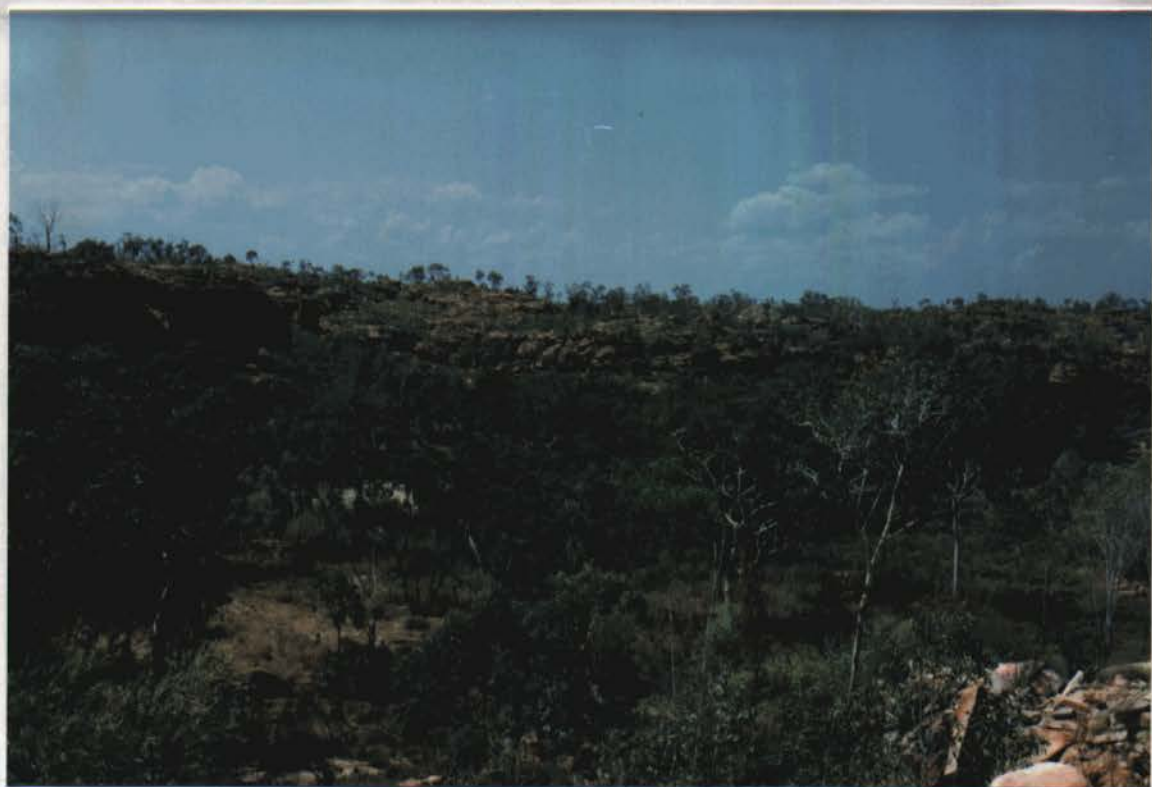
PHOTO 16

View looking south across EMU-1 showing vegetation regrowth amongst rehabilitated excavations.

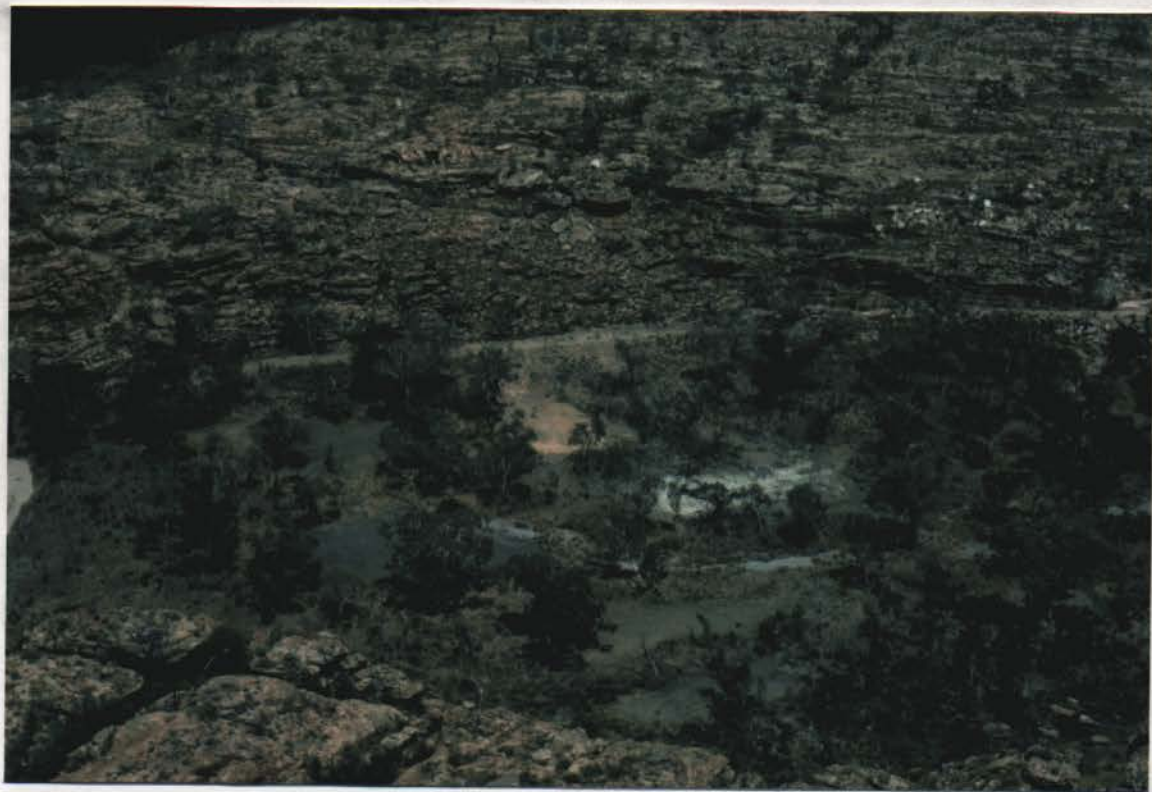
PHOTO 17 Aerial view looking west showing filled and recontoured costeans and vegetation regrowth within EMU-1 (E1A, E1B, E1C, E1D and E1E).

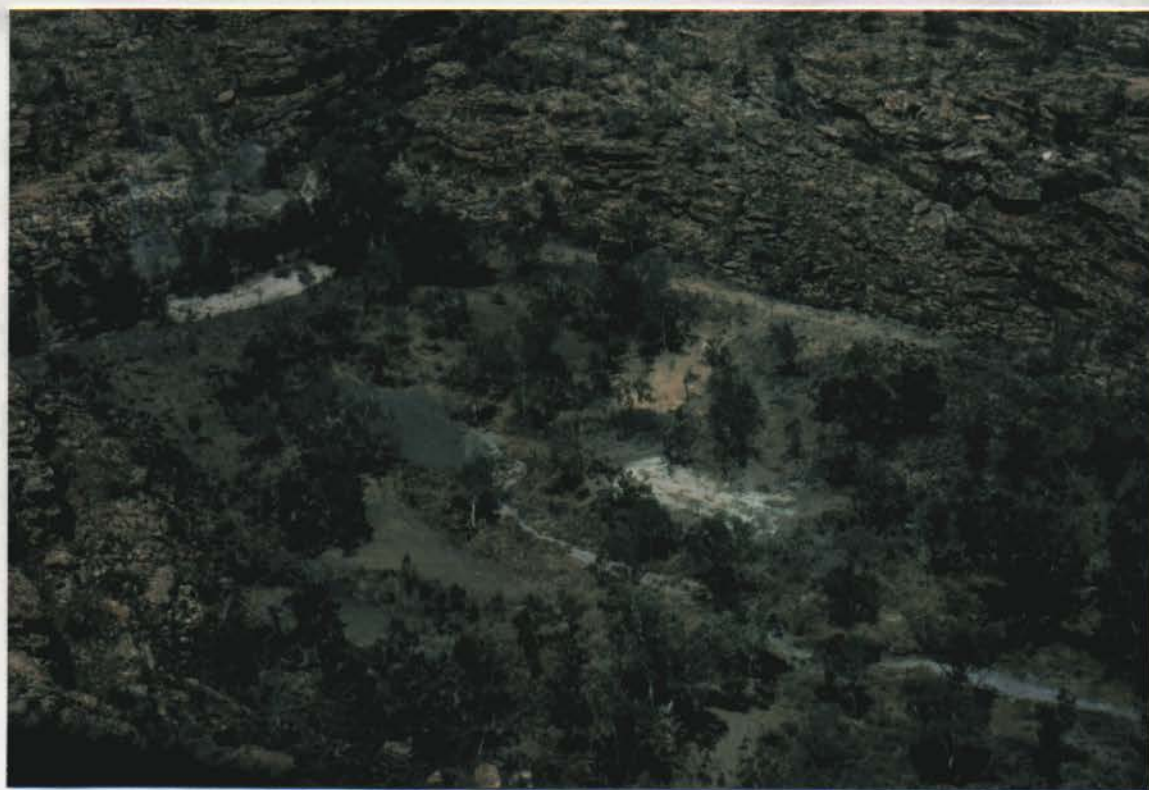
PHOTO 18 Aerial view looking southwest as per photo 17.

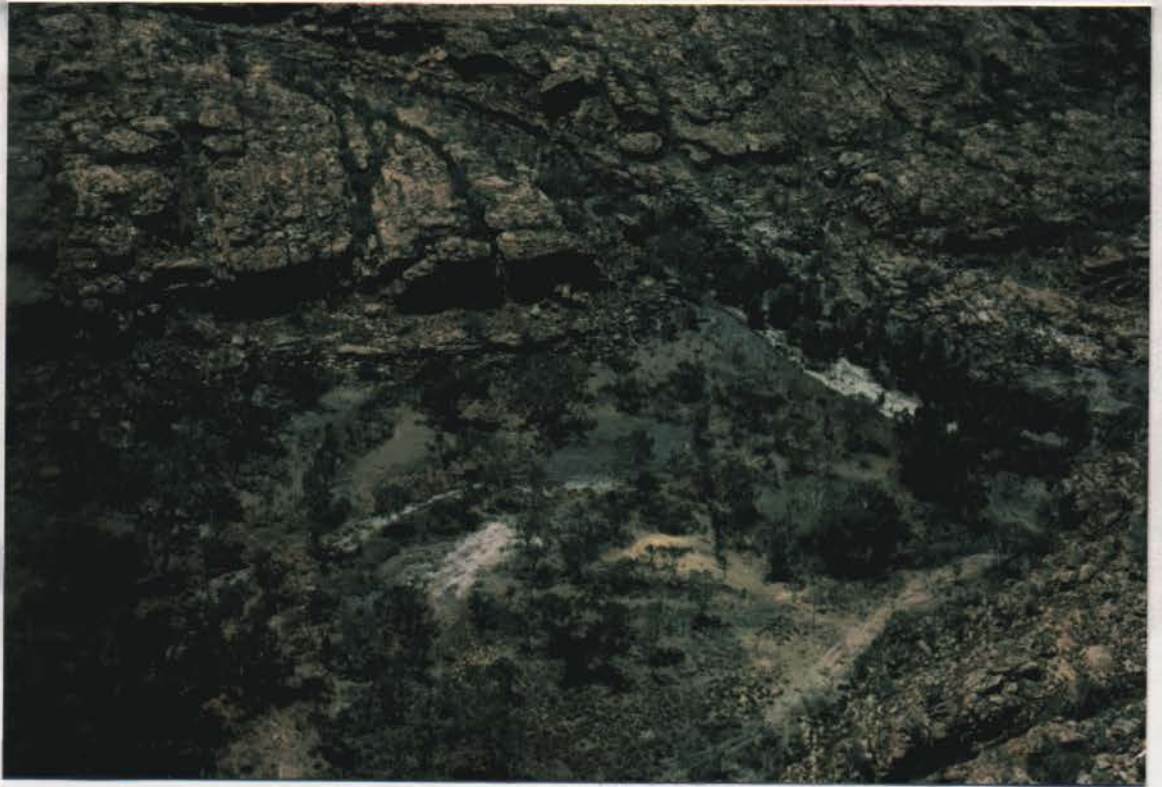
PHOTO 19 Aerial view looking east as per photo 17.

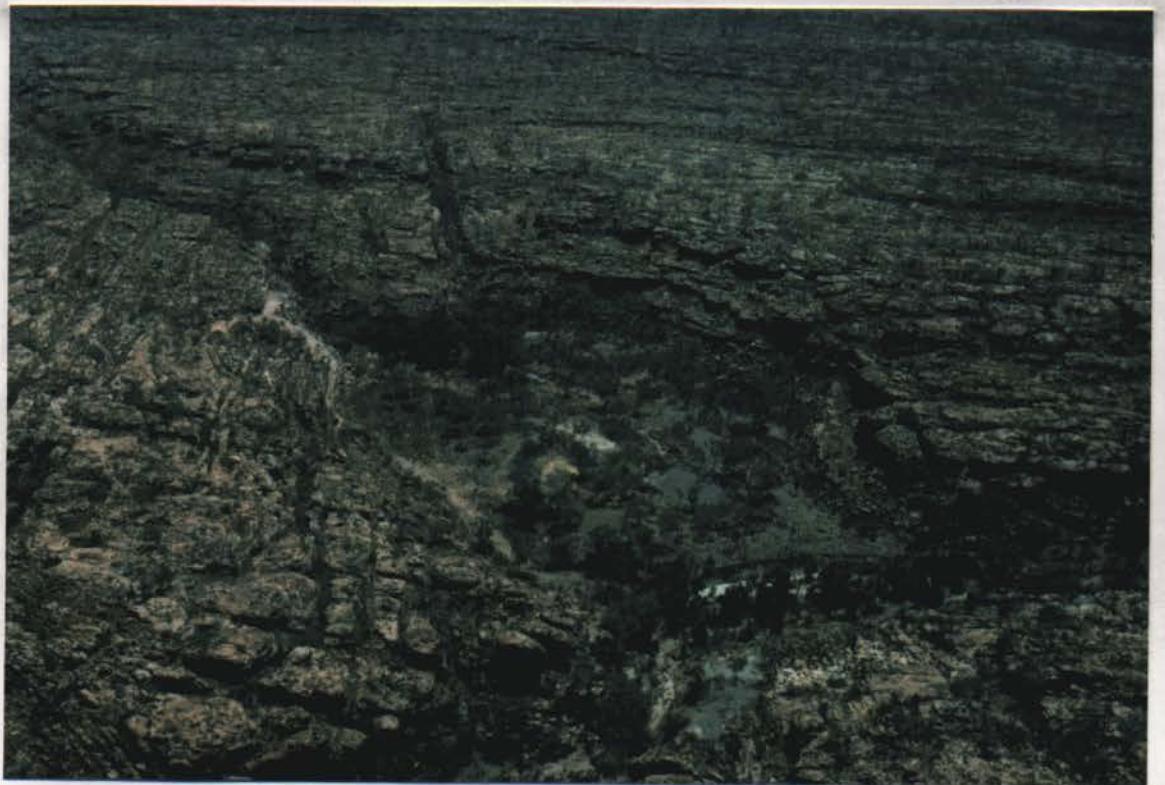
PHOTO 20 Aerial view looking north showing EMU-1 and indistinguishable access track (LHS) on plateau surface.

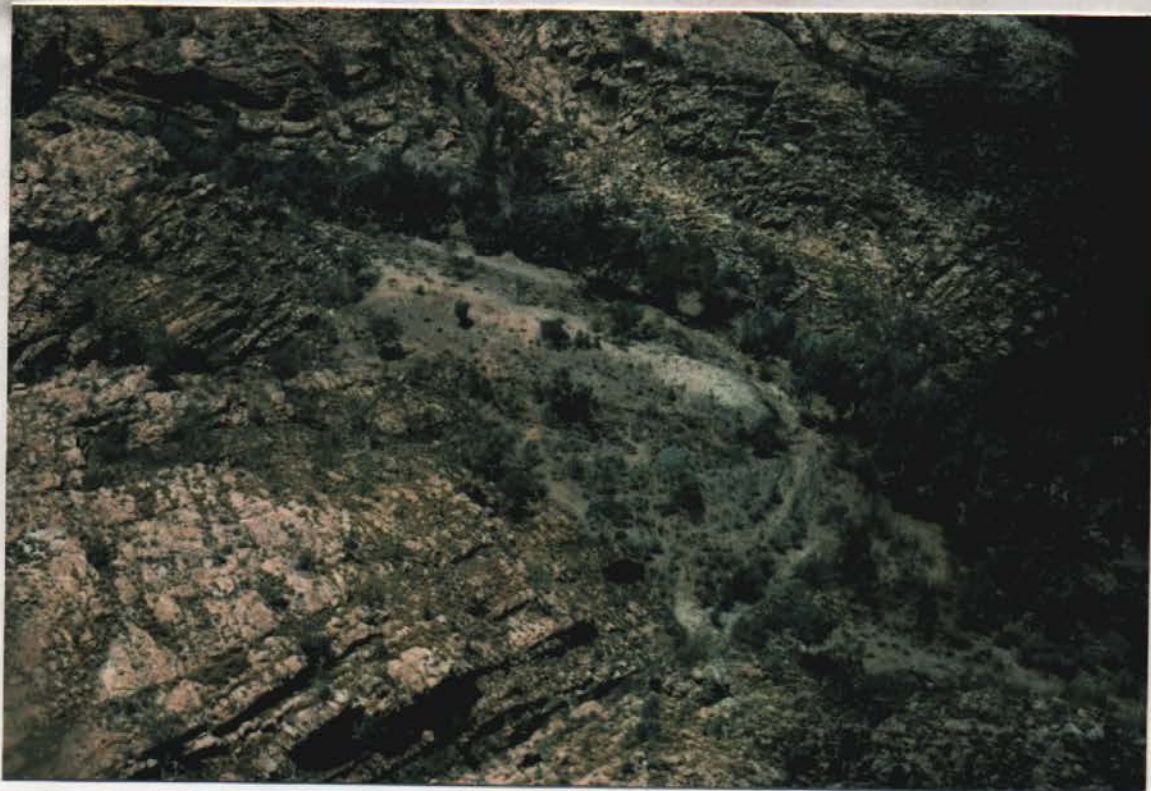
PHOTO 21 Aerial view looking northeast showing filled and recontoured costeans and vegetation regrowth within EMU-2 (E2A, E2B, E2C and Area A).

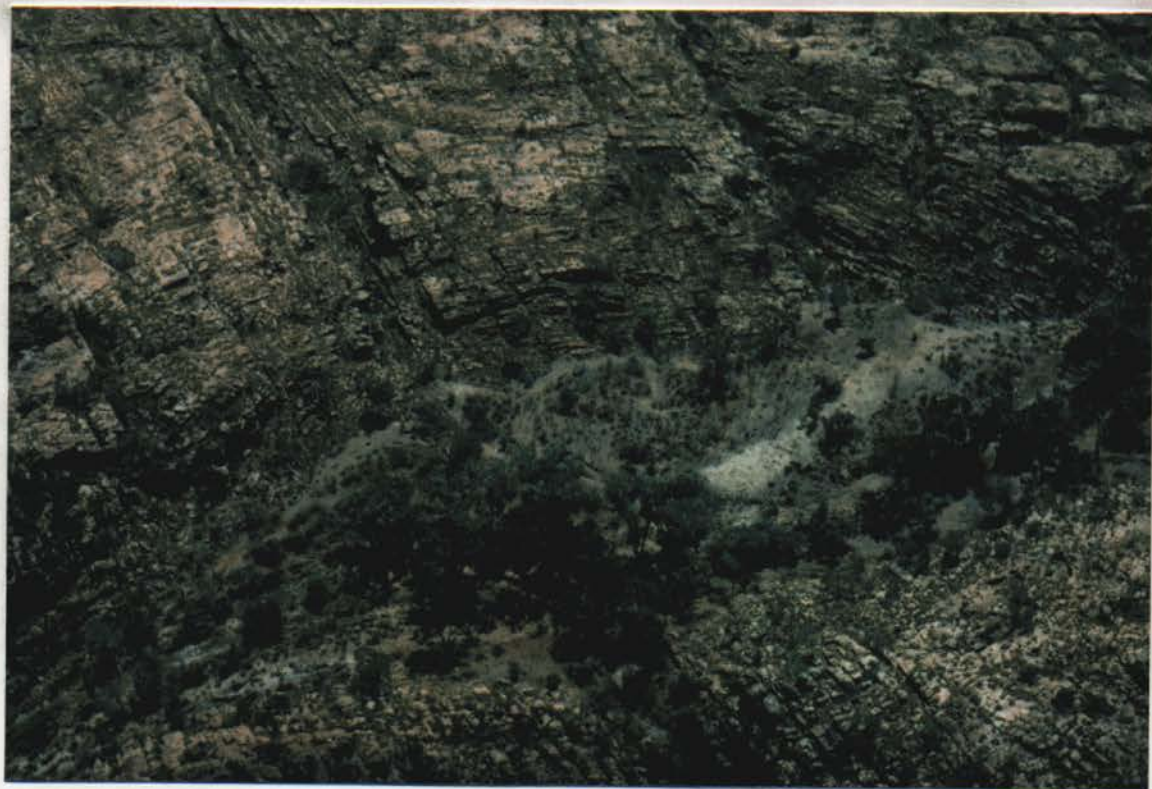
PHOTO 22 Aerial view looking southeast as per photo 21.
