**Mine Closure Plan
Mud Tank Operation
MIN 165**

Document ID: EN041 – MCP
Version 2

September 2013

Prepared for Australian Vermiculite Industries

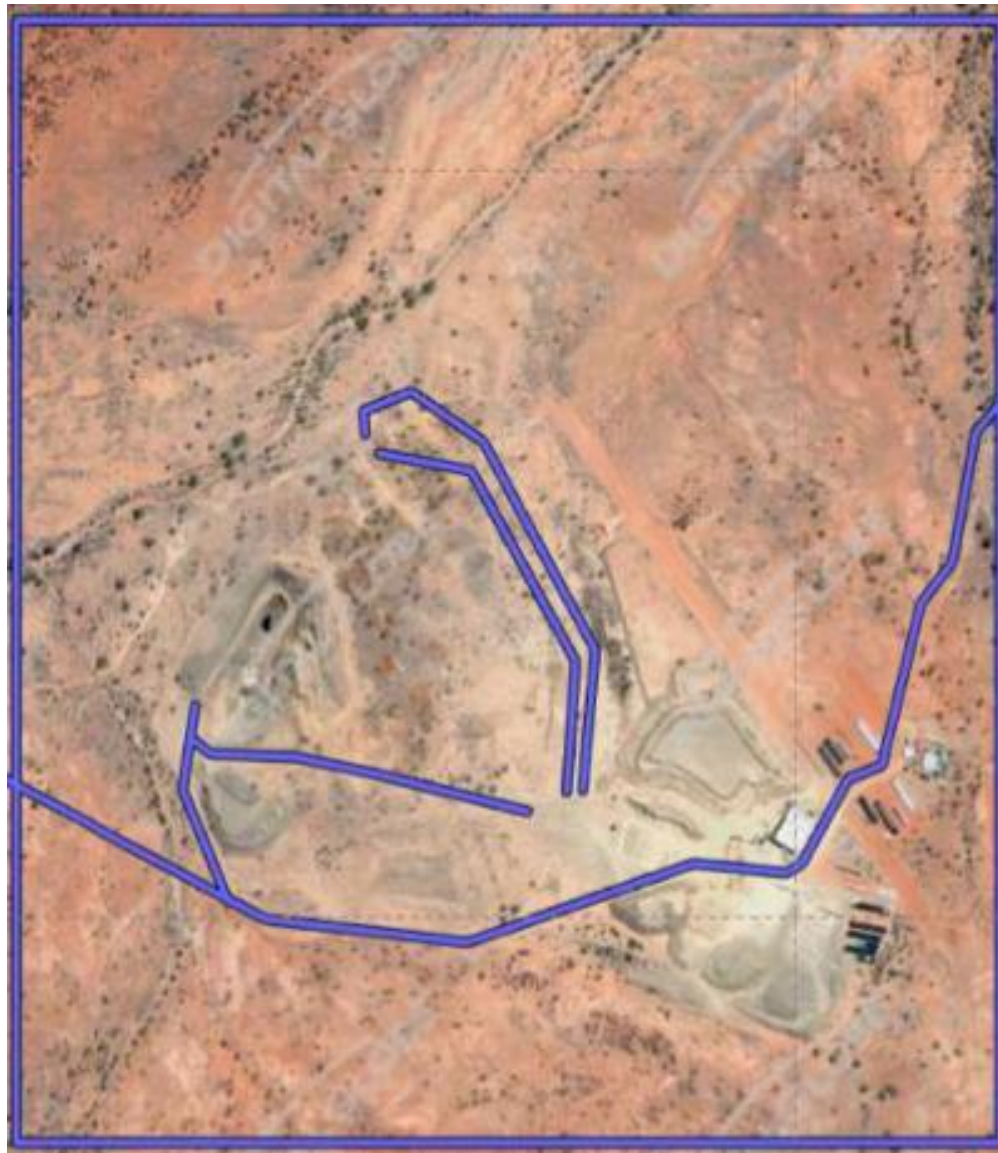
Figure 9 - Roads to be rehabilitated

A number of roads have been previously established by the fossicking community prior to the commencement of mining in 1995. The roads that have been identified as pre-existing fossickers roads and tracks will remain post closure, refer to figure 8 below. Haul roads and primary mining roads will be rehabilitated by contour ripping and seeding. Roads to be rehabilitated are depicted in figure 8.

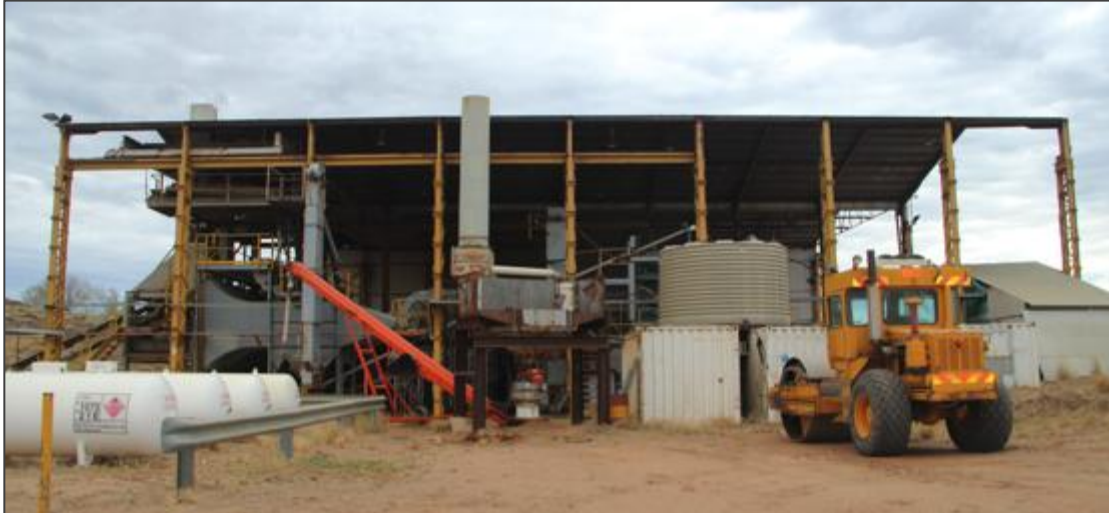
Figure 10 - Processing Plant Feb 2013

The processing plant domain comprises of plant infrastructure, small water tanks, office hut, shed and cement flooring. The sites power generator and its associated fuel storage tank is also located within this domain.

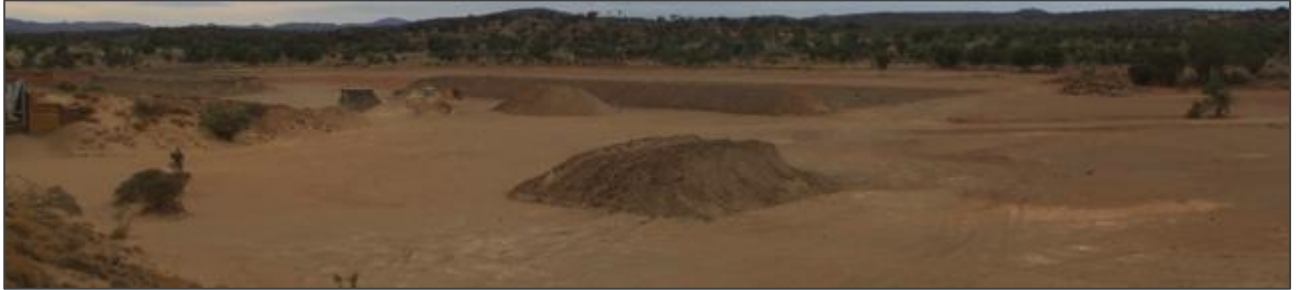
Figure 13 - ROM Feb 2013

The Run of Mine Pan (ROM) is a flat area that was used to stockpile and dry ore prior to processing. Included in this domain is the loading ramp used to feed the processing plant.

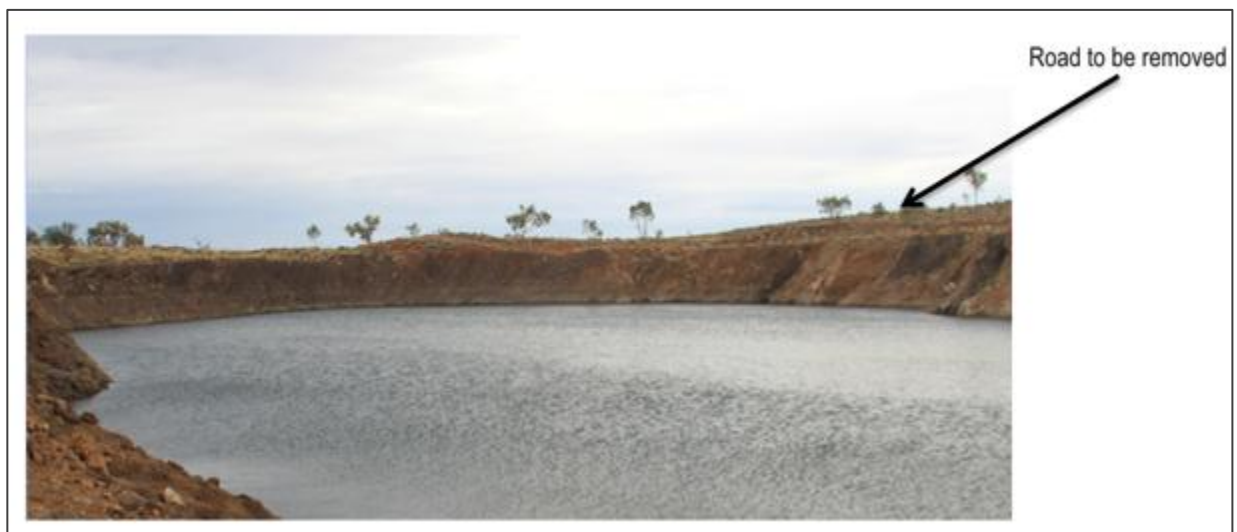
Figure 18 - Pit A road to be removed

Infrastructure	Closure Task/Activity
Pit A	<ul style="list-style-type: none"> Remove road access around perimeter of pit Install signage 50 m intervals Finalise earthworks at water access point to make the access point safe and stable

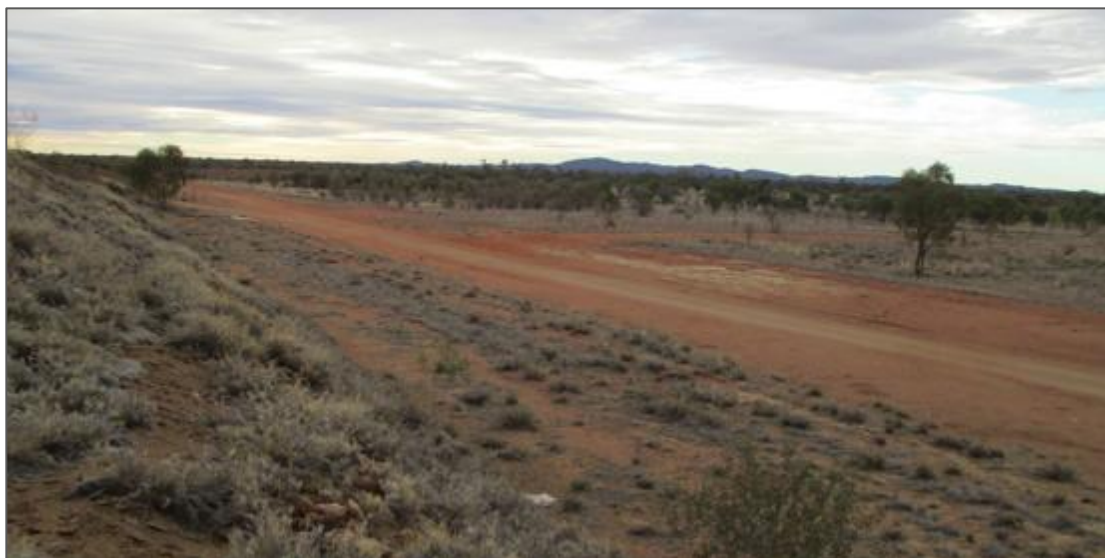
Figure 25 – Airstrip from waste dump old

Infrastructure	Closure Task/Activity
Airstrip	<ul style="list-style-type: none"> • Remove all miscellaneous items • Reshape to form free draining surfaces • Deep rip all surfaces along the contour • Broadcast seeding

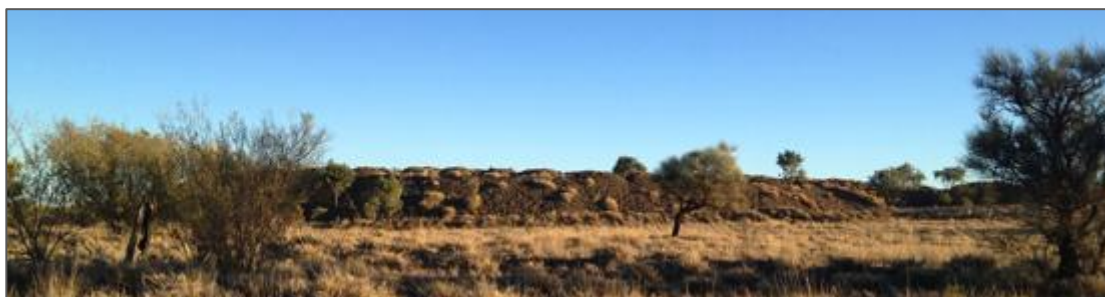
Figure 26 - Pit A Overburden

Infrastructure	Closure Task/Activity
Overburden Stockpile	<ul style="list-style-type: none"> • Primary earthworks to construct crest bund • Create concave surface • Primary earthworks to profile landform • Broadcast seeding

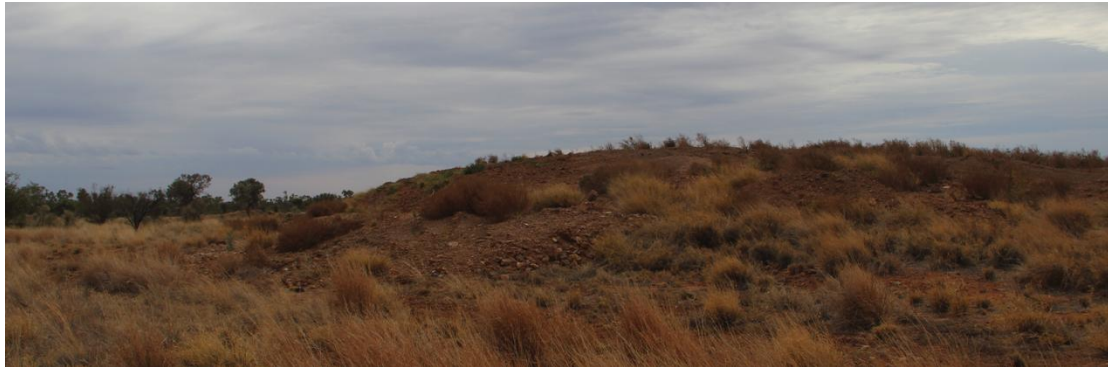
Figure 27 - Pit B Overburden

Infrastructure	Closure Task/Activity
Overburden Stockpile	<ul style="list-style-type: none">• Re-rip landform with contour ripping• This overburden stockpile is significantly smaller than that of the waste dumps and the overburden stockpile from Pit A. Due to its size (0.85ha) it not considered necessary to reshape the landform to create a water storage basin. The incidental rainfall will infiltrate the stockpile or shed along the contours.• Broadcast seeding
