MINEMAKERS AUSTRALIA PTY LIMITED
ARRUWURRA

TRIAL PIT DSO CRUSHING PROGRAM
SUMMARY REVIEW

MAY 2010

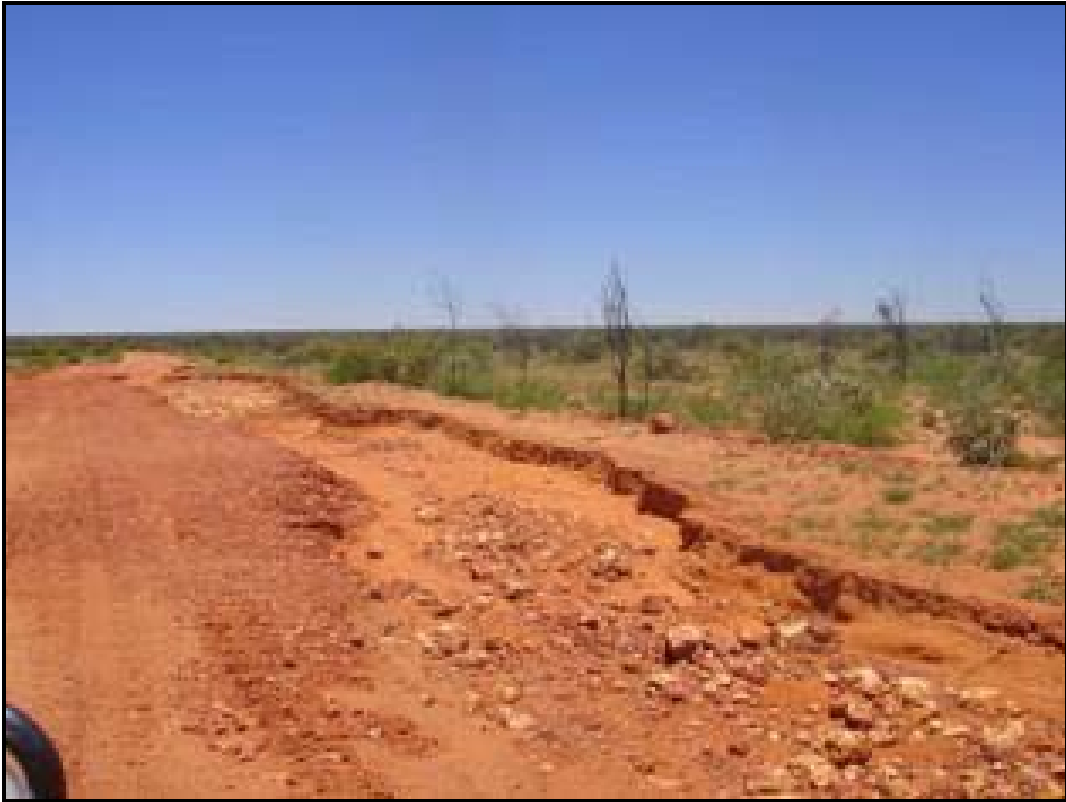
Photograph 1 – Typical area of previously formed road requiring repairs.

1. Repairs to the previously gravelled road, to fill and re-grade washout areas. (As shown in Photograph 1). (March 30th to April 9th).
2. To build up and gravel the remaining 5.2km of access road at the Arruwurra end, which was not gravelled in December due to the start of the wet season rain.

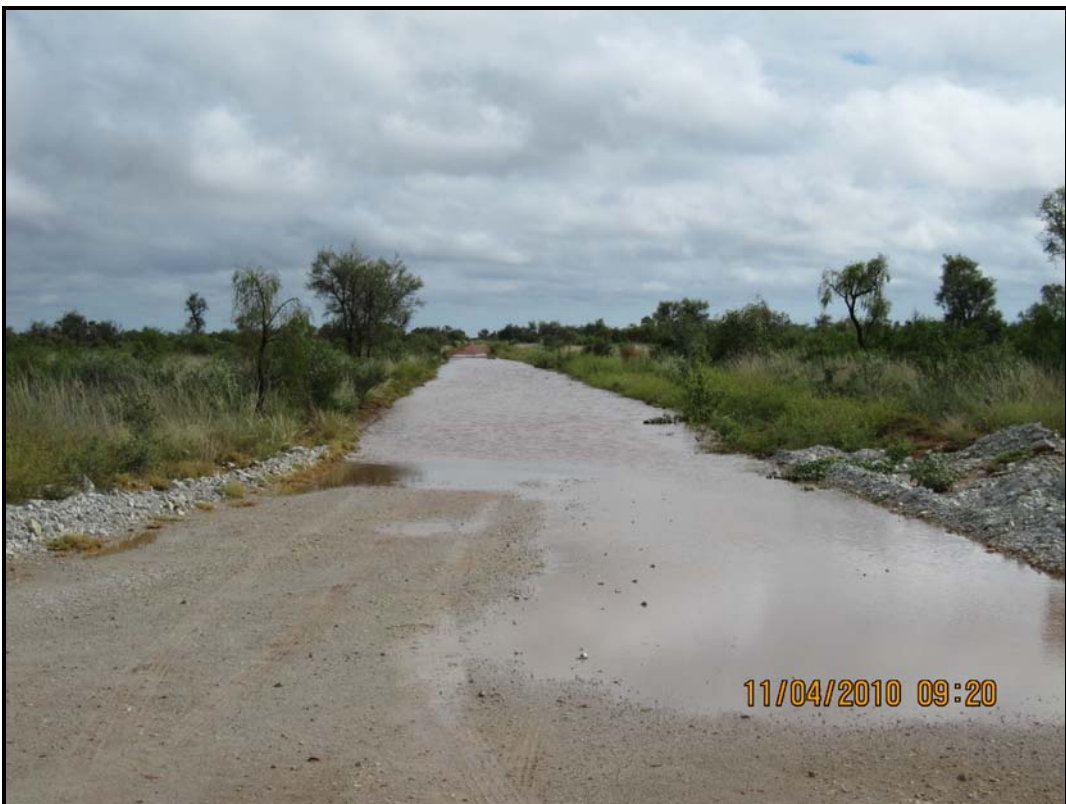
Photograph 2 – Result of rain in the early hours of 11th April

Phase 2 continued but was interrupted by rain (approximately 50mm) in the early hours of Sunday 11th April. (Photograph 2).

Phase 2 work was unable to proceed on 11th and 12th April, with work to repair the rain damage continuing from 13th April, until completed on 23rd April.

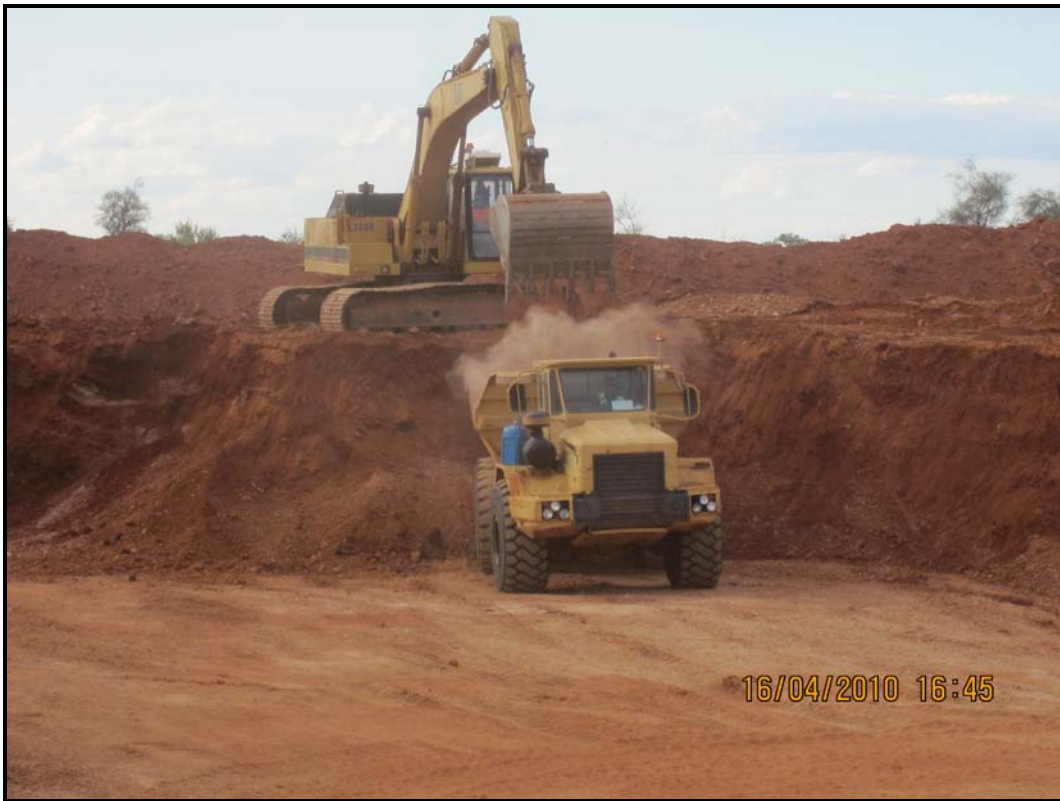
Photograph 3 – Removing gravel for road construction from the gravel borrow pit.

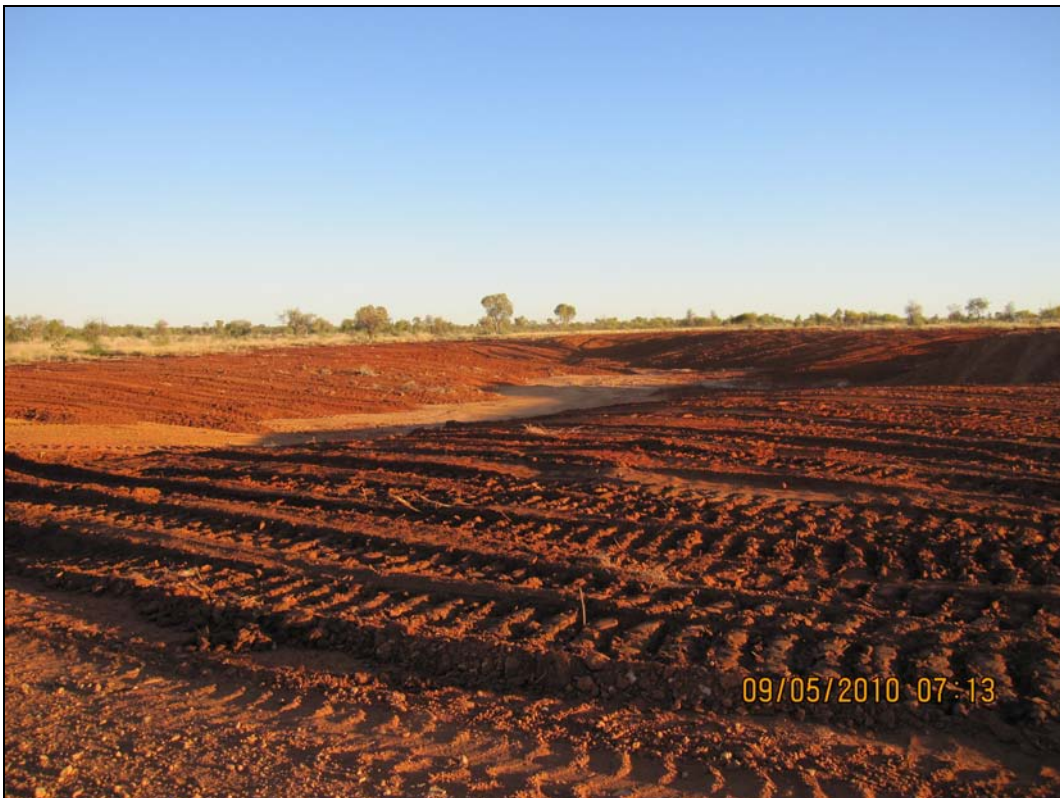
Photograph 4 – Rehabilitation completed at the gravel borrow pit.

Following the use of a gravel pit adjacent to the Arruwurra bore road turnoff from the Access Road, the pit was rehabilitated and landscaped to allow capture of seasonal rainfall.(Photograph 4).

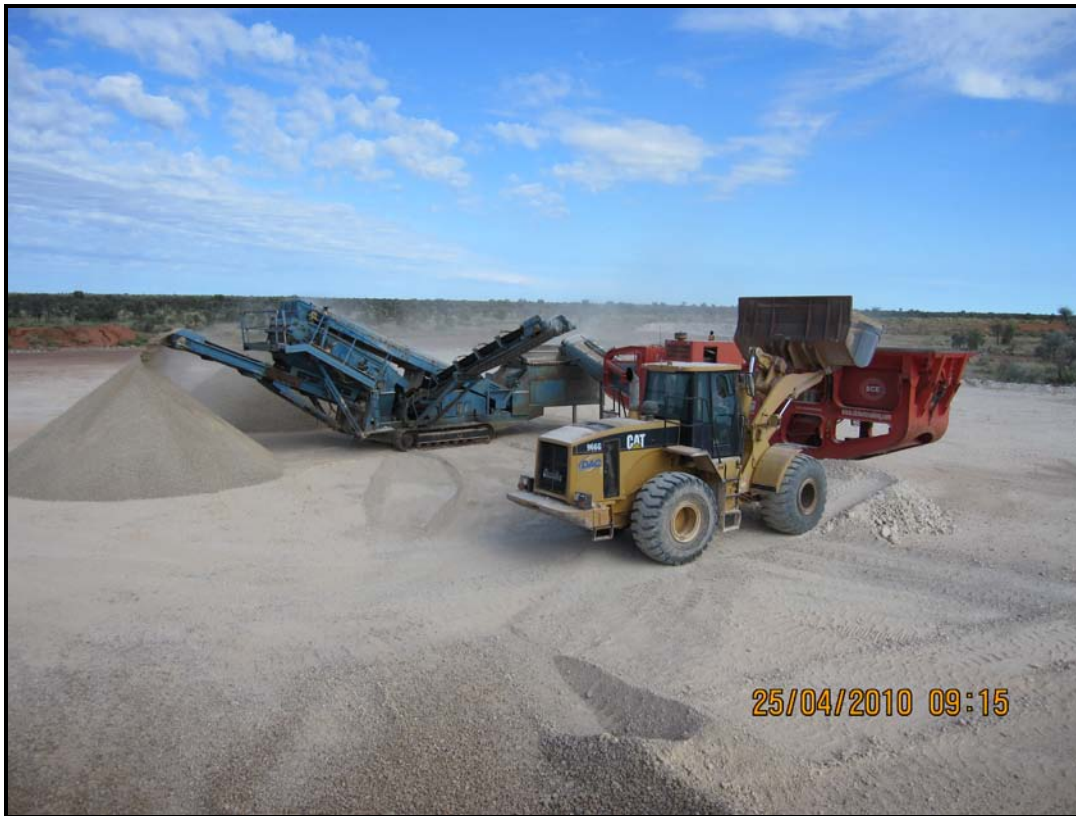
Photograph 5 - Re-crushing DSO "Intermediates" – combining crushing plant and screening plant.

3. Oversize and intermediate products from the First Screening were then re-crushed with the Impactor settings closed down to 6mm. At this setting the throughput rate of the crusher was reduced, and as a result, the crusher product was able to be conveyed directly into the screening plant. (Photograph 5).

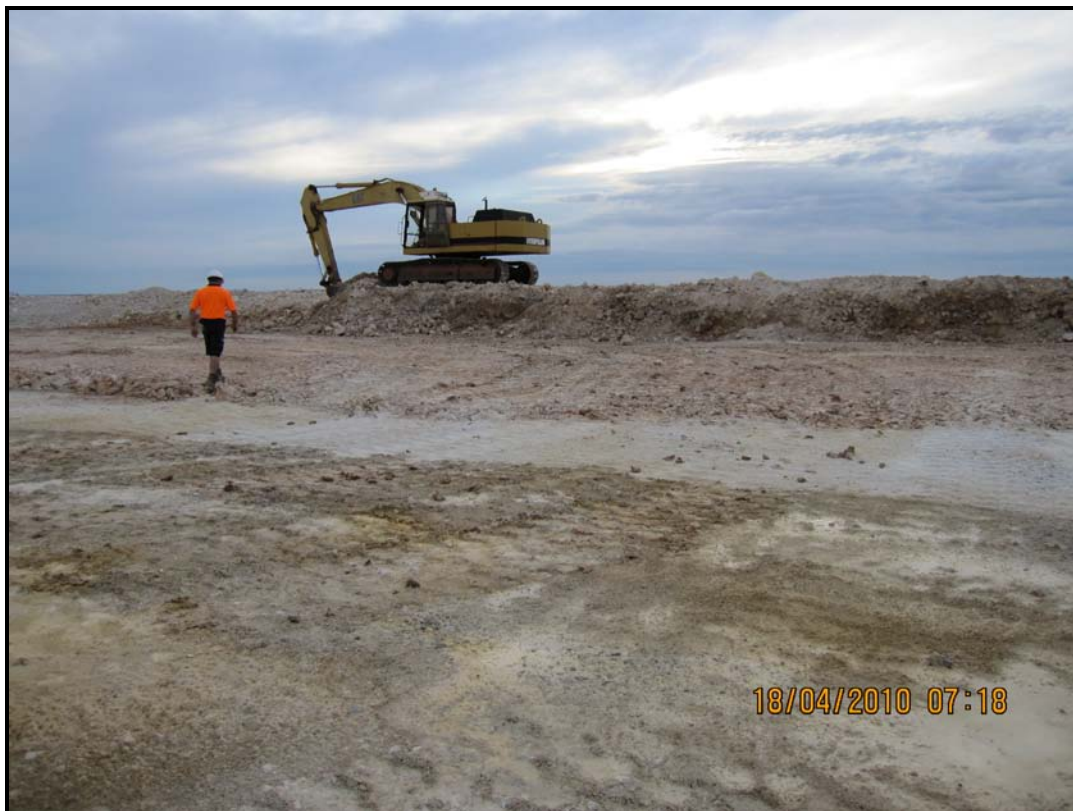
Photograph 6 - 200mm of BPH remaining on Waste Dump Floor.

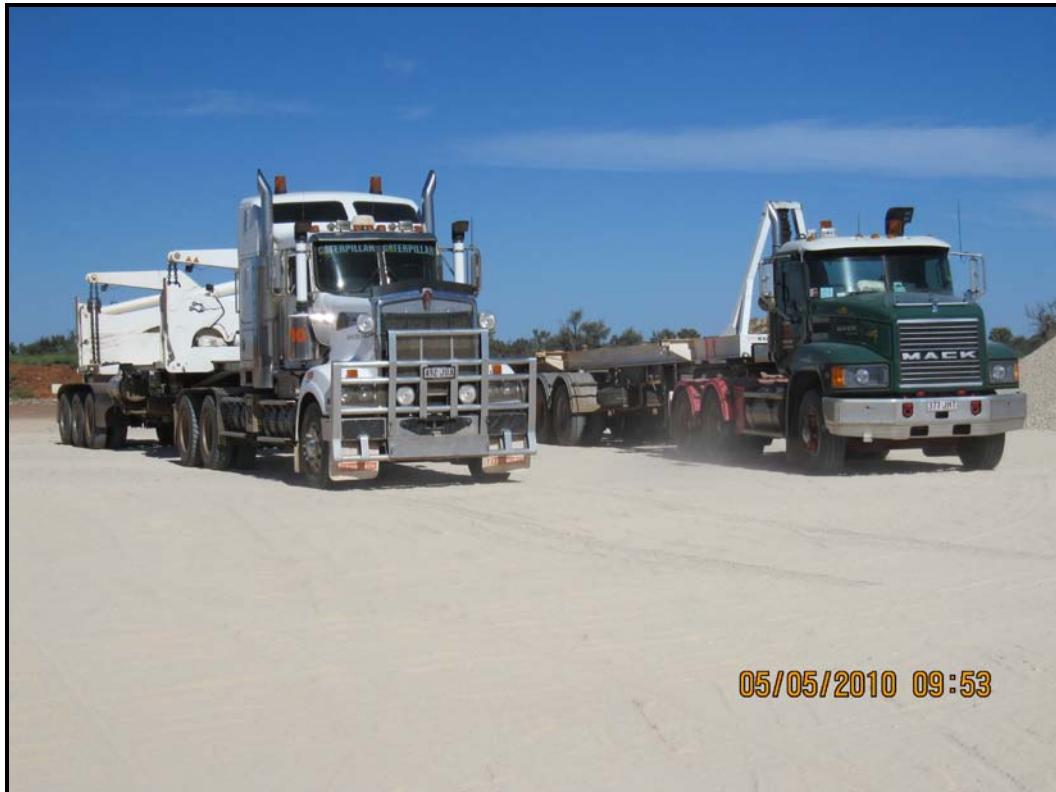
Photograph 7 – Side-lifter and Tipping Skel.

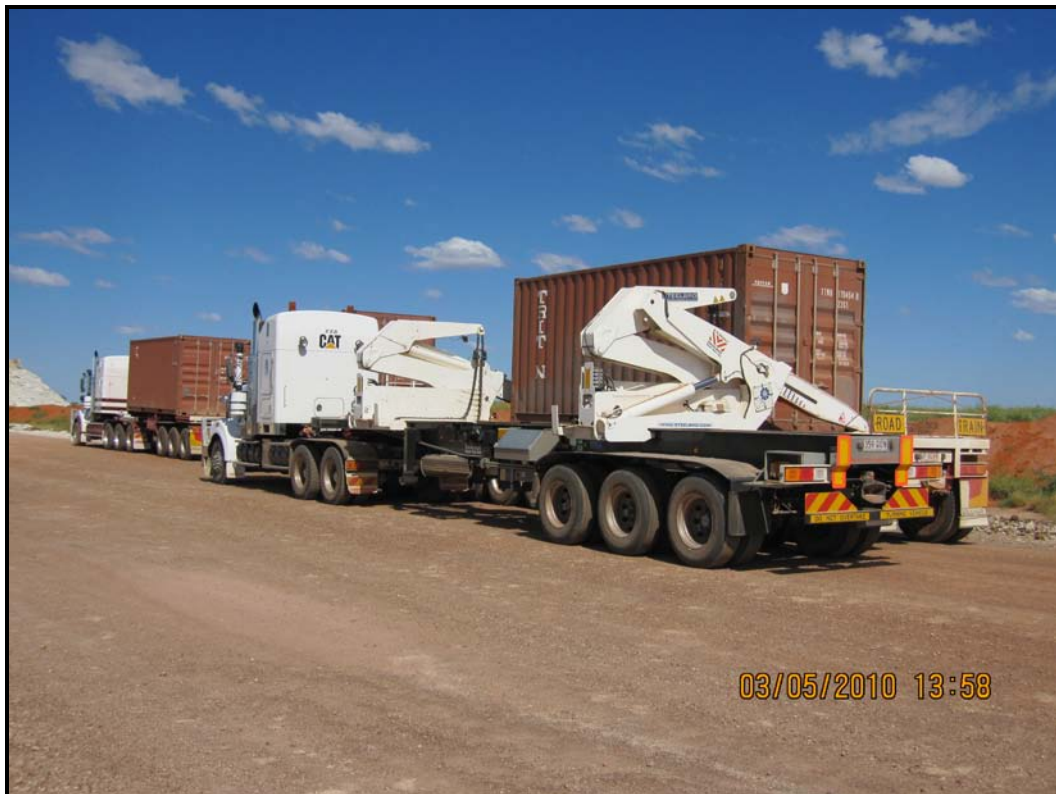
Photograph 8 – Lifting full containers from road train onto side-lifter.

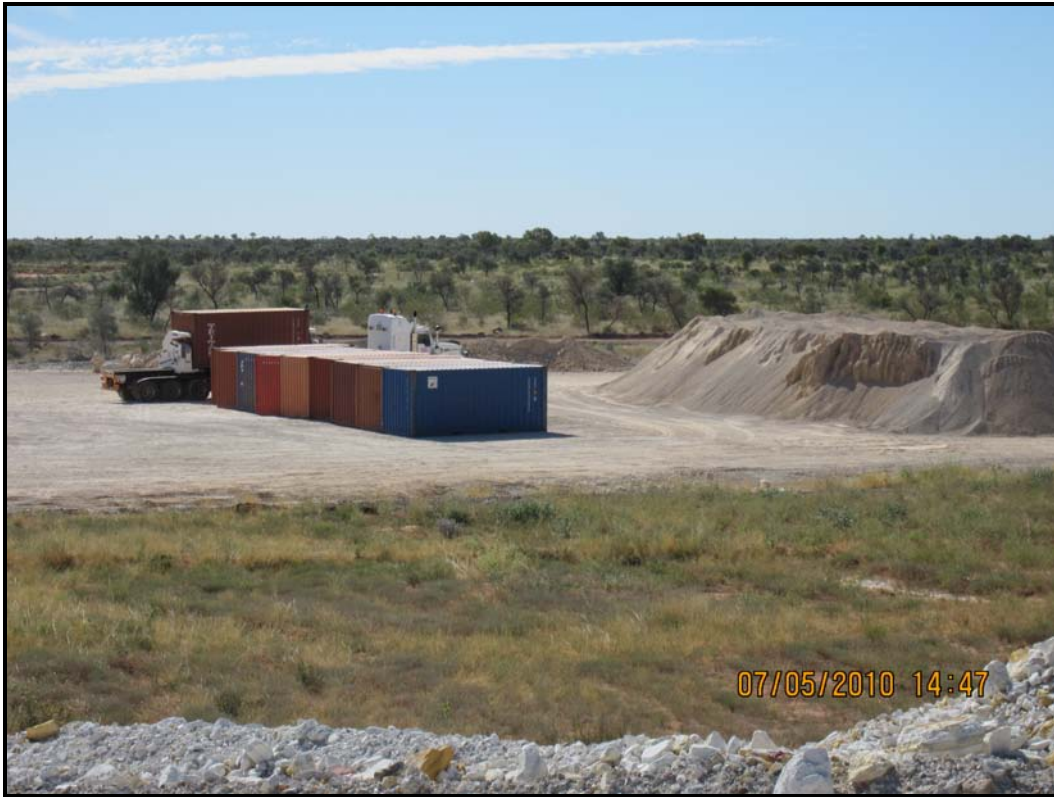
Photograph 9 – Loading last container for New Zealand.(Remaining containers to go to India).

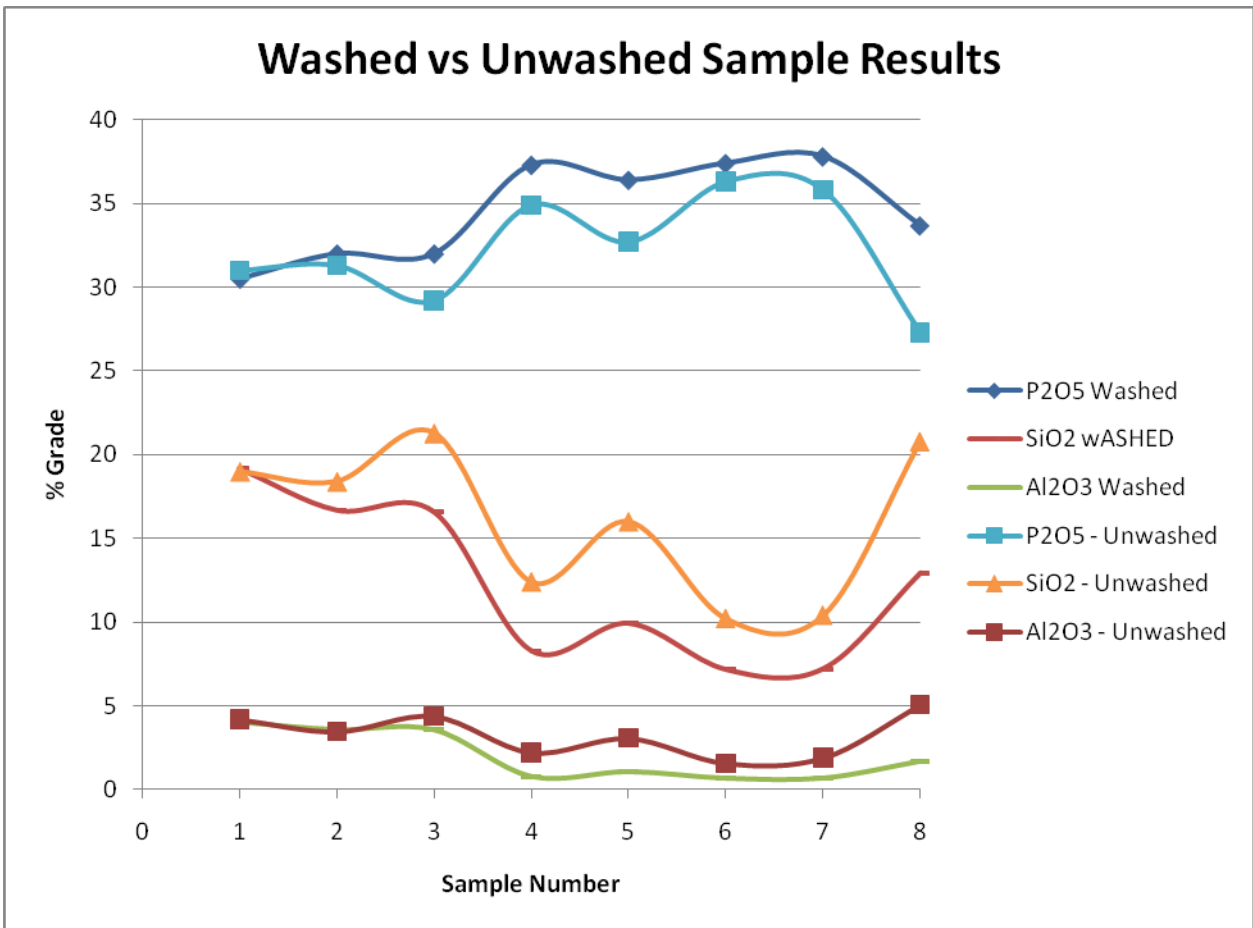
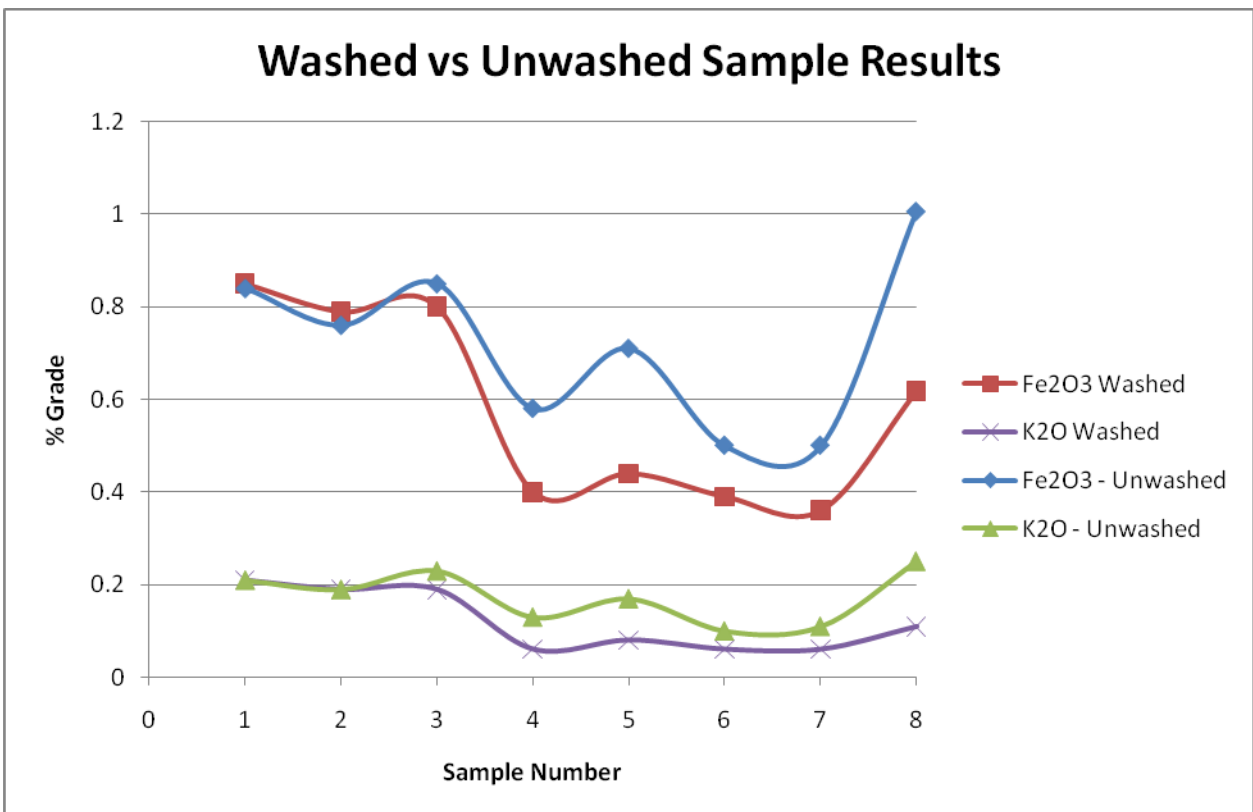
APPENDIX 1

The graphs clearly indicate that in 7 of the 8 samples screening or washing has removed the fine/slime fraction resulting in a reduction in SiO₂, Fe₂O₃ and Al₂O₃ grade, and a subsequent increase in P₂O₅ grade.

Sample 1, 2 and 3 were dry screened, and samples 4-8 inclusive were washed.
