GROUP ANNUAL TECHNICAL REPORT  
FOR EL27972 "CHARLOTTE" AND  
EL27974 "CENTRAL RAILROAD" FOR  
PERIOD ENDING 20<sup>TH</sup> SEPTEMBER 2015

Titleholder:	Tellus Holdings Ltd
Operator:	Tellus Holdings Ltd
Tenements:	EL27972 Charlotte, EL27974 Central Railroad
Project Name:	Chandler Project
Report Title:	Group Annual Technical Report for EL27972 "Charlotte" and EL27974 "Central Railroad", for the period 21 September 2013 to 20 September 2015
Author:	Jaime Livesey
Target Commodity:	Halite (Sodium chloride) and trace minerals
Date of Report:	12 November 2015
Datum/zone:	GDA94 / zone 53
250K map sheet:	SG5302 Rodinga, SG5305 Kulgera, SG5306 Finke
100K map sheet:	5648 Charlotte, 5748 Rodinga, 5547 Erldunda, 5647 Idracowra
Address:	Tellus Holdings Ltd Suite 2, Level 10, 151 Castlereagh Street Sydney, NSW, 2000
Telephone:	+61 2 8257 3395
Fax:	+61 2 8233 6199
Email for further Technical details:	jaime@tellusholdings.com
Email for Expenditure:	jaime@tellusholdings.com

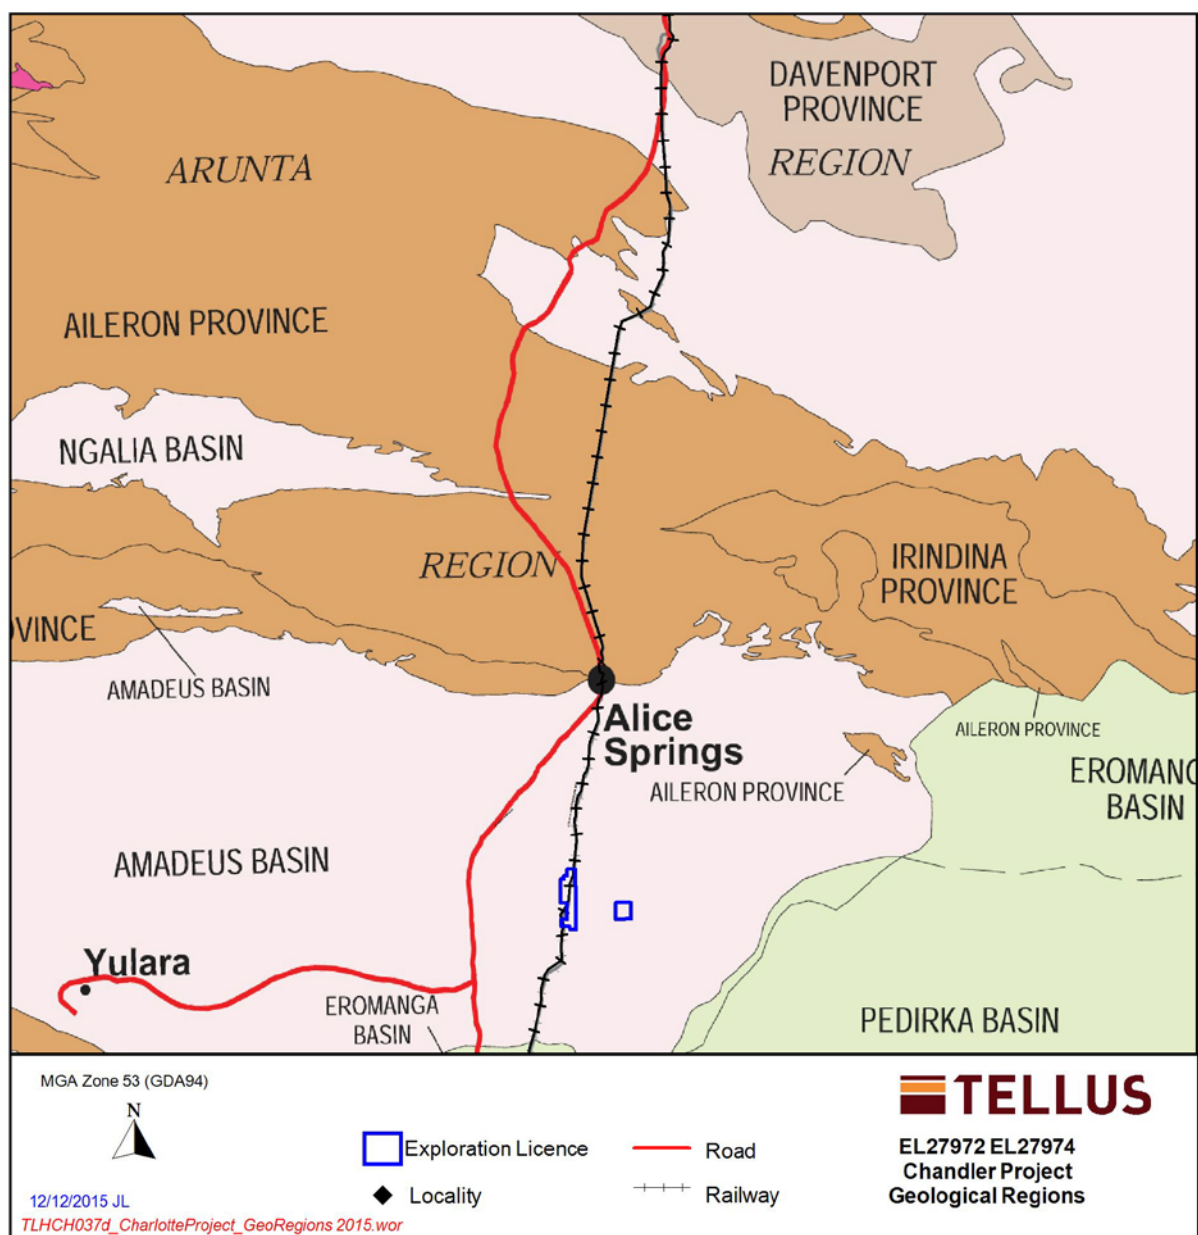
Figure 2: Geological Regions of Northern Territory (adapted from NTGS, 2006)

The Amadeus Basin is an asymmetrical, east-west trending, intracratonic depression covering 155000 sq km of central Australia (Figure 2).

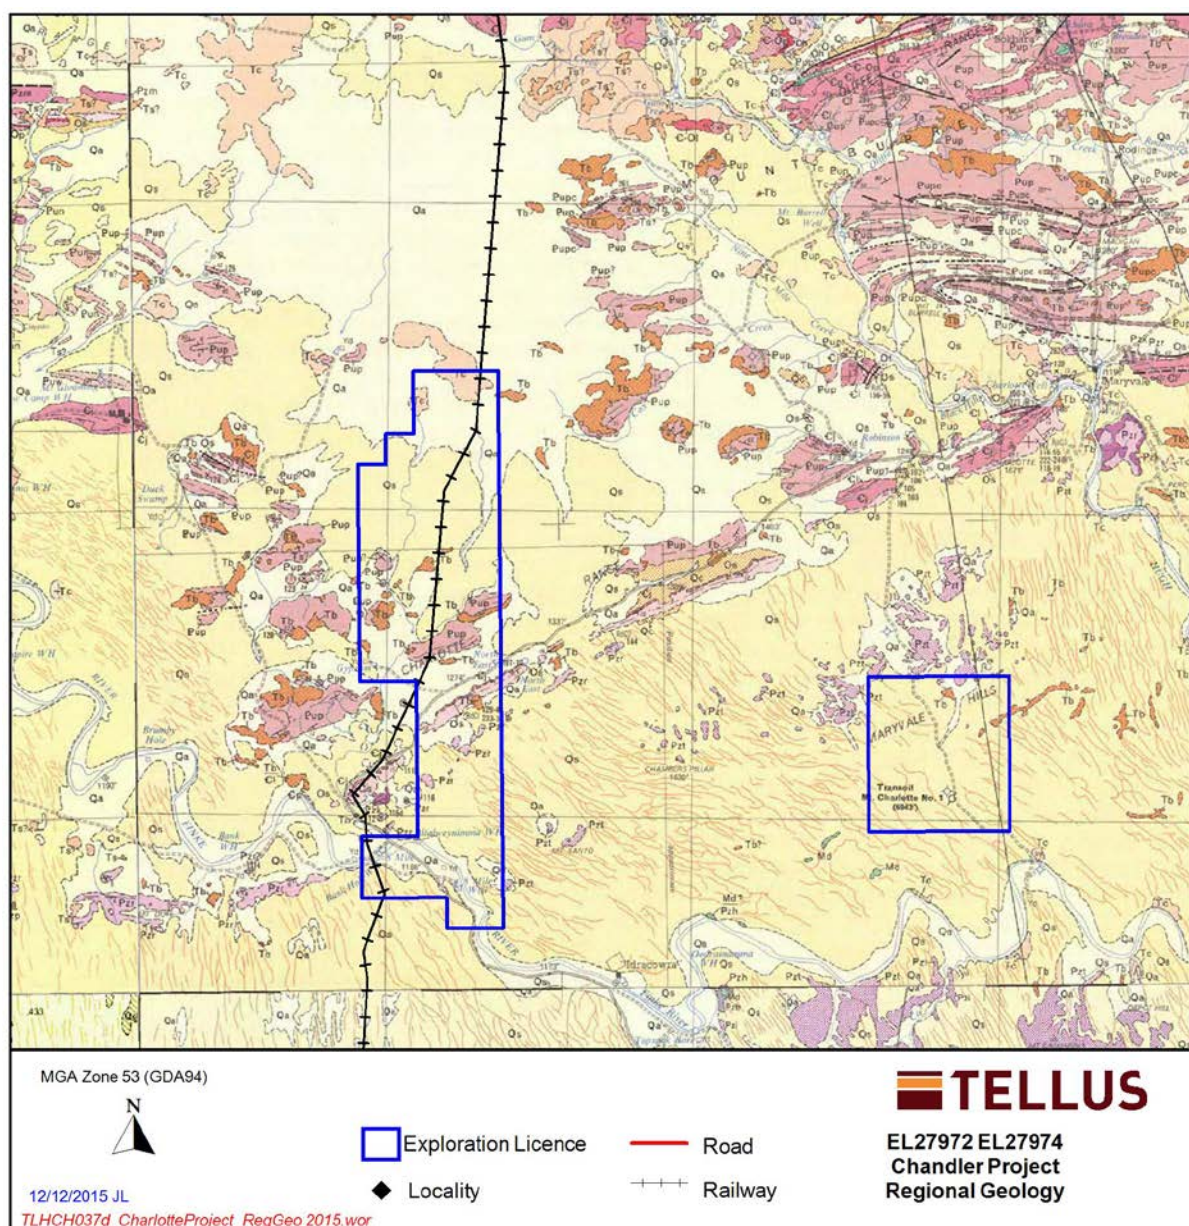
Figure 3: Geology over EL27972 and EL27974

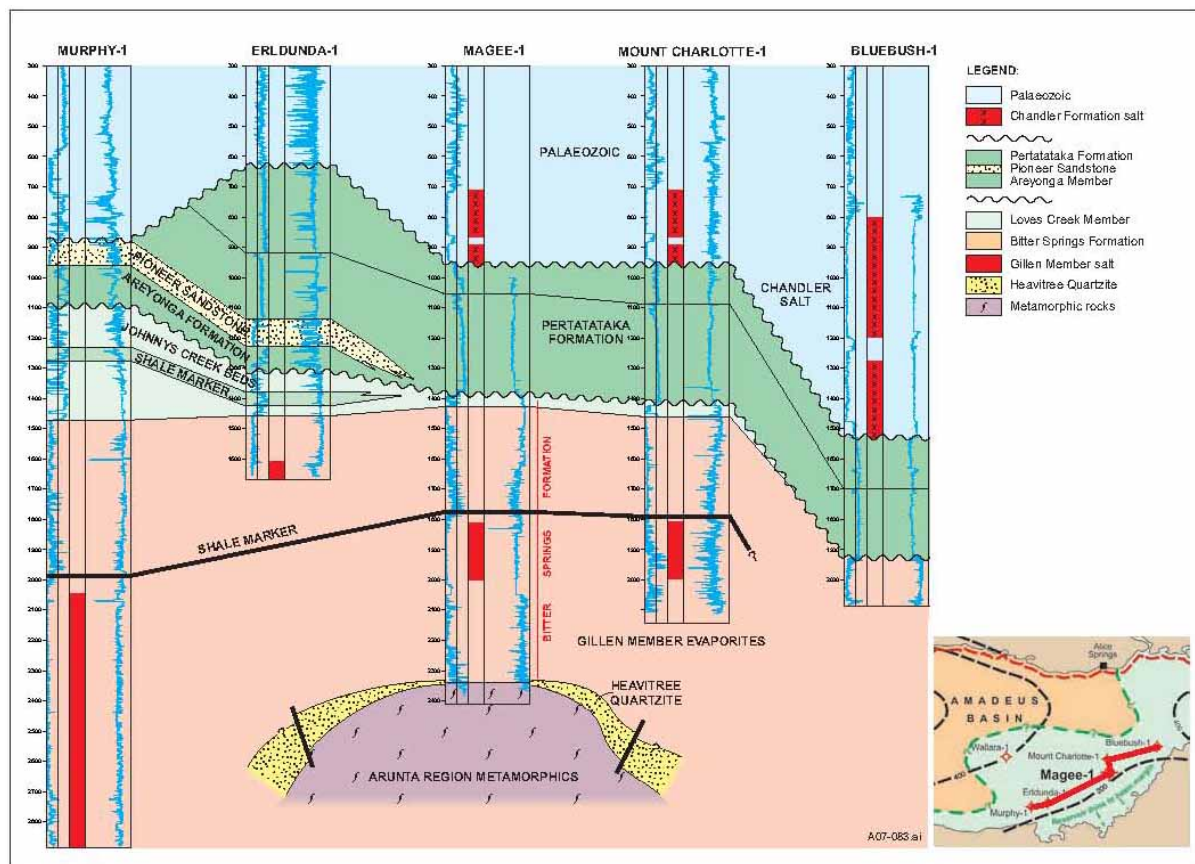
**Figure 5: Correlation between wells (from Young and Ambrose, 2007)**

The stratigraphy within the Charlotte area has been well defined from drilling of petroleum wells Mt Charlotte 1 and Magee 1, the generalised local stratigraphy is given in Table 2 and published stratigraphic correlation across the Southern Amadeus basin is shown in figure 5.

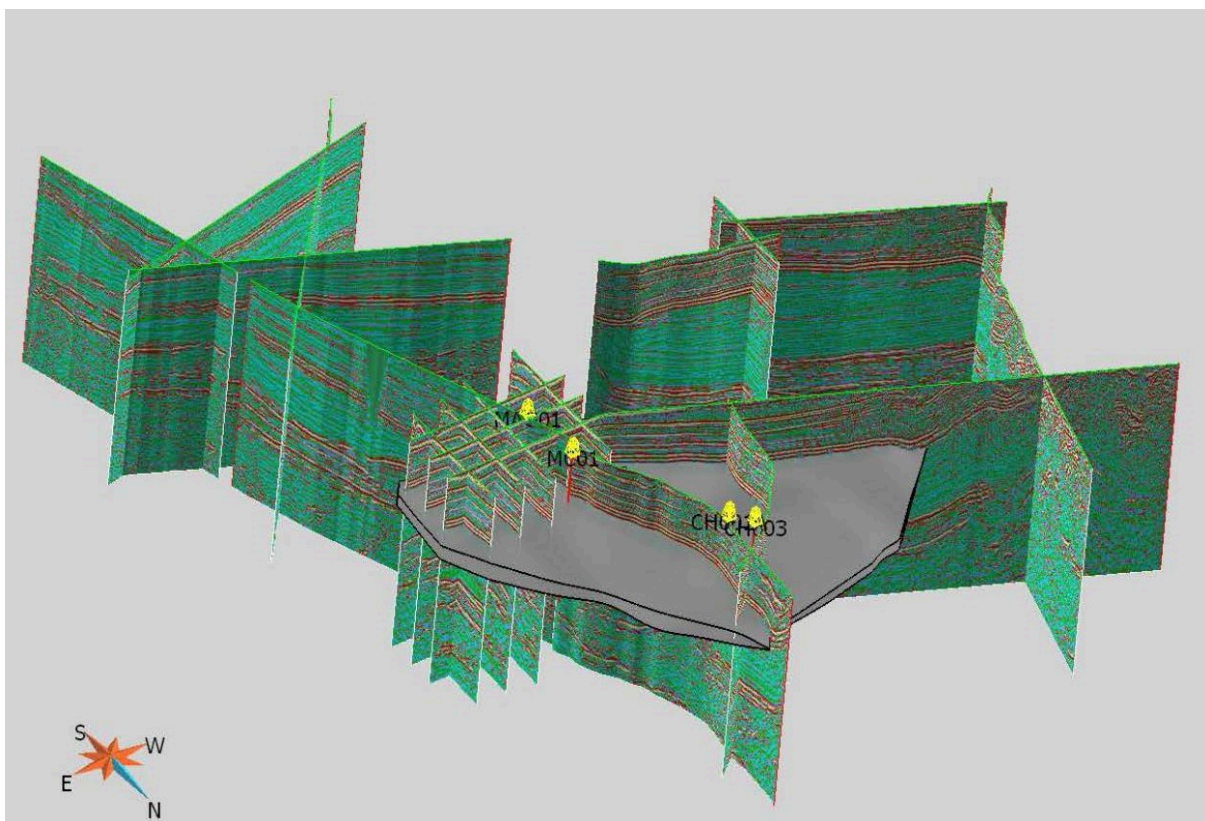
**Figure 6: seismic modelling of Chandler Formation extent**

The interpretive geological model over the project area has been updated and refined (Figure 6).

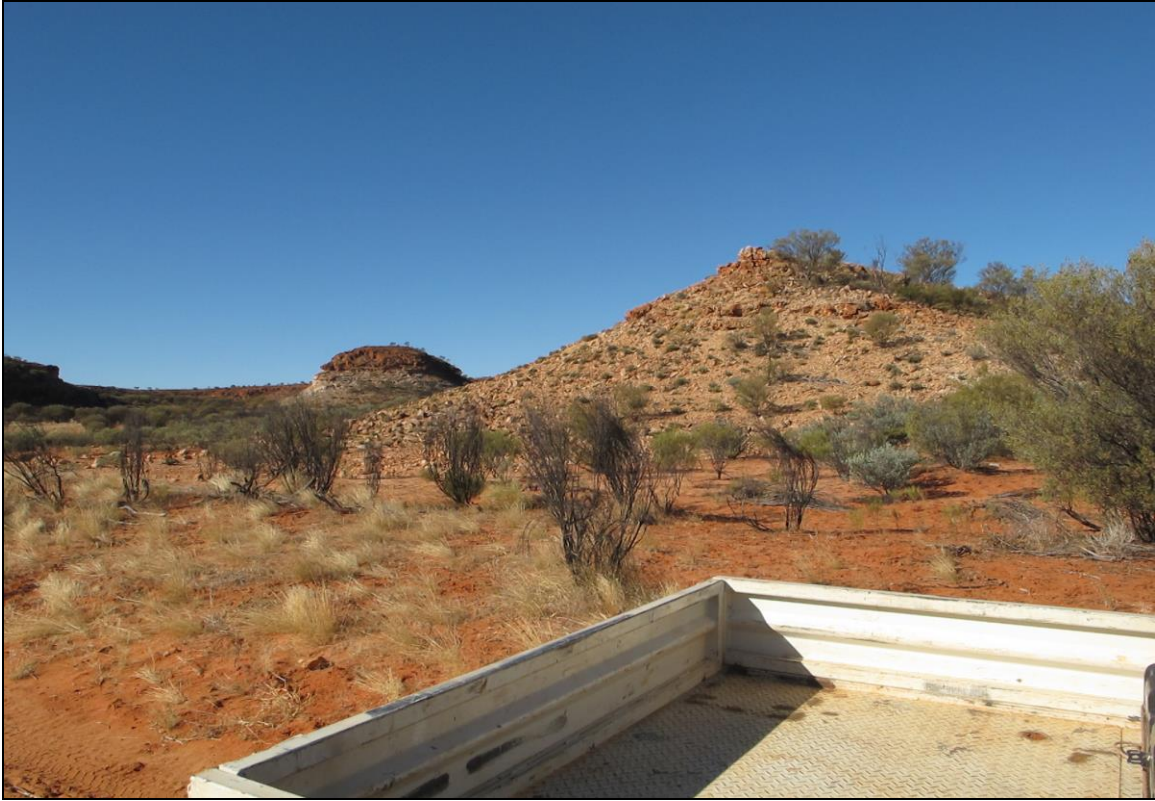
**Plate 1:** Santo Sandstone outcrop along track (394635mE, 7254100mN).

Further south, the track passed through an area of heavily eroded ridgelines that trended roughly east-west (outcropping Late Palaeozoic Santo Sandstone) and the track followed the edge of a shallower section of the outcrop (394635mE, 7254100mN). Several panorama photographs being recorded (Plates 1&2).

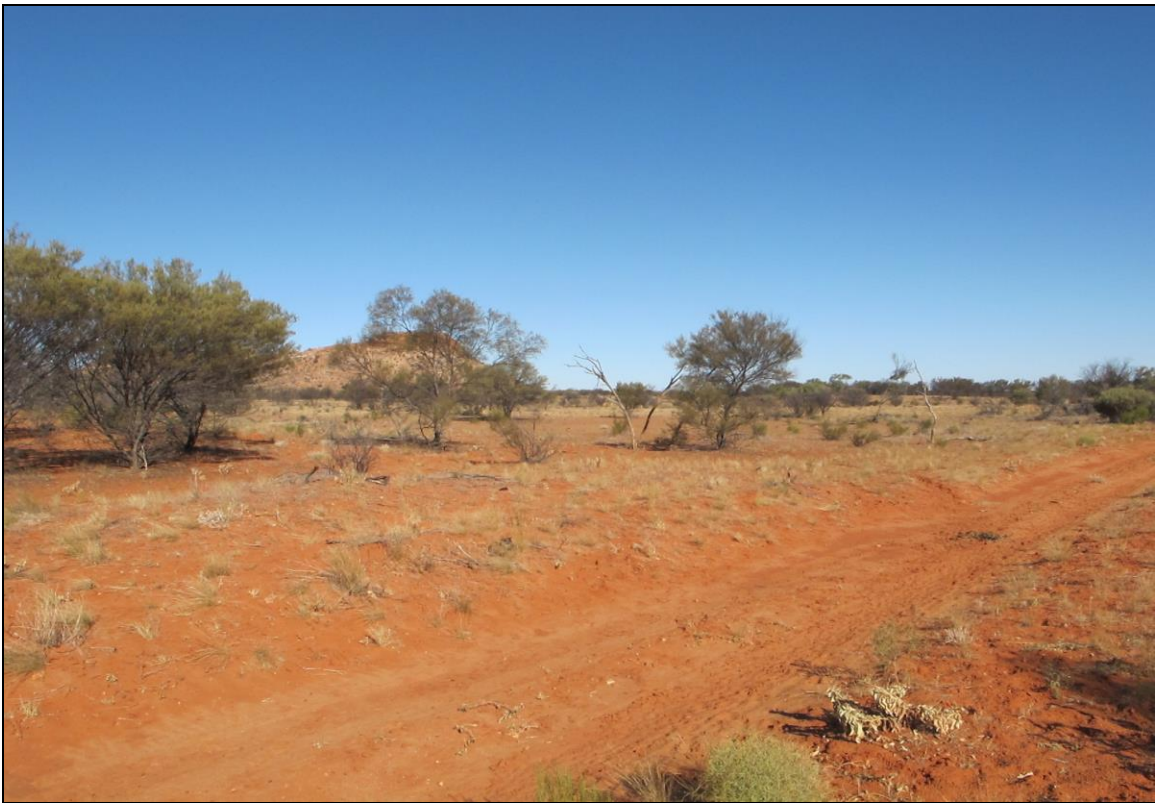
**Plate 2:** Panorama view south from outcrop along track (394635mE, 7254100mN).

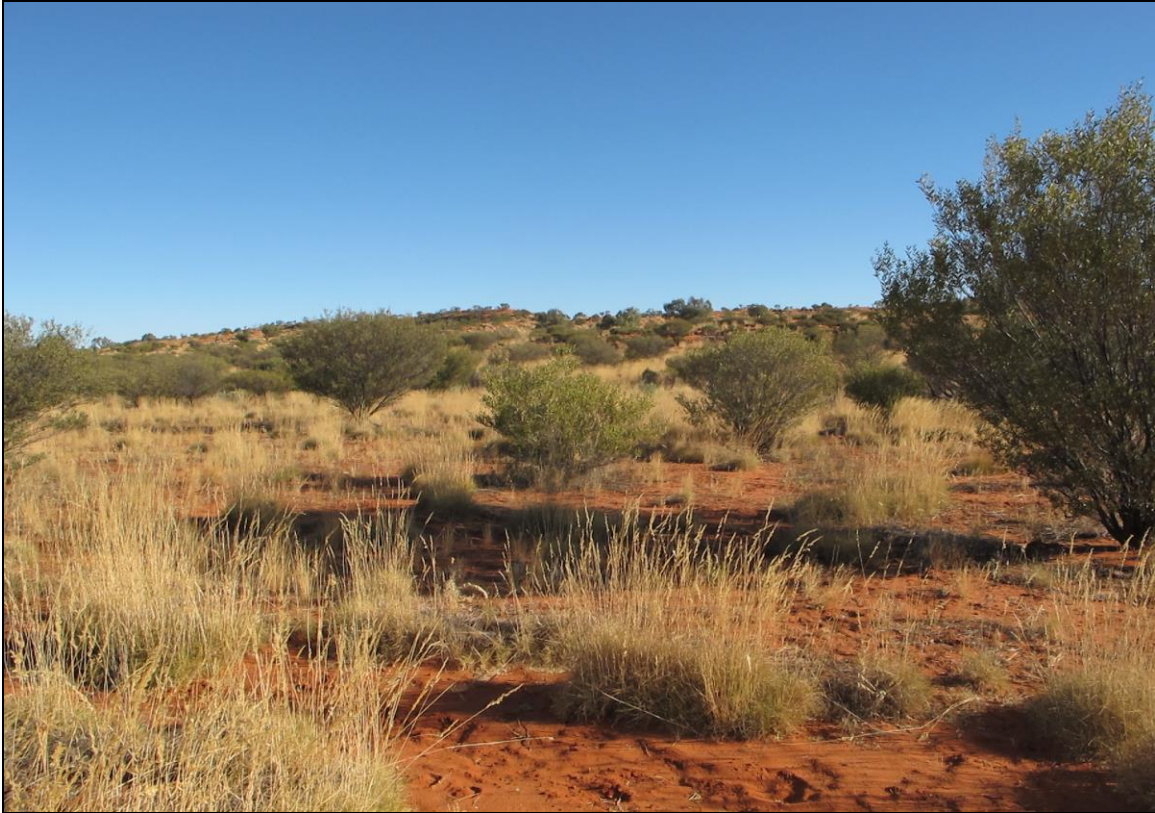
**Plate 3:** View west from calcrete creek towards large sand dune (401225mE, 7253490mN).

Further south from the yards, the station track continued southward through sandy soils and intermittent dunes with a predominance of acacia scrub. Several large dunes were mapped and photographed further south (401225mE, 7243490mN). The track continued towards south-east into a more undulating landscape, comprising irregular calcrete exposures and a series of deeply incised creeks, filled with gravels on eroded calcrete (402075mE, 7242500mN) and surrounded by large sand dunes located just north of Magee Bore (Plate 3). Black poly pipe (water pipeline currently feeding the tanks at Eric's yard?) was observed in shallow exposures along the verge of the track and provided an indication that the bore was nearby. The track continued south for a few hundred meters through more densely vegetated country, comprising large eucalypts, tea tree and other acacia species down to the edge of the Finke River.

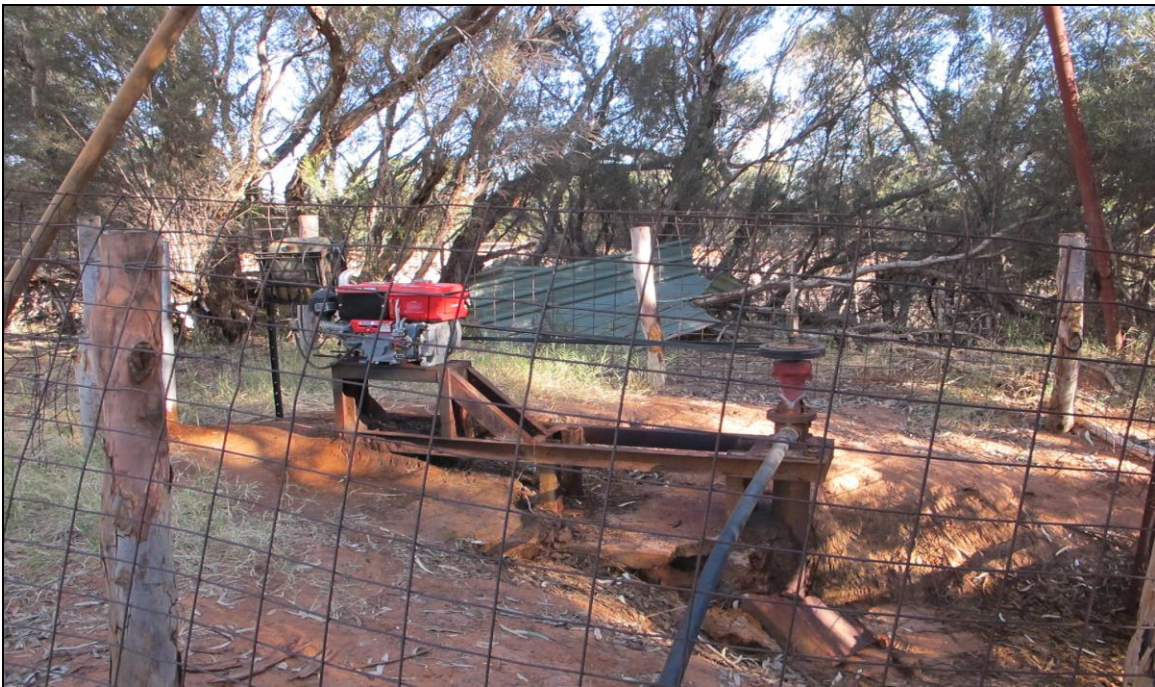
**Plate 4:** Magee Bore RN16632 (402262mE, 7242276mN). Finke River can be observed in the background, through thick tea tree scrub about 50metres south of the bore.

Magee Bore RN16632 (402462mE, 7242276mN) was found at the end of the track at a distance of 17.9km from the Tellus Camp on the northern bank of the Finke River which was the first bore successfully located during the reconnaissance program. The bore was confirmed to be operating and was currently feeding the same black poly-pipe (Eric's yard source?) via a Kubota diesel powered helica-rota (belt-driven) bore pump (Plate 4).

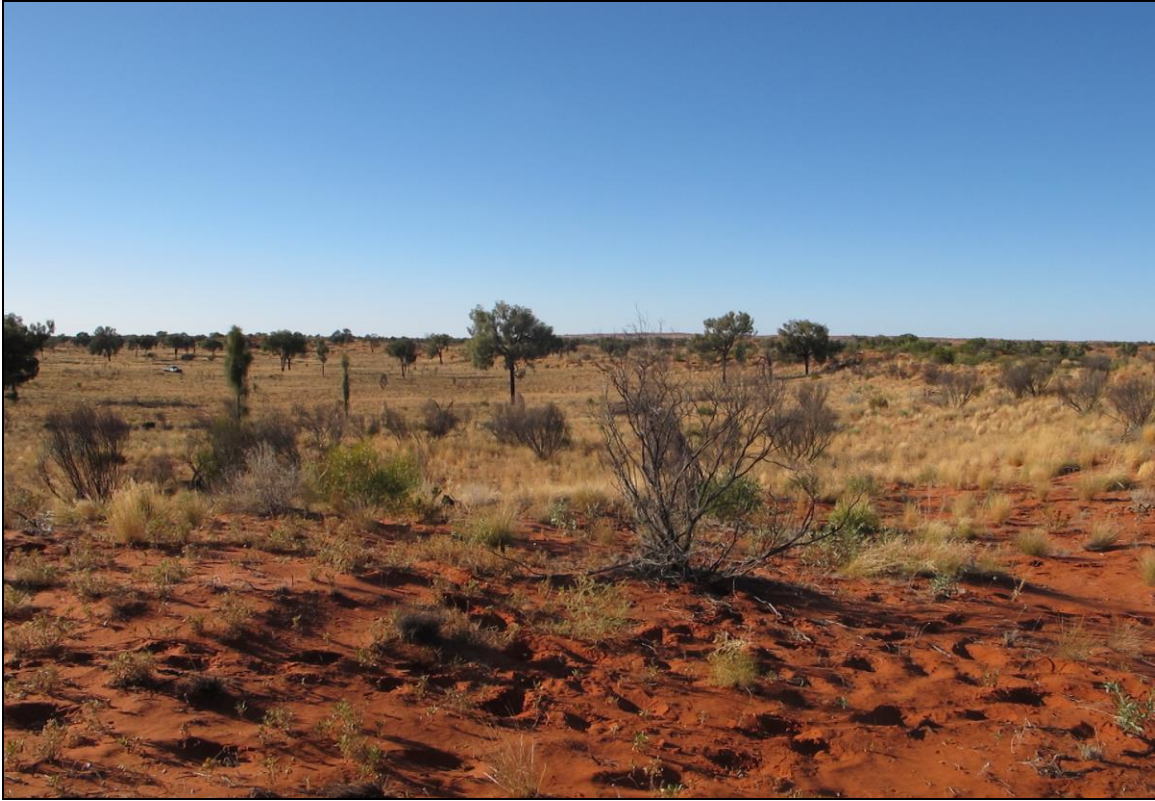
**Plate 5:** View south across the mapped location of Magee No1 Oil Exploration bore.

The area was gridded for several hundred metres around the collar point with no success, with old drilling reports being reviewed to re-confirm the co-ordinates. The search was abandoned around 9AM after a thorough search of the area failed to locate the bore. The area was photographed (Plates 5&6) before the return journey commenced back to Eric's yard to locate the remaining two bores.

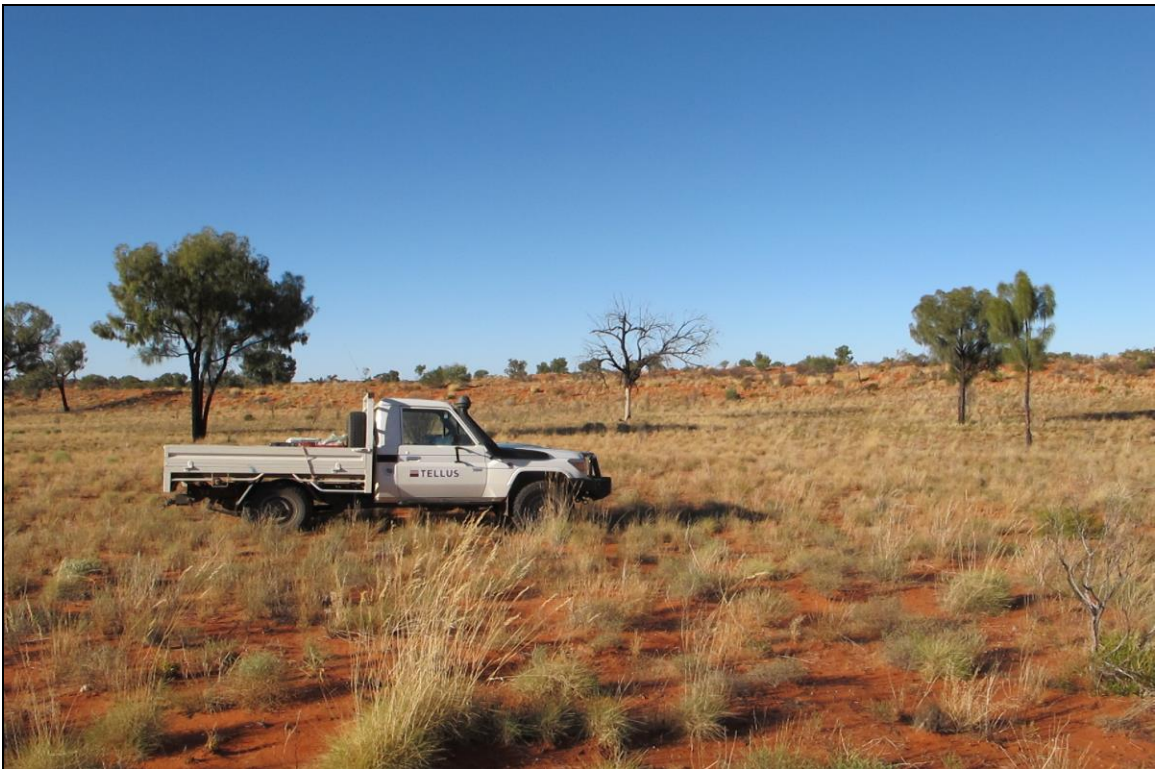
**Plate 6:** Mapped location for Magee No1 Oil Exploration bore (393800mE, 7245400mN). Area is surrounded by sand dunes up to 5m in height and trending NNW-SSE.

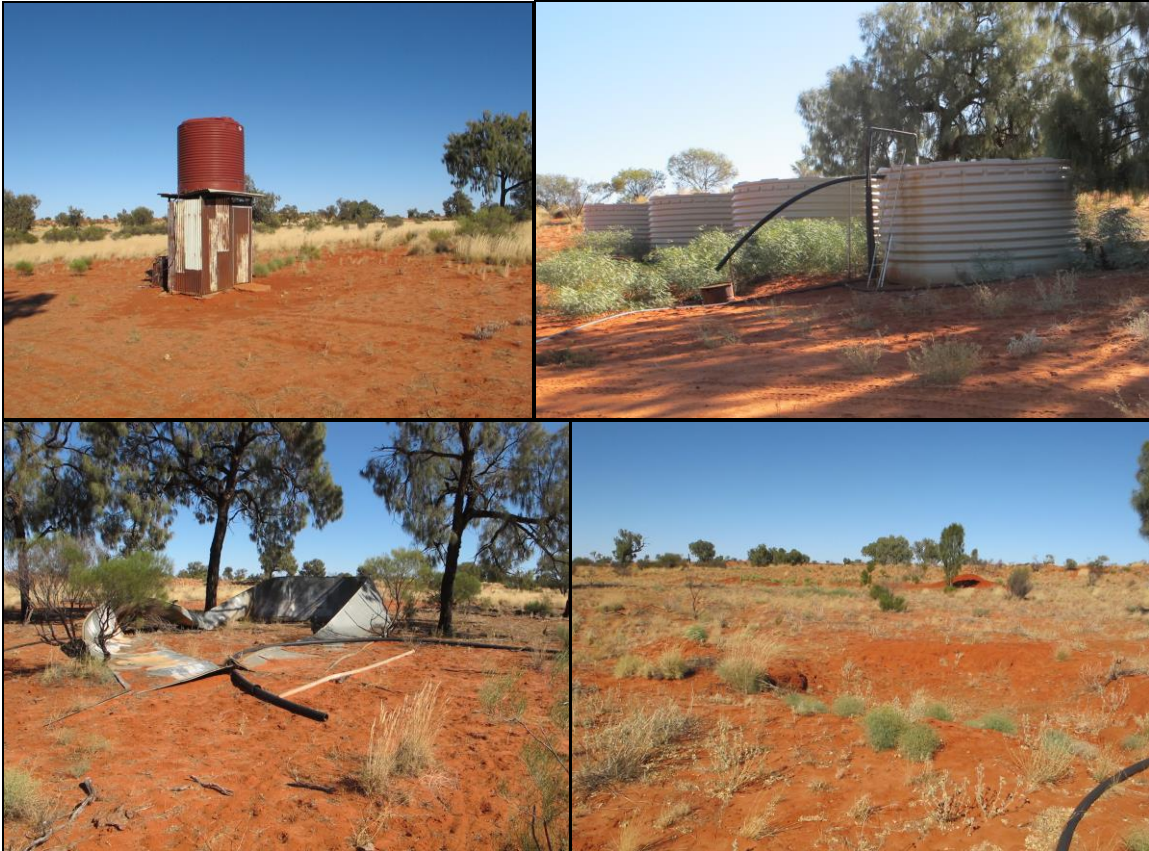
**Plates 7-10:** Shower at the stockman's camp (Top LH); Poly tanks fed by Magee Bore at Eric's yard (Top RH); Collapsed tank and costeans south of Eric's yard (Lower images).

Once back to the main station track at Eric's yard, it was noted that water was being pumped to the tanks via the poly-pipe from Magee Bore (Plate 7). A water sample was collected for analysis before the search commenced to locate Eric's dud bore RN4623. A further search of the immediate area on-foot (around the mapped co-ordinates; 398232mE, 7245503mN) failed to locate the bore with the surrounding area being subsequently gridded. This further search identified the old collapsed water tank (398180mE, 7245710mN) and an area containing several shallow costeans (398195mE, 7245630mN). Fragments of old pipe and offcuts of black poly-pipe were also identified around the immediate area however, the bore location could not be found (Plates 8-10).

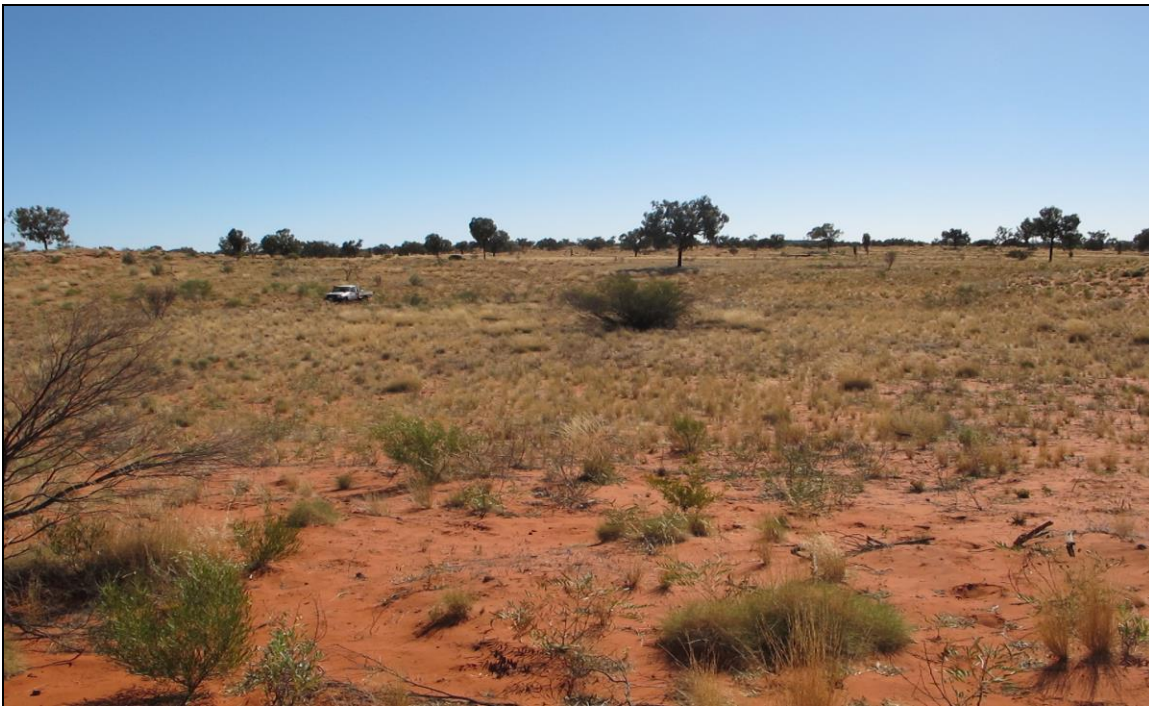
**Plate 11:** Reconnaissance of historical co-ordinates, for alternative location for Eric's dud Bore (133°59'21"E, 24° 53'04"S).

A review of old well records for RN4623 identified an alternative location (133°59'21"E, 24° 53'04"S), with a new reconnaissance being conducted towards the east of the station track several kilometres to the north of Eric's yard which also failed to locate the bore (Plate 11). The search to find Eric's dud bore was abandoned at 10:30AM, with all efforts then being focused towards locating the only remaining bore; Mt Charlotte Oil Exploration Bore (RN10970) which was located about 5km further north according to the base map.

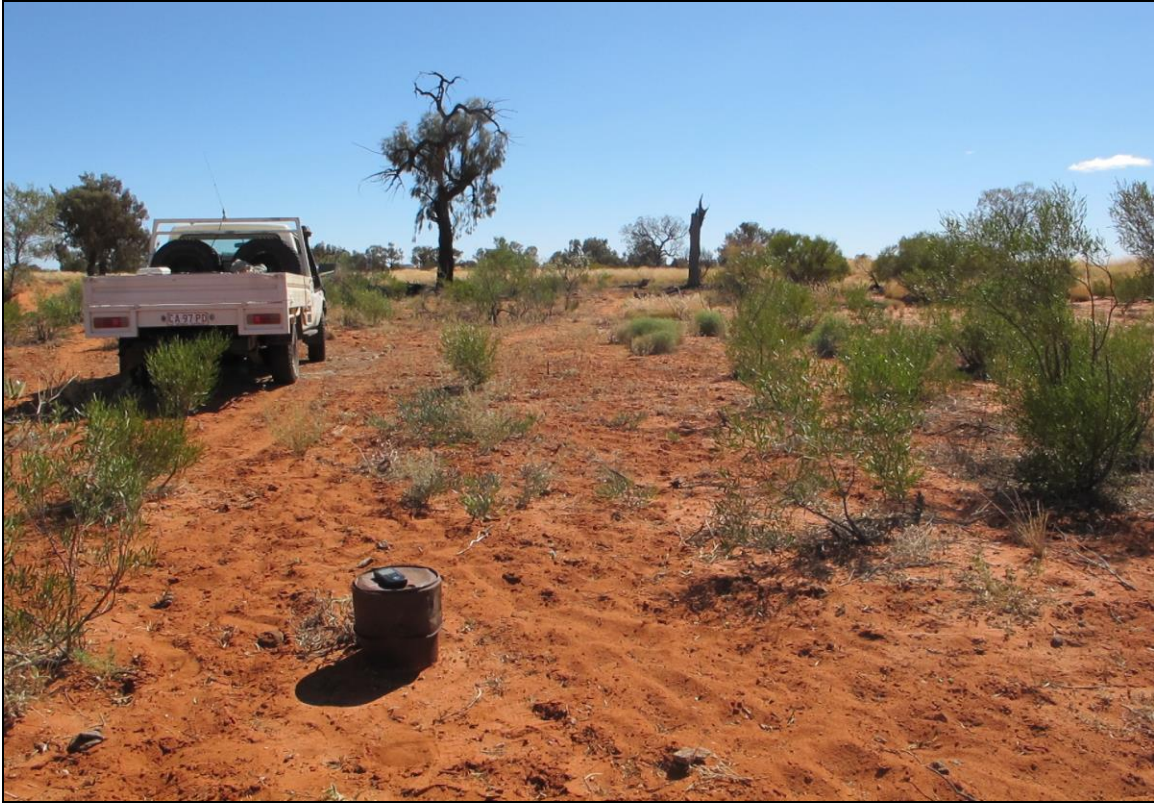
**Plate 12:** Mt Charlotte Oil Exploration Bore RN10970 (397844mE, 7246512mN)

Further south, the reconnaissance conducted on the previous day had mapped a large dam, just east of the track which may have indicated a potential drilling site. An inspection of the area on-foot successfully located Mt Charlotte Oil Exploration Bore (RN10970) about 5metres north of the dam (397844mE, 7246512mN). No head works were located at the bore, apart from the single steel casing which was capped by a loosely-fitting bucket (Plate 12).

Detailed notes, measurements and photographs were recorded and attempts were made to obtain a water sample. The depth of the water table was around 90m with most of the sample being lost by the time the dipper was retrieved back to the surface however. This work was completed by 11:15AM with departure back to the Tellus camp.

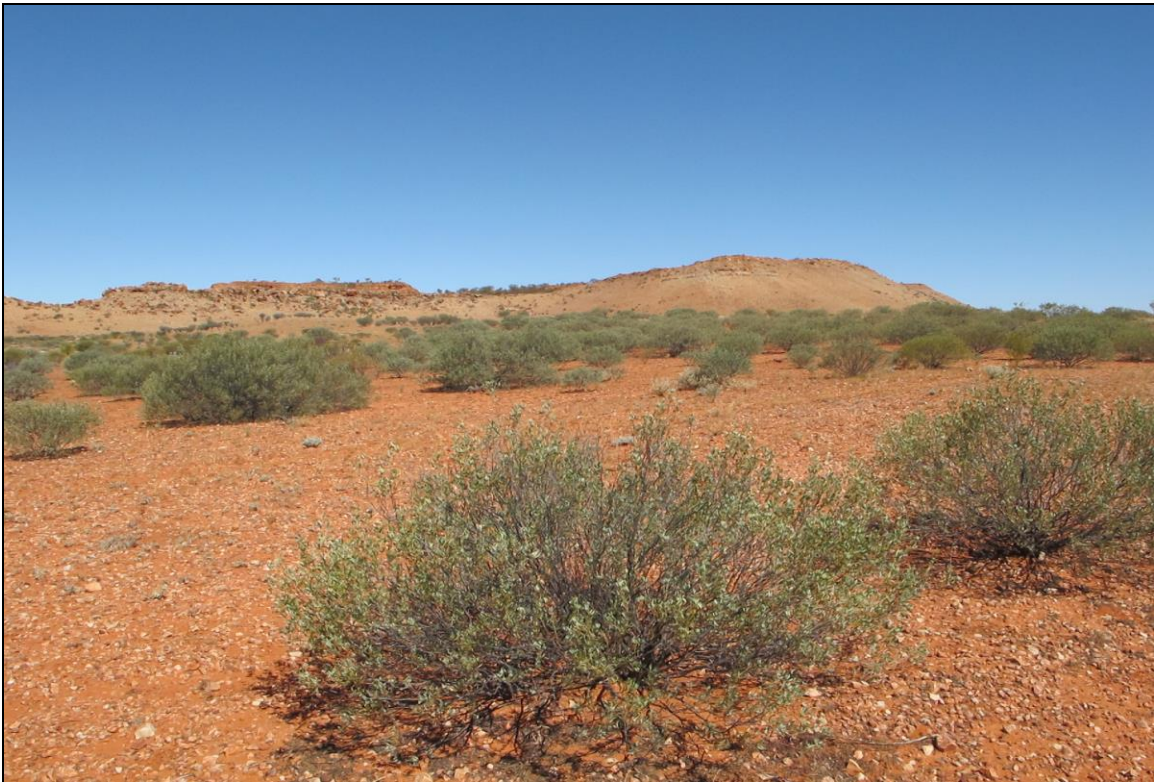
**Plate 13:** View south across the deflation plain, at recorded location for Halfway Bore (Abd Exoil exploration bore; RN10969). This bore was not located during the traverse.

The track was heavily rutted in areas from just west of the turnoff with a change in the vegetation and soils from sandy soils to sand and clay loam soils and thicker mulga and acacia scrub being observed. The station track continued west along the northern tip of a shallow, upward grading and gravel-covered deflation plain in the area close to the mapped bore location. The deflation plain was distinctive owing to the coarse gravels and small bushy acacia species that continued in the southern direction up to the ridgeline outcrop located several hundred metres further south (Plate 13).

A traverse was conducted on-foot in the area around the recorded location for RN10969 which failed to locate the bore. The search was halted around 1:30PM with documentary photographs being recorded of the area before the traverse was continued along the disused station track towards the western direction to locate the #84 bore, which was located about 10km further west.

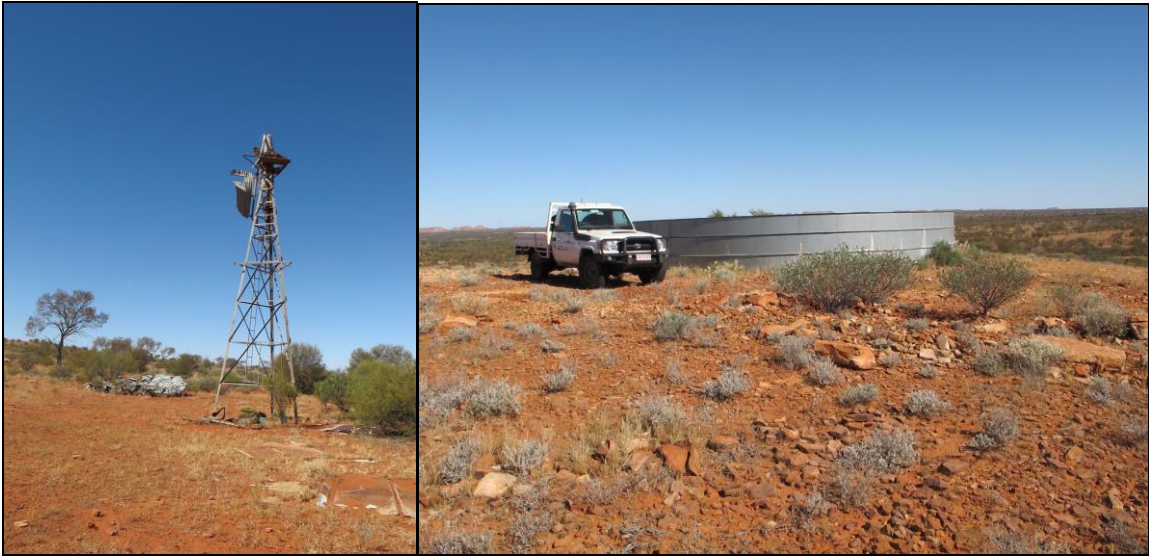
**Plates 14&15:** Abandoned windmill, located 1km east of #84 bore (384100mE, 7258750mN) and large decommissioned water tank, located on crest of ridgeline, Charlotte Range (384125mE, 7259060mN). Location of #84 bore was later identified to be about 1km further south-west from this vantage point.

The first station infrastructure identified in the area was a decommissioned windmill and tank (384100mE, 7258750mN) located immediately east of the station track at the base of a steep ridgeline (Plate 14). The location was mapped and several photographs were recorded before the search continued to locate #84 bore. According to the base map, this bore was located along a short track running along the ridge crest towards the west of the windmill however, the mapped co-ordinates identified a position several hundred metres further south.

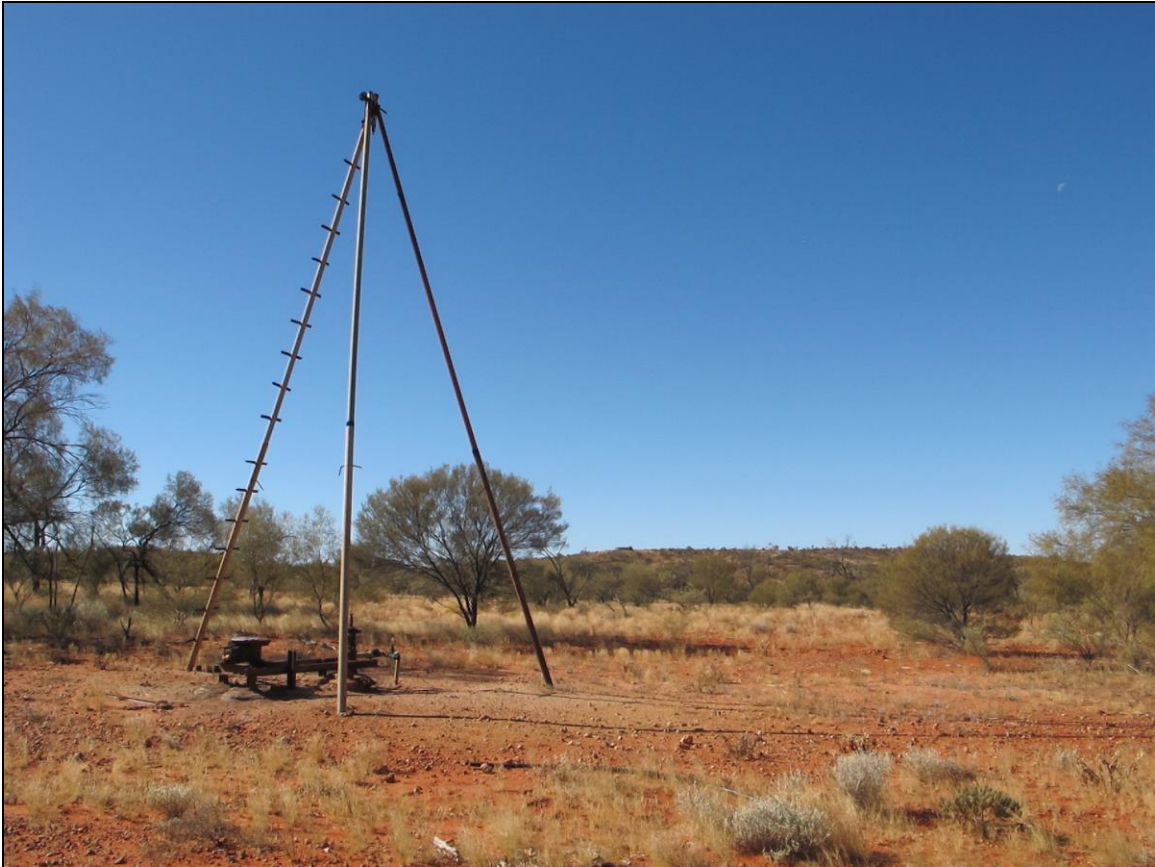
**Plate 16:** #84 bore RN14584, located on southern edge of Charlotte Range (383802mE, 7258610mN).

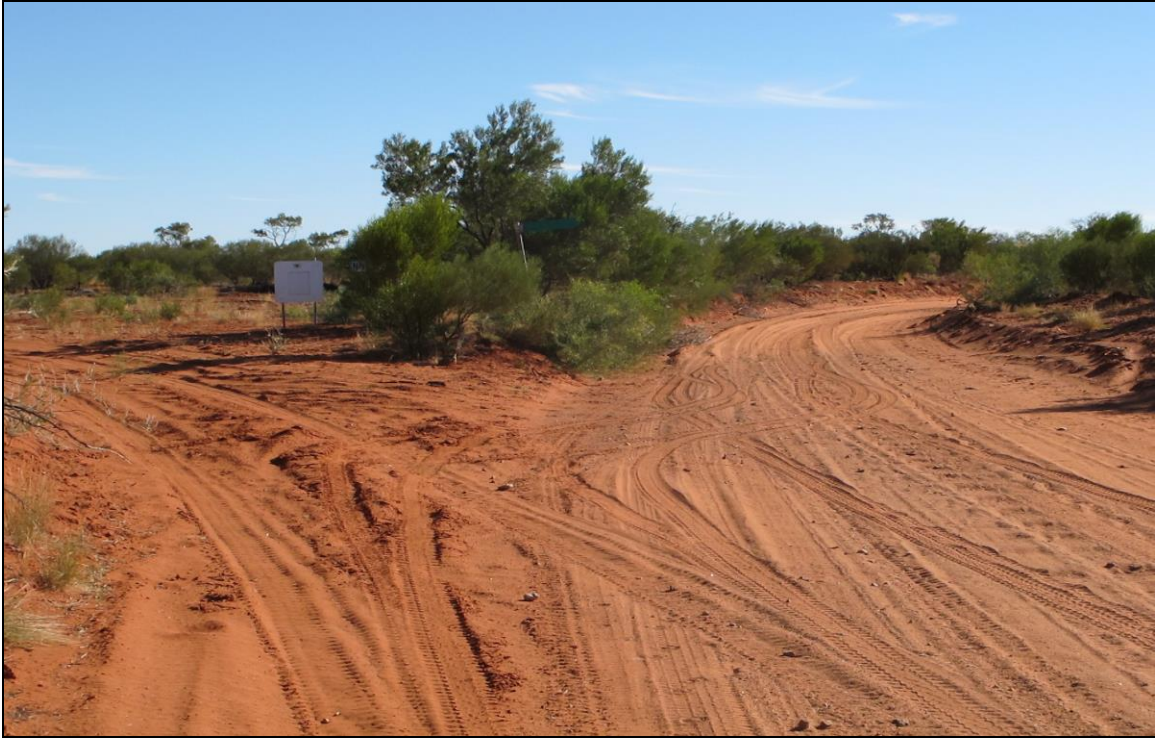
**Plate 17:** View towards west (approaching) of junction between Titjikala Chambers main access road and station access track to Tellus camp site (394967mE, 7266245mN).

The main access road was then followed east towards Titjikala and consisted of gravel for several kilometres (near to the Charlotte Range ridgelines), passing into sandy soils and mulga scrub for about 10kilometres. This track was noted to be in good condition (close to all weather), with some corrugated sections being encountered in the sandier areas. An open gravel plain was then crossed (388000mE, 7264140mN) with good road conditions being encountered for most of the way to the intersection with the main station track (394967mE, 7266245mN) which lead down to the Tellus camp site (Plate 17).

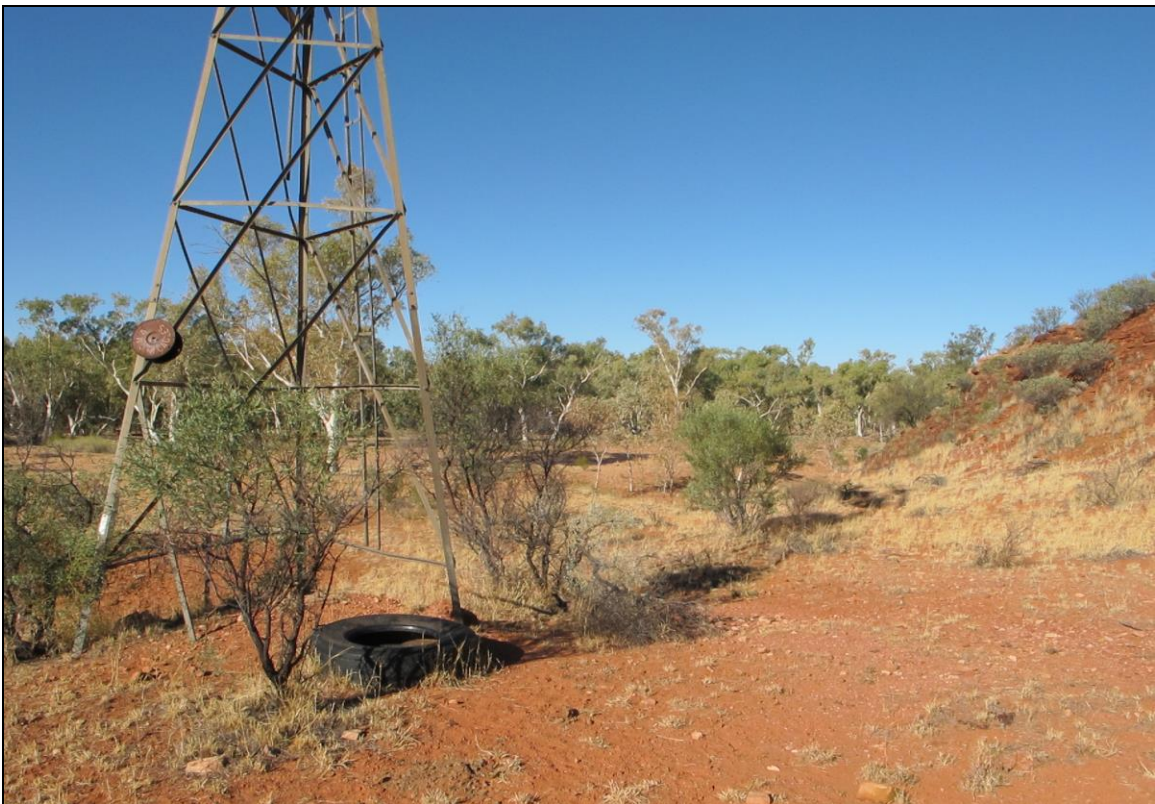
**Plate 18:** Black Hills Bore RN2957, located on western bank of the Hugh River, adjacent to a sharp/steep sandstone ridgeline (399493mE, 7269618mN).

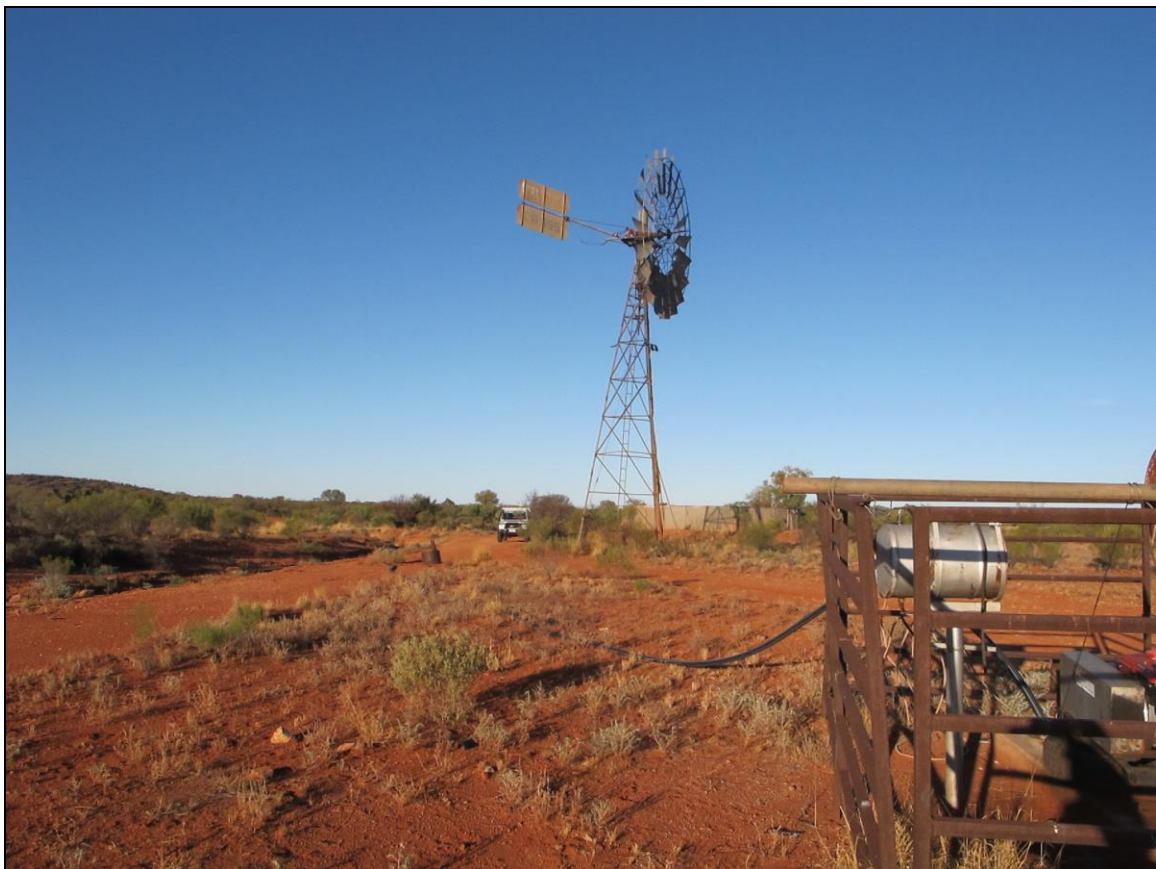
**Plate 19:** Bokhara Bore RN15443 (foreground), located 30metres west of the decommissioned windmill (RN3288) and tanks. This was the most northern bore examined as part of the April 2015 reconnaissance program.

Detailed notes, measurements and photographs were recorded for both the windmill RN3288 and Bokhara Bore RN15443. The windmill bore (RN3288) was observed to have collapsed, but Bokhara bore (RN15443) was currently commissioned and operating via an electric pump powered by a Kubota diesel generator. A water sample could not be collected owing to the pump being fitted. This work was completed by 5:30PM which concluded the field work for the day with the return journey being completed straight back to camp.

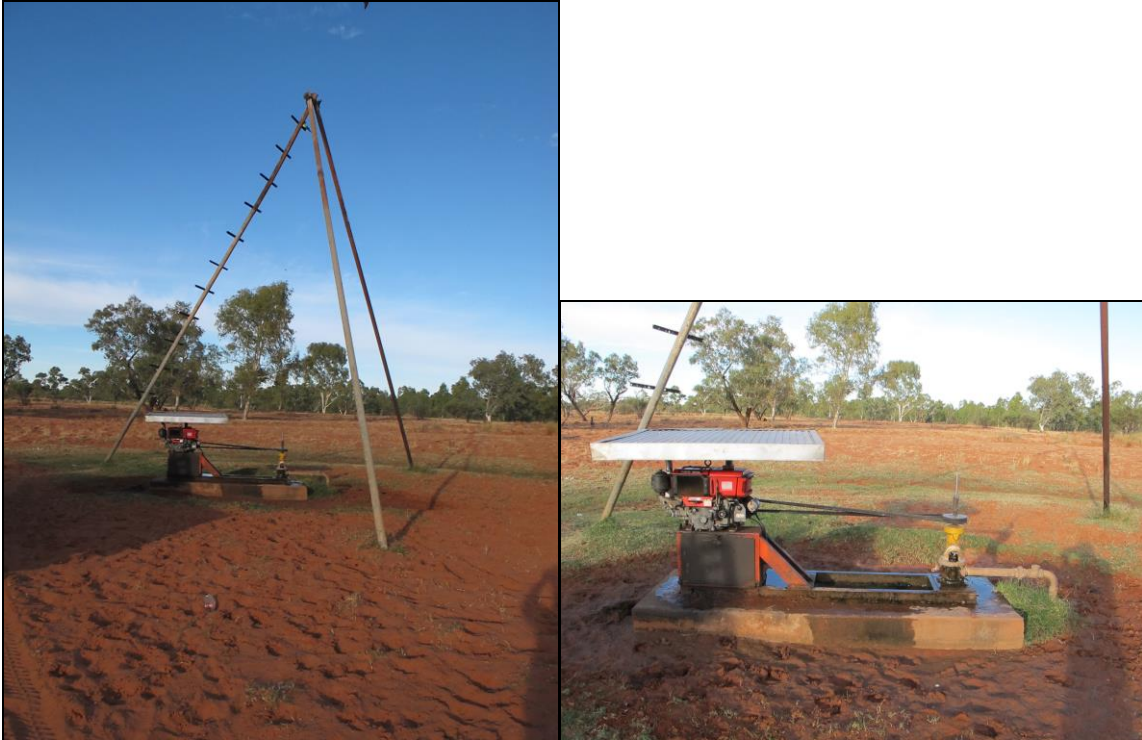
**Plates 20&21:** Unmarked bore (RN1385 or 3289?), located at the south-western corner of the boundary fence line for the Titjikala town site, on the north bank of the Hugh River.

According to the base map, this bore was either RN1385, or RN3289 however, there was some confusion at this point of the reconnaissance owing to the large number of documented bores included in the Titjikala town area. The bore was fitted with a helix-rotor (belt-driven diesel Kubota) which did not allow a water sample to be collected however, a small bleed tap was noted that would allow for sampling when the bore was running.
