GROUP ANNUAL TECHNICAL REPORT  
FOR EL27972 "CHARLOTTE" AND  
EL27974 "CENTRAL RAILROAD" FOR  
PERIOD ENDING 20<sup>TH</sup> SEPTEMBER 2015

Titleholder:	Tellus Holdings Ltd
Operator:	Tellus Holdings Ltd
Tenements:	EL27972 Charlotte, EL27974 Central Railroad
Project Name:	Chandler Project
Report Title:	Group Annual Technical Report for EL27972 "Charlotte" and EL27974 "Central Railroad", for the period 21 September 2013 to 20 September 2015
Author:	Jaime Livesey
Target Commodity:	Halite (Sodium chloride) and trace minerals
Date of Report:	12 November 2015
Datum/zone:	GDA94 / zone 53
250K map sheet:	SG5302 Rodinga, SG5305 Kulgera, SG5306 Finke
100K map sheet:	5648 Charlotte, 5748 Rodinga, 5547 Erldunda, 5647 Idracowra
Address:	Tellus Holdings Ltd Suite 2, Level 10, 151 Castlereagh Street Sydney, NSW, 2000
Telephone:	+61 2 8257 3395
Fax:	+61 2 8233 6199
Email for further Technical details:	jaime@tellusholdings.com
Email for Expenditure:	jaime@tellusholdings.com

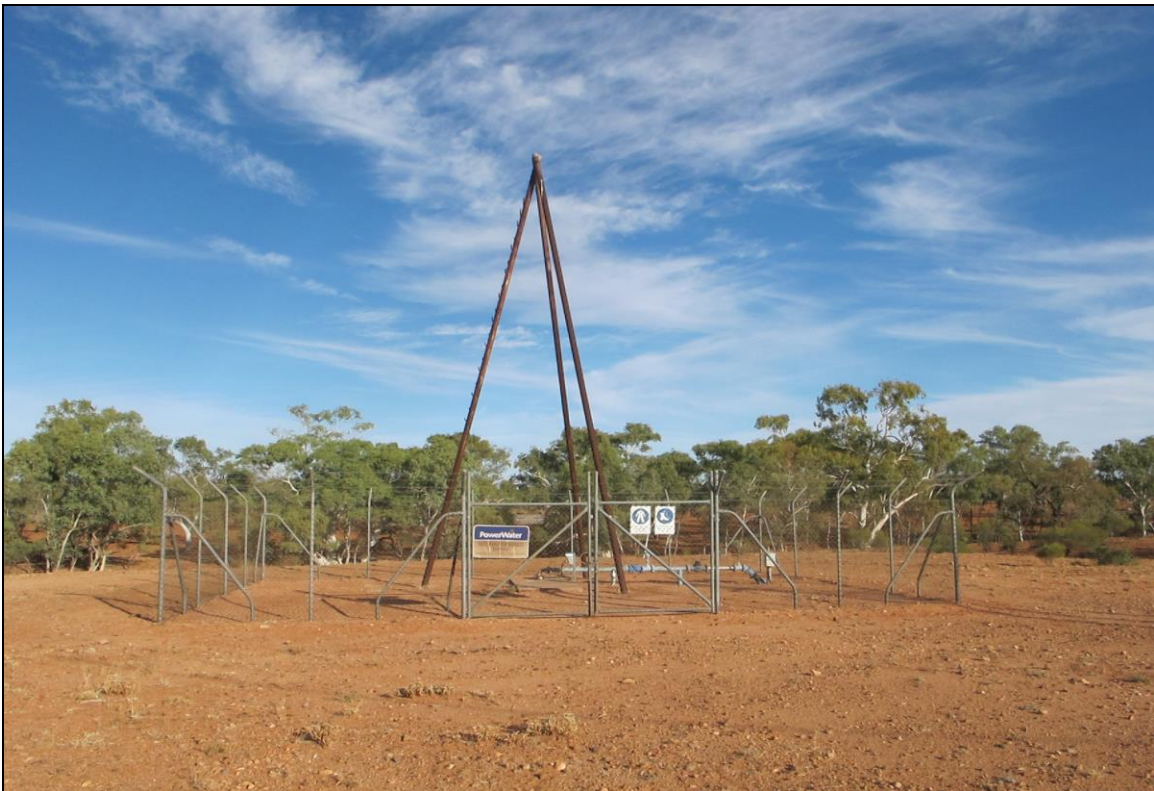
**Plate 22:** View west of town water supply bore for Titjikala. Previously mapped (unmarked) bore is located beyond the creek-line, in the background of the photograph.

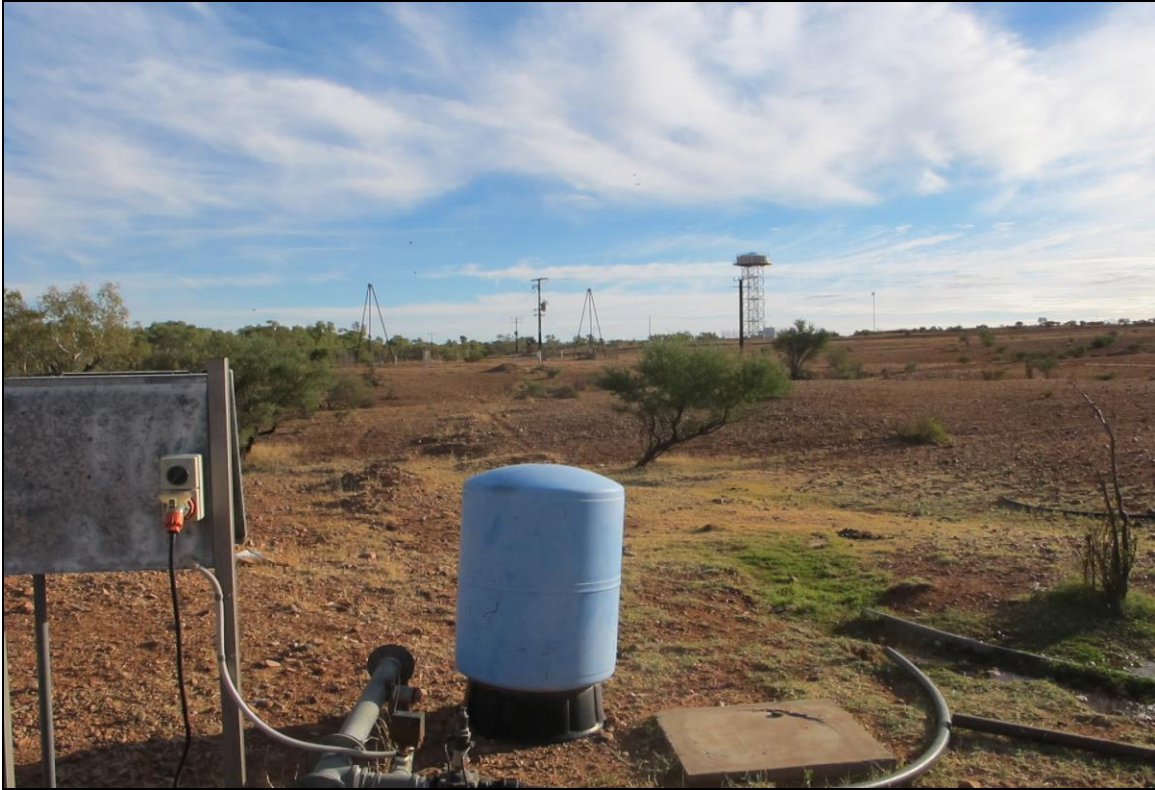
**Plate 23:** Agriculture bore, panorama view north showing town bores (tripods) and large water storage tank.

The site supervisor was then questioned with regards to the bore locations and he confirmed that the two fenced bores were for the Titjikala town water supply with the third bore being the 'agriculture bore' which was currently supplying a horticulture project located on the south edge of the town.

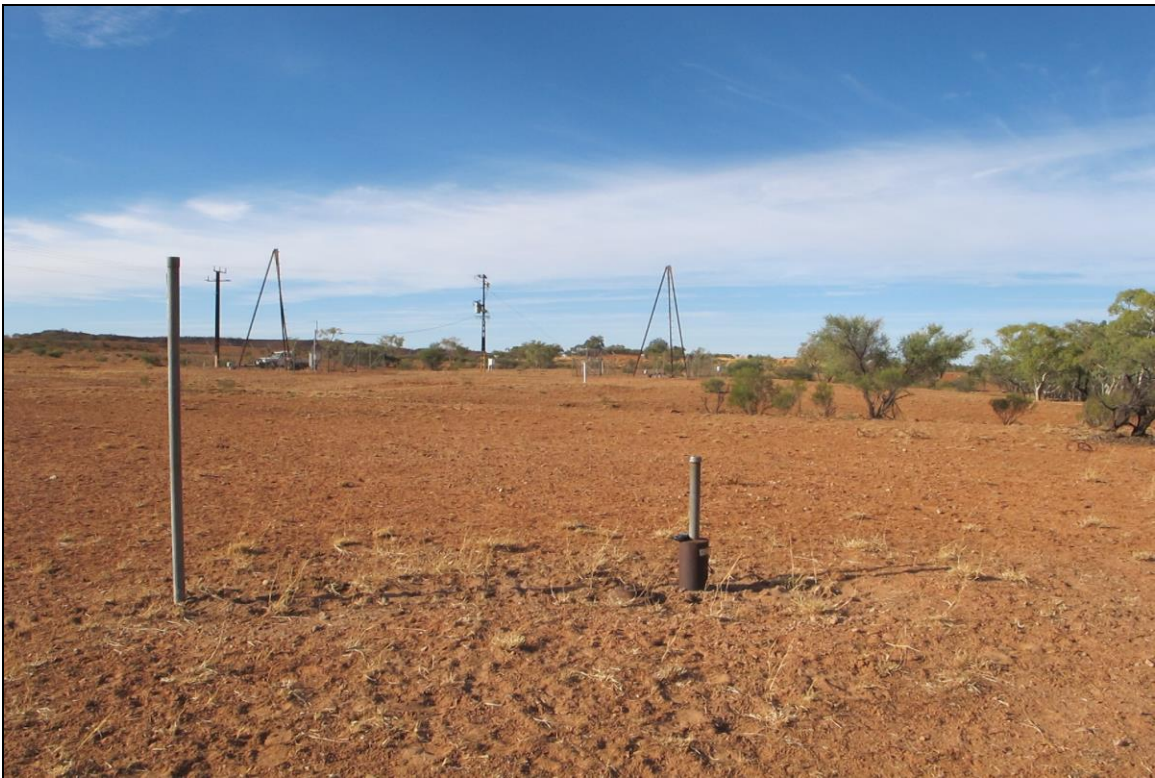
**Plate 23:** Bore RN15901, panorama view towards east showing two fenced town bores.

Two capped bore were also identified in the immediate area, which were both marked and confirmed to be RN15902 (406323mE, 7269798mN) and RN15901 (406248mE, 7269851mN) which was located about 50m further to the south-east (Plate 23). These locations were incorrect according to the original base map but, both of the bores had NTG labels and were subsequently mapped according to the RN number detailed with detailed notes, measurements and photographs being recorded. Both bores had had smaller diameter inspection pipe being fitted within a welded plate over the bore casing. There was a screw cap at the top of each inspection pipe that did not appear to be welded and could probably be removed with the use of a large wrench or spanner on future visits which would allow for water sample collection and bore monitoring to be completed.

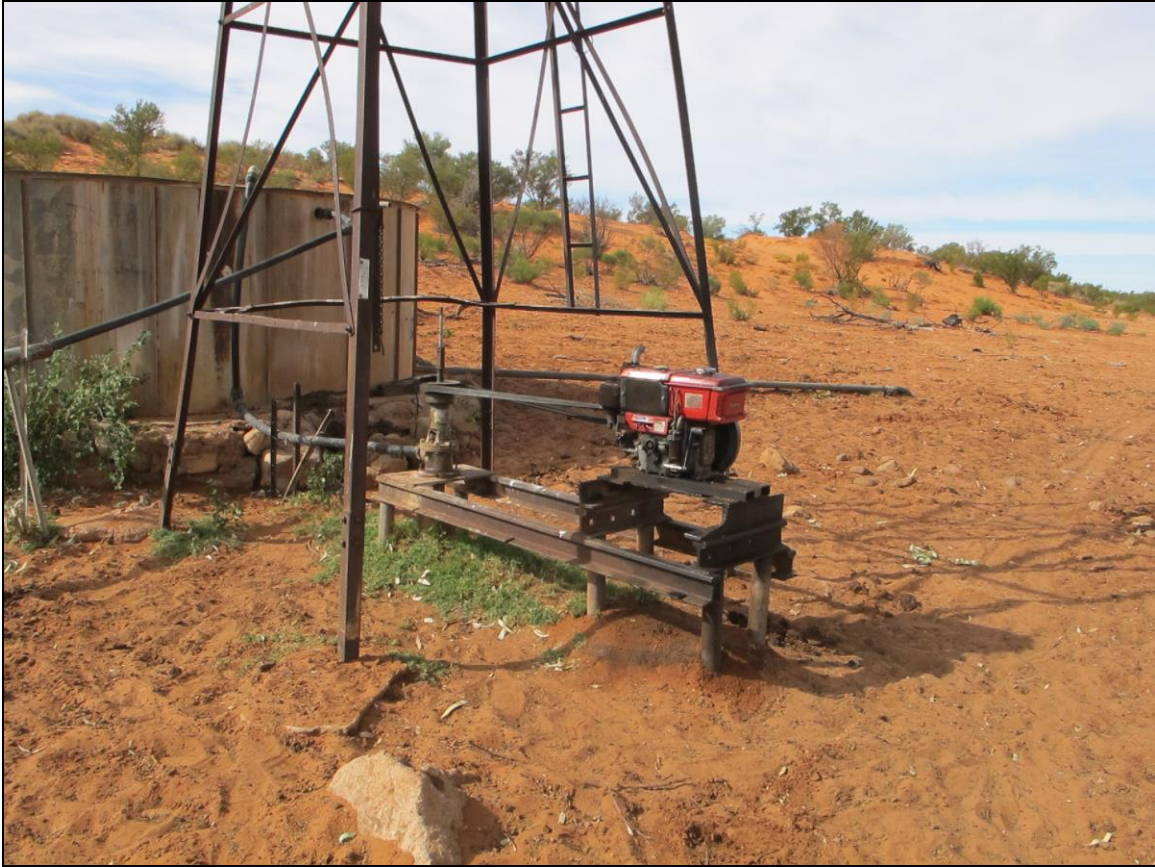
**Plate 24:** Redbank bore RN4469, on the eastern edge of Hugh River plain.

located at the base of a located at the edge of steep sand dunes on the eastern edge of the river plain about 1 km further towards the south (Plate 24) at a distance of 47.4km from the Tellus camp site. An old windmill, water tank, yards and trough were located at Redbank, which was still being used for stock purposes (stock were observed in the immediate area during the site visit).

A black poly-pipe connected to the bore with a helix-rotor (belt-driven diesel Kubota) which was noted to run east along a station track and assumed to feed the nearby yards. The helix-rotor did not allow a water sample to be collected however, a small bleed tap was observed which may allow for future water samples to be collected whilst the bore was being operated.

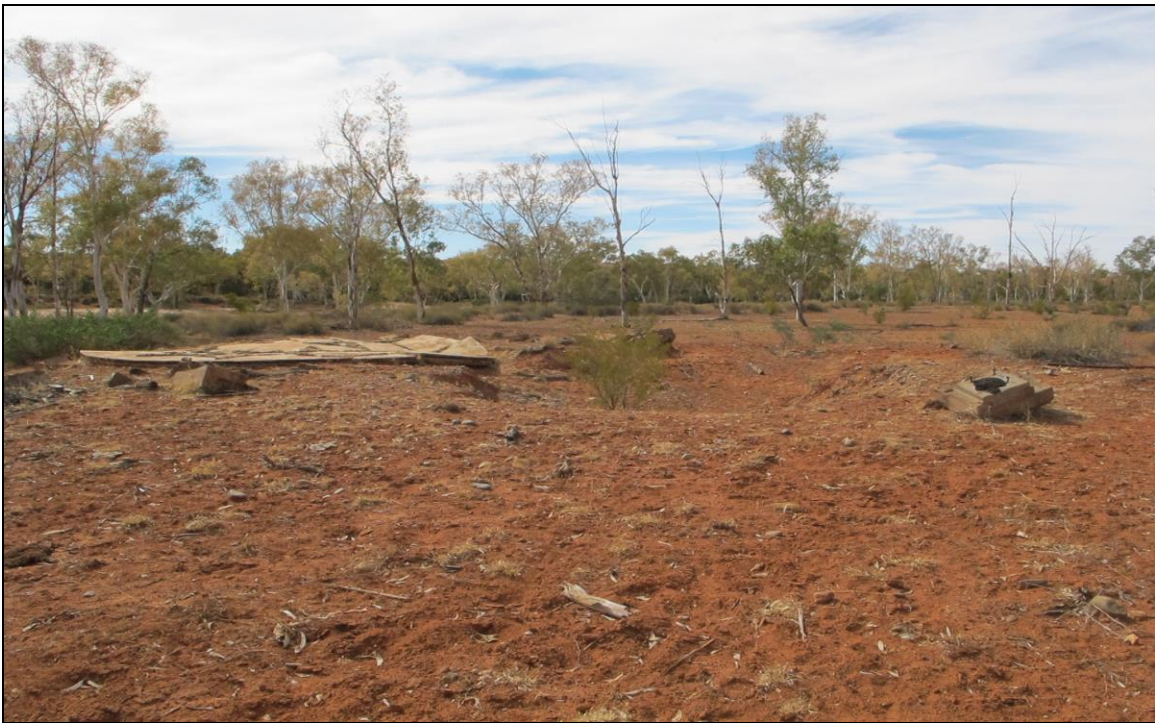
**Plate 25:** Hayes bore (abandoned), located several kilometres further south of Redbank bore, on the western edge of Hugh River.

The track was followed further south for about 1 km along the eastern riverbank to the next river crossing (408780mE, 7263290mN). After crossing to the western river bank, the track was followed towards the southeast for several kilometres to an abandoned bore (408830mE, 7263000mN). A review of the base map identified this to be Hayes bore (Plate 25). The site was inspected, identified concrete footings for the old bore, tank stand and wooden trough footings before several photographs were recorded to document the site.

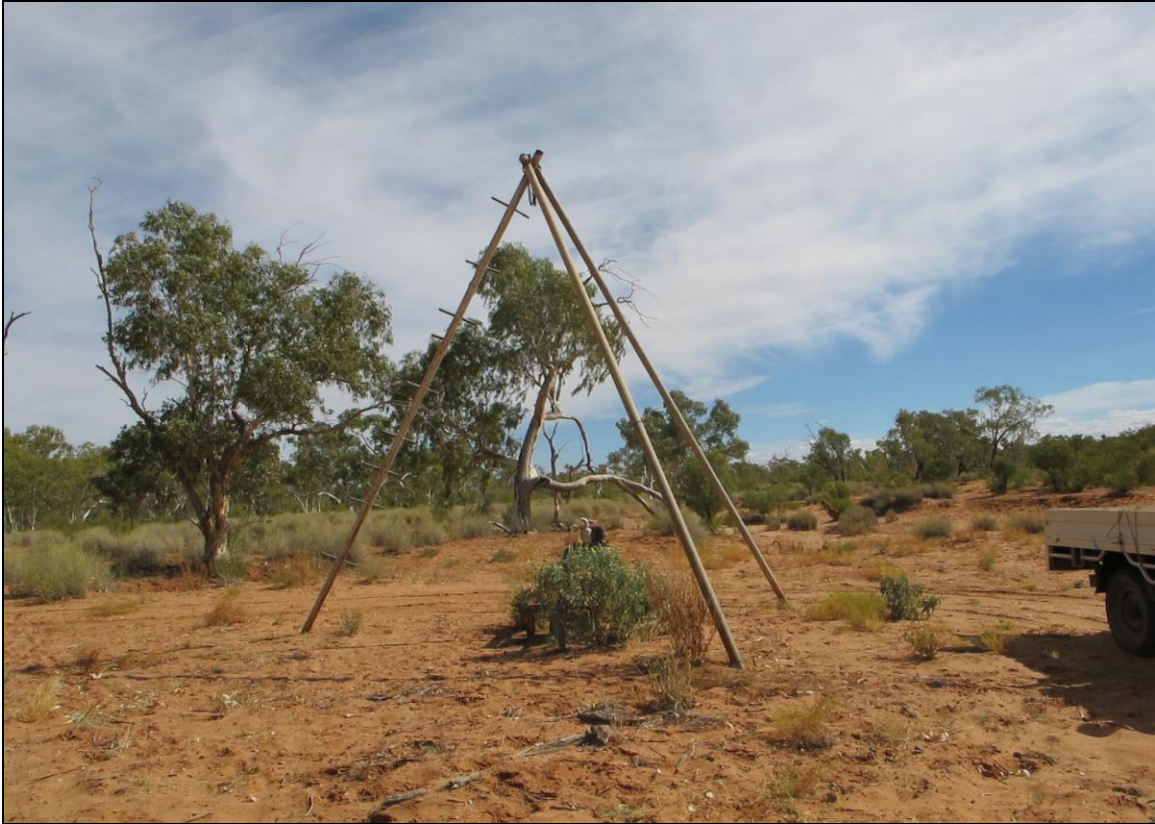
**Plate 26:** Wireyard bore RN14572 (411781mE, 7255634mN), located on the eastern edge of the Hugh River.

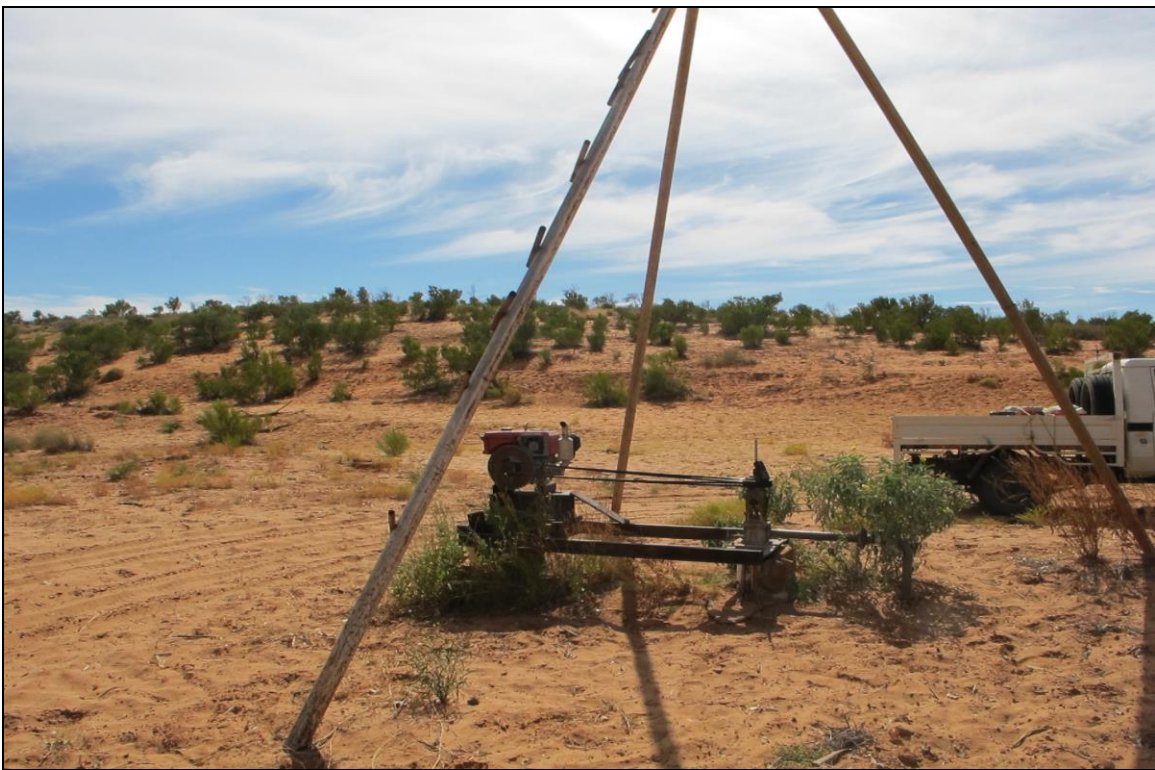
**Plate 27:** Wireyard bore RN14572, showing start of sand dunes towards east.

The track continued along the western riverbank for another 10 km, with shallow, rough calcrete sections being encountered for the last kilometre down to the final river crossing (411720mE, 7255480mN). Having crossed the Hugh River back to the eastern bank, the tripod located above Wireyard bore RN14572 (411781mE, 7255634mN) was located on a steep sandy bank about 100metres east of the river channel on the edge of an area of steep sand dunes (Plates 26&27) at a distance of 61km from the Tellus camp site.

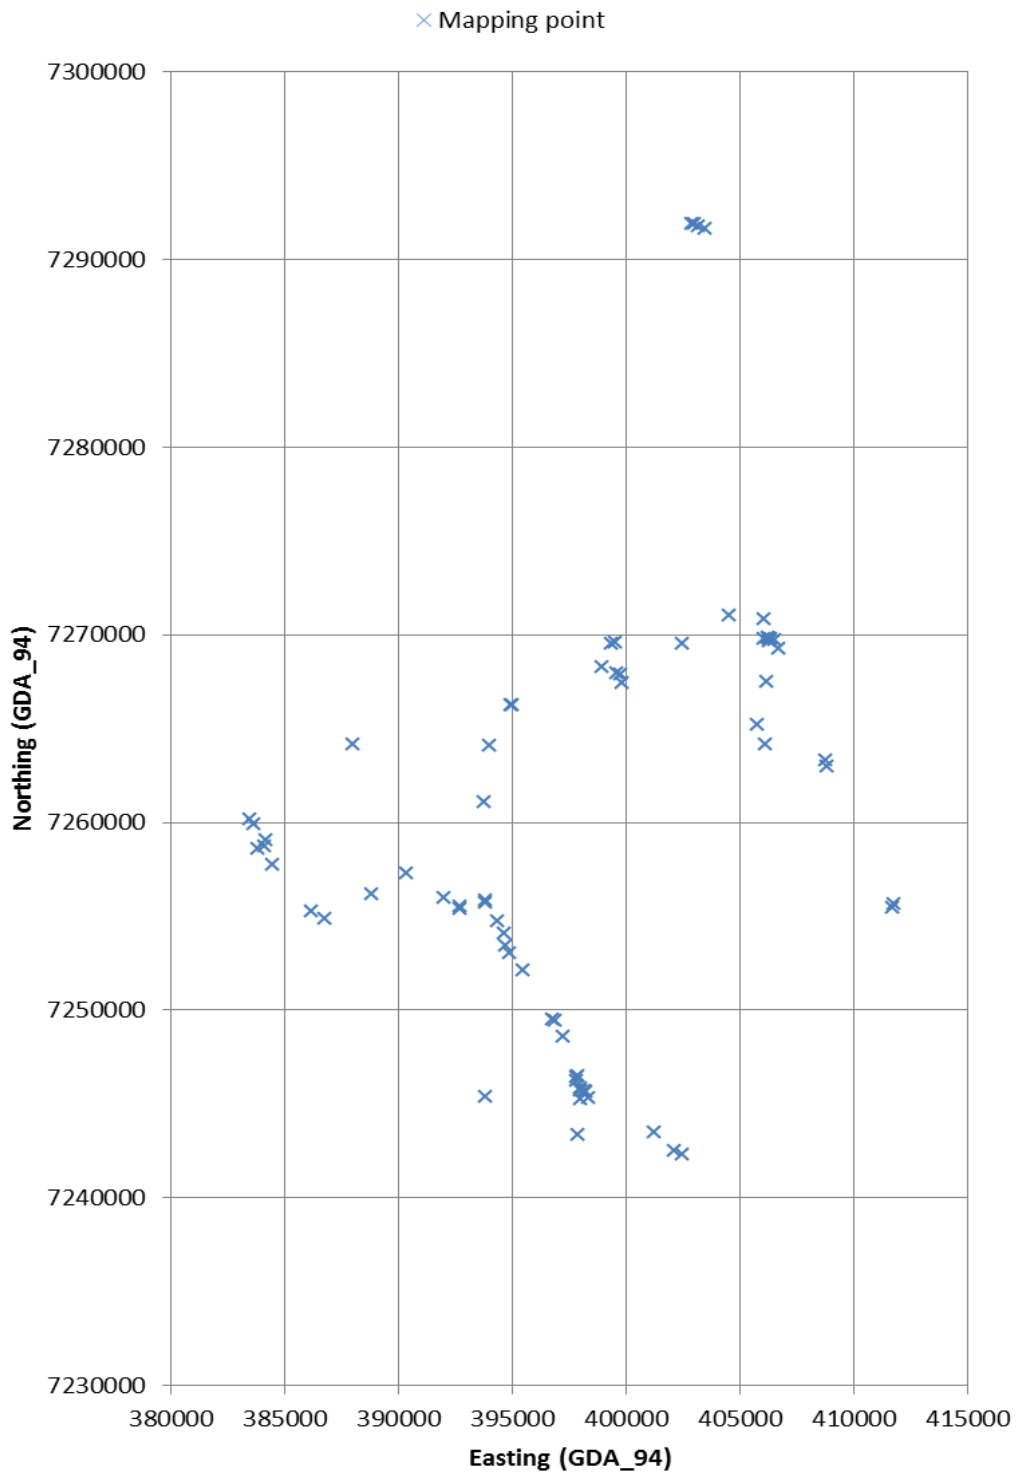
**Figure 1:** Mapping points recorded during the April 2015 reconnaissance program.

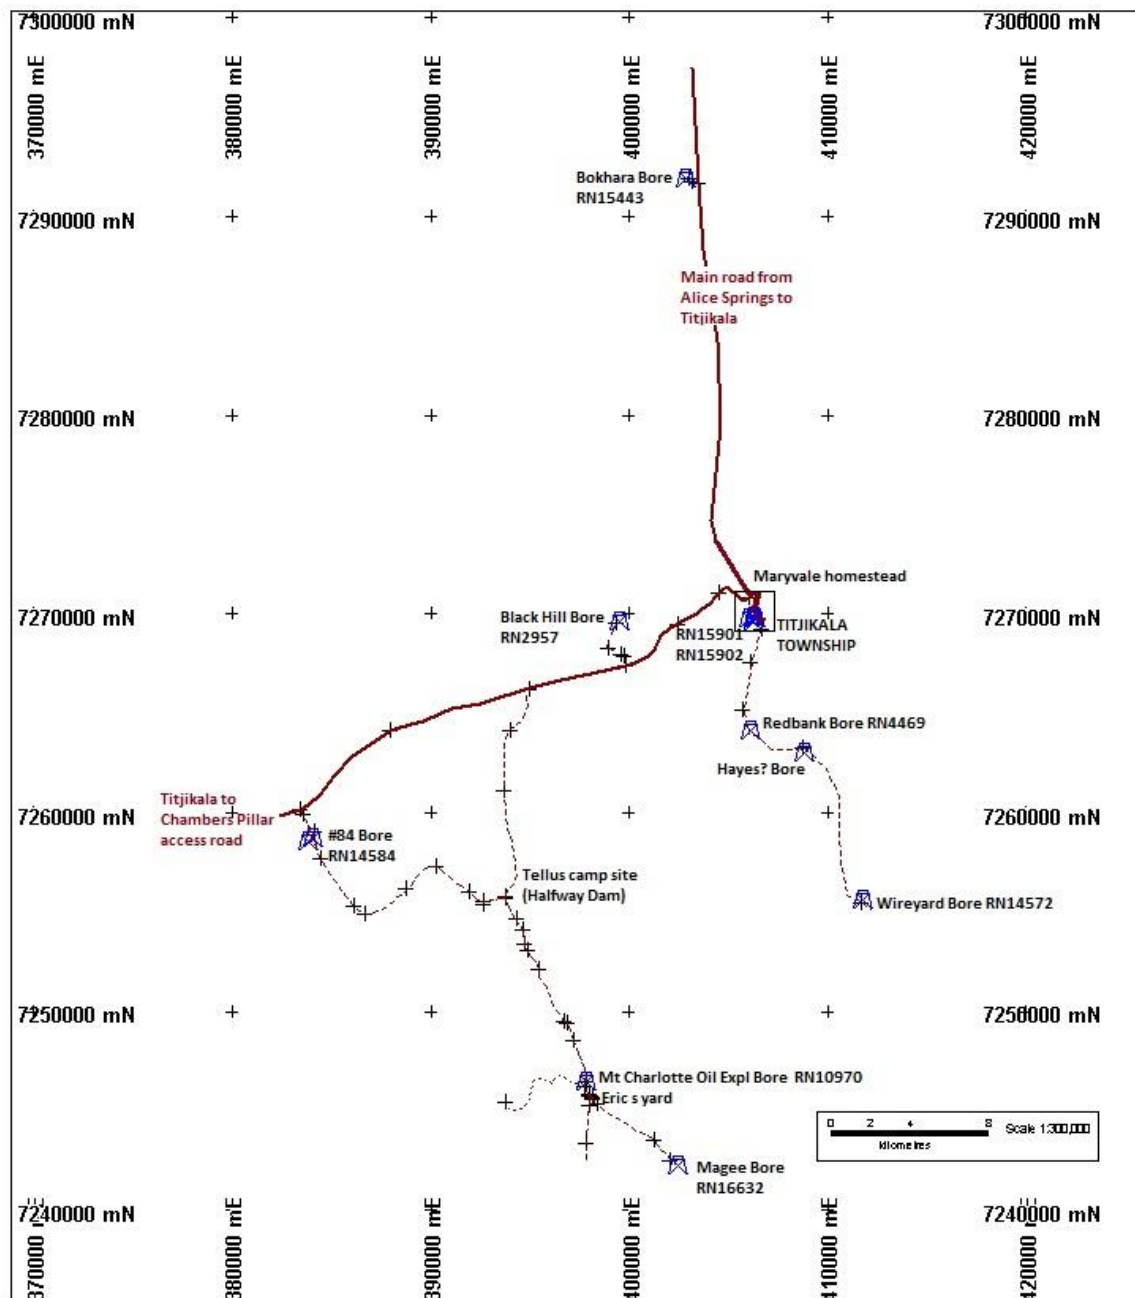
**Figure 2:** Access tracks and bore locations visited during the April 2015 reconnaissance program, Maryvale pastoral station.
