ANNUAL REPORT Year 20 MINERAL LEASE MLN1154 “MERLIN DIAMOND PROJECT”

Annual Report For The Period
1st January 2017 to 31st December 2017

Title Holder: Merlin Operations Pty Ltd

Operator: Merlin Diamonds Limited

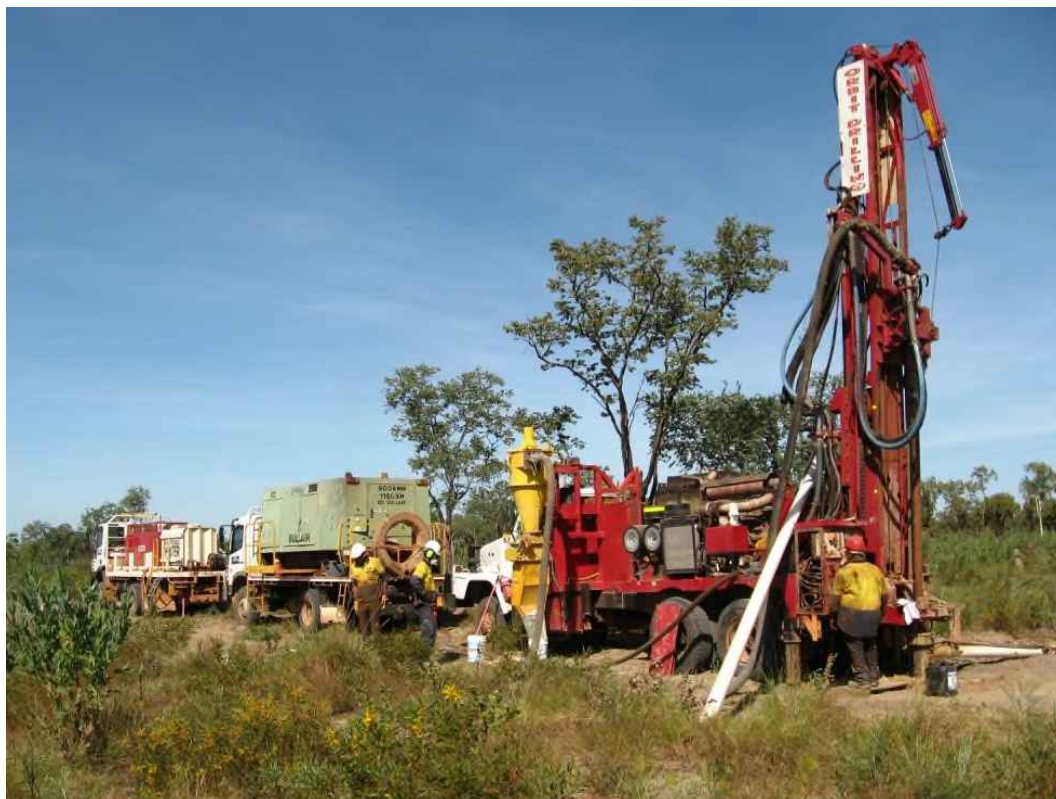
PHOTO 1: Orbit Drilling Hydco RC 40 drill rig with booster compressor

Drilling commenced on 11th July, and was completed on 21st August. The drilling method was reverse circulation (RC) with a drill-hole width of 120mm. The rig was a Hydco RC 40 mounted on a 6 x6 UD Nissan. The support truck, a 6x6 Trakker, had with capacity to carry 2,500L of water and 4,500L diesel, and the personnel truck was a 2006 4x4 Mitsubishi Canter. As most of the holes drilled were less than 20 metres in depth, with the deepest being 60 metres, residence time for all equipment at each drill-site was usually one to two hours.

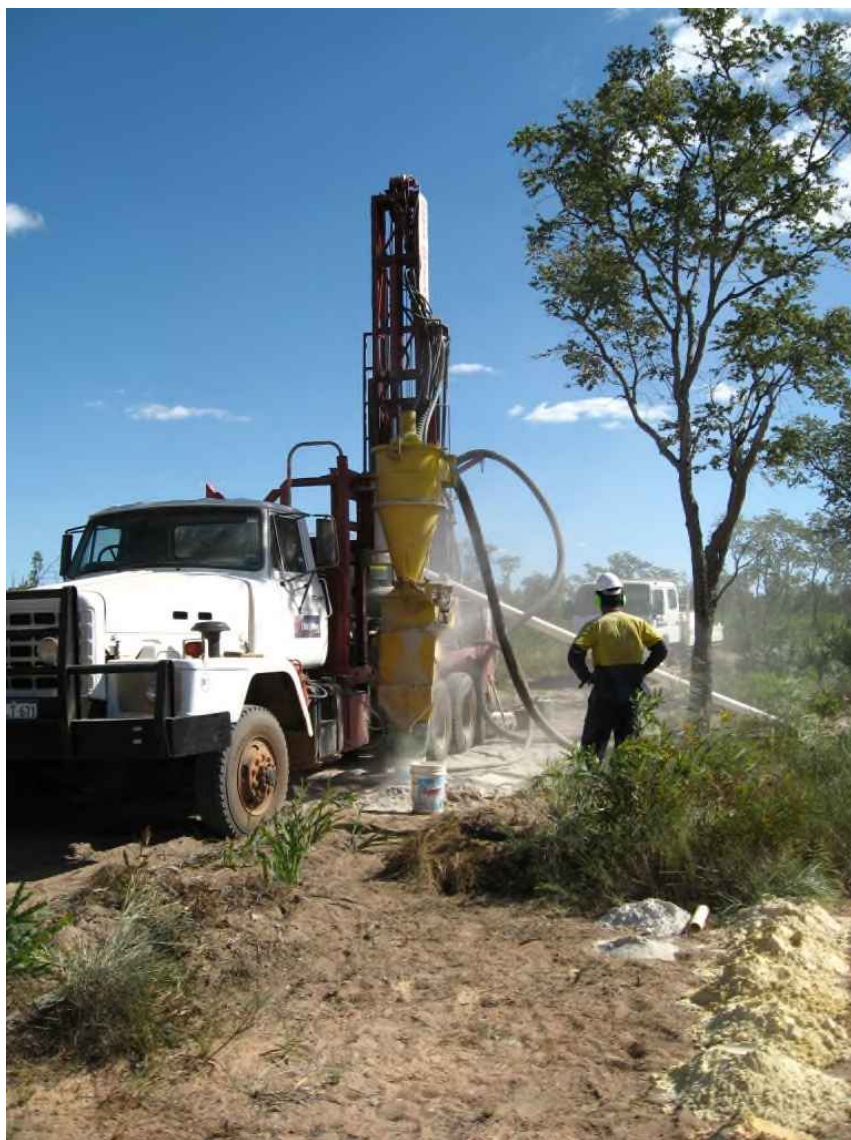
PHOTO 2: Orbit rig in action – drill spoil samples on right-hand-side

After a few days of drilling, it was apparent the Orbit drill rig was experiencing significant difficulty when drilling deeper than 25 metres due to the high water table and problems with down-hole air pressure. The rig's on-board compressor was unable to keep the ground water out of the hole, leading to problems with blocked bits due to wet clay layers and subsequent drill collar blow-outs. When the booster compressor was utilised, the drill spoil sample was reduced to powder with

minimal rock chips making down-hole logging impossible. Hence, instead of drilling one hole at the centre of each target to a set depth, the primary hole was taken only to a depth where the geologist was certain the rock-type was Bukalara Sandstone and not Cretaceous infill. Remaining holes were taken to between 15 to 20 metres depth, and logged by comparing with the stratigraphy with that of the first hole. Overlapping angled holes at magnetic targets were changed to a line of short vertical holes at 10-metre collar spacing.

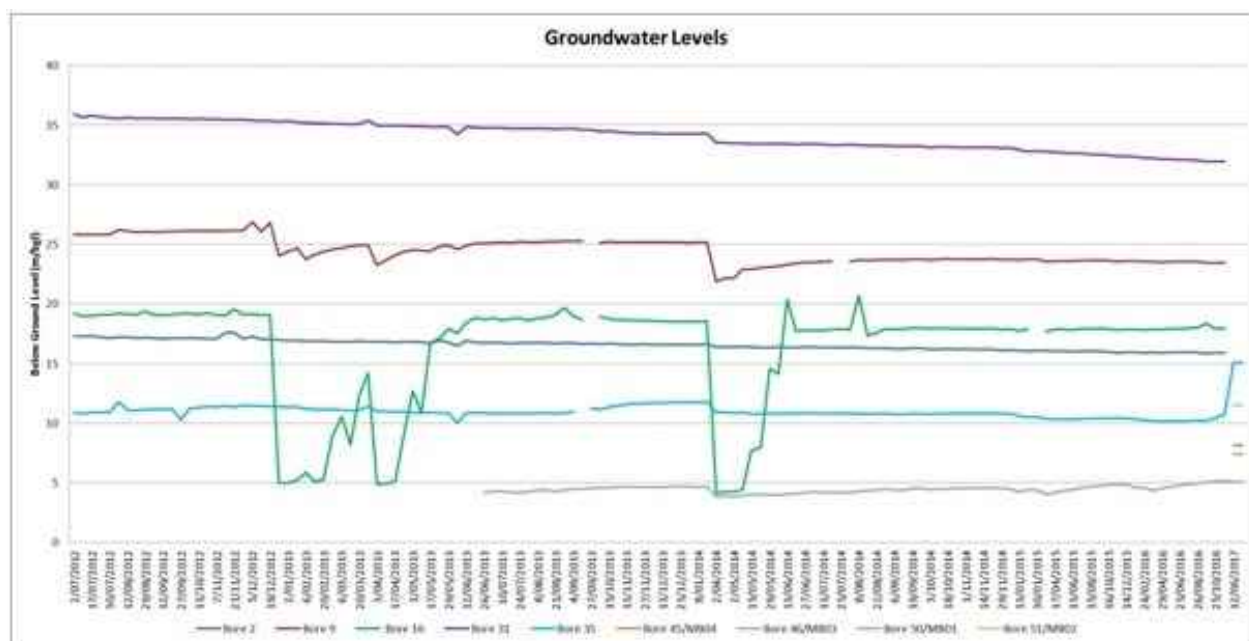
FIGURE 1: Changes in groundwater levels measured between July 2012 and June 2017

Groundwater levels in meters below ground level (m/bgl) have been plotted in [Figure 1](#) for bores 2, 9, 16, 31, 35, 45, 46, 50 and 51.

Overall groundwater levels in monitoring bores are relatively shallow, sitting between 3.84 m and 35.9 m/bgl. With the exception of Bore 2, all of the monitoring bores respond to wet season rainfall by showing short term water level increase following a rainfall event. Over the dry season months most bores recede back to stable levels. Overall, groundwater levels have slightly increased since monitoring resumed in 2012. Bore 31 has the most notable increase of 4 metres from 35.9 m/bgl in 2012 to 31.93 m/bgl in 2016. Bores 9, 16, and 35 also show similar, subtle rising trends.

Figure 1 indicates Bore 2 levels have risen gradually from depths of 17.3 to 15.87 m/bgl since 2012 and appears to be the least responsive to rainfall. Bore 9 also gradually rose almost 3 metres until October 2014, where it has remained between 23.45 and 23.77 m/bgl. It follows a similar response pattern to Bore 16 when rainfall is received with less magnitude. Bore 16 is the monitoring bore for the Airport production bore which supplies water to the camp. During pumping, the bore draws down and after large rainfall events it has risen up as much 13 metres.

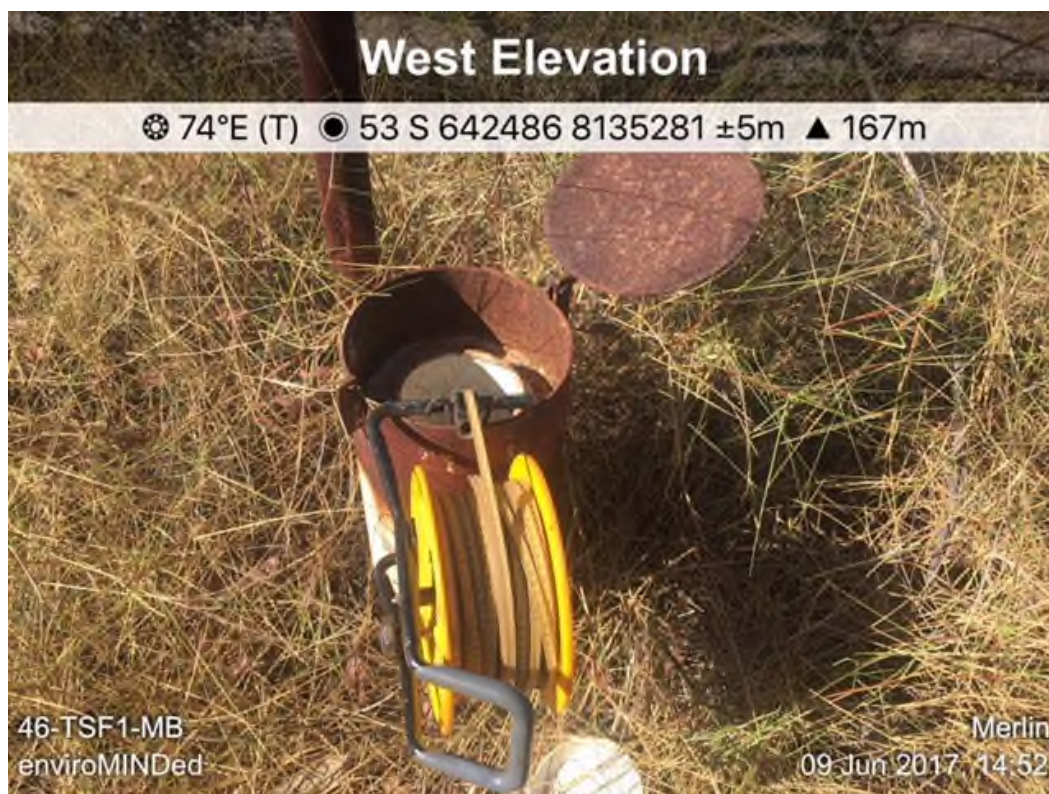
PHOTO 3: Measuring the standing water level of a tailings monitoring bore using a Heron Dipper T meter

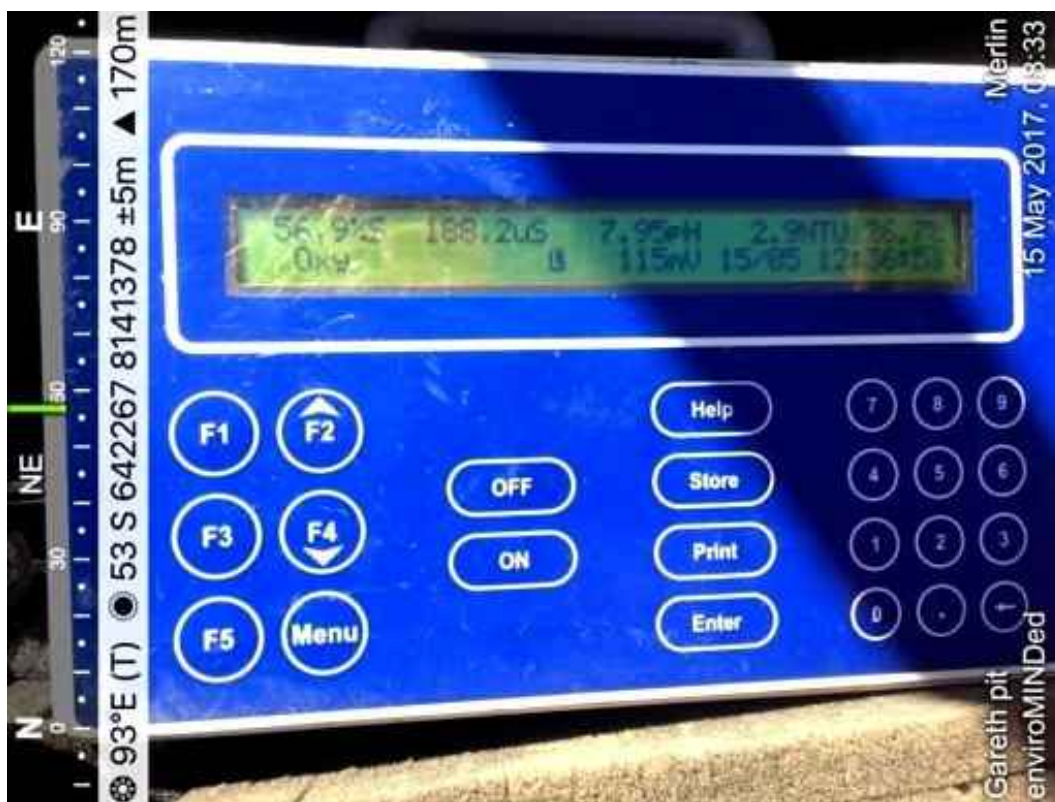
PHOTO 4: Gareth pit void field data collect in May 2017

The TPS 90 FLT water quality meter was sent for repairs in late 2016 as the 'pH' and 'dissolved oxygen' probes were faulty. The meter was returned to site in May 2017, and sampling of the pit voids for field water quality resumed. Results plotted in the 2018 MMP update indicate overall pit void water is of good quality.

Water neutrality - pH has gradually increased from between 6 and 7 to between 7.4 and 10 since early 2013. The gradual pH increase is most likely attributed to the water being exposed to alkaline kimberlite material (ore) remaining in the mine pits.

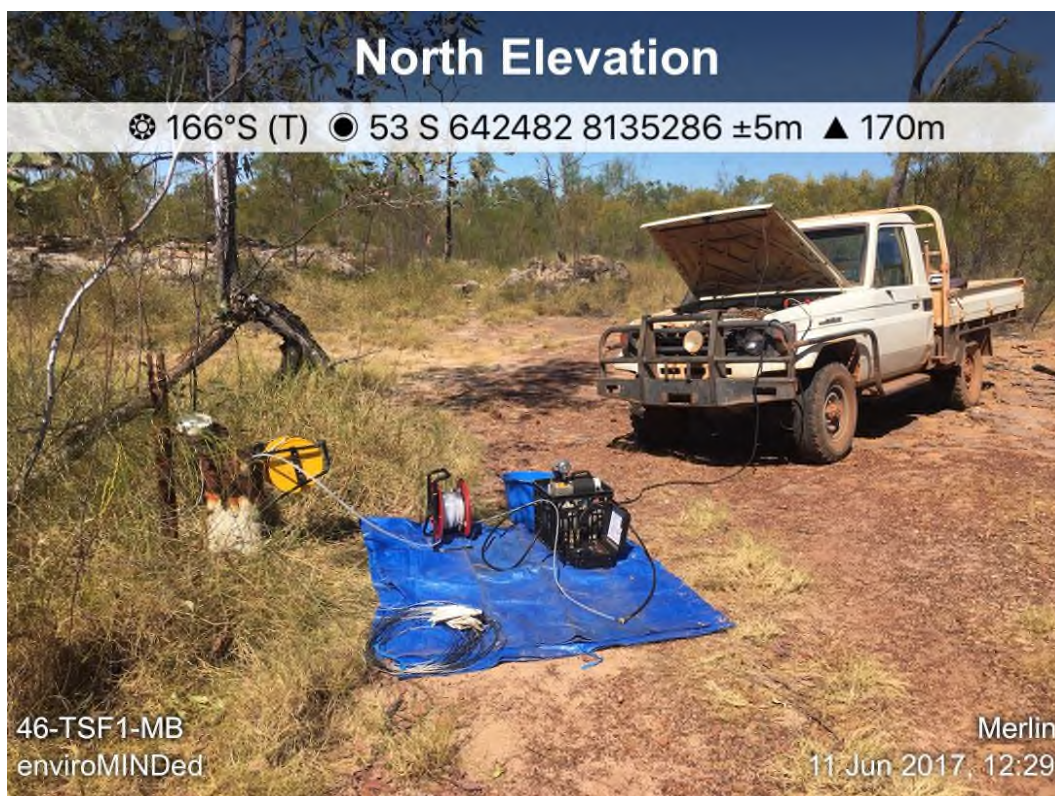
PHOTO 5: Sampling TSF MB 46 – June 2017

Electrical conductivity measured in bores located around the TSF from 1999 to 2003, ranged from 30 to 240 $\mu\text{S}/\text{cm}$. The most recent sampling in 2017 ranged from 50 to 100 $\mu\text{S}/\text{cm}$. EC levels remain below the ANZECC 2000 trigger value of 250 $\mu\text{S}/\text{cm}$, and continue to decline.

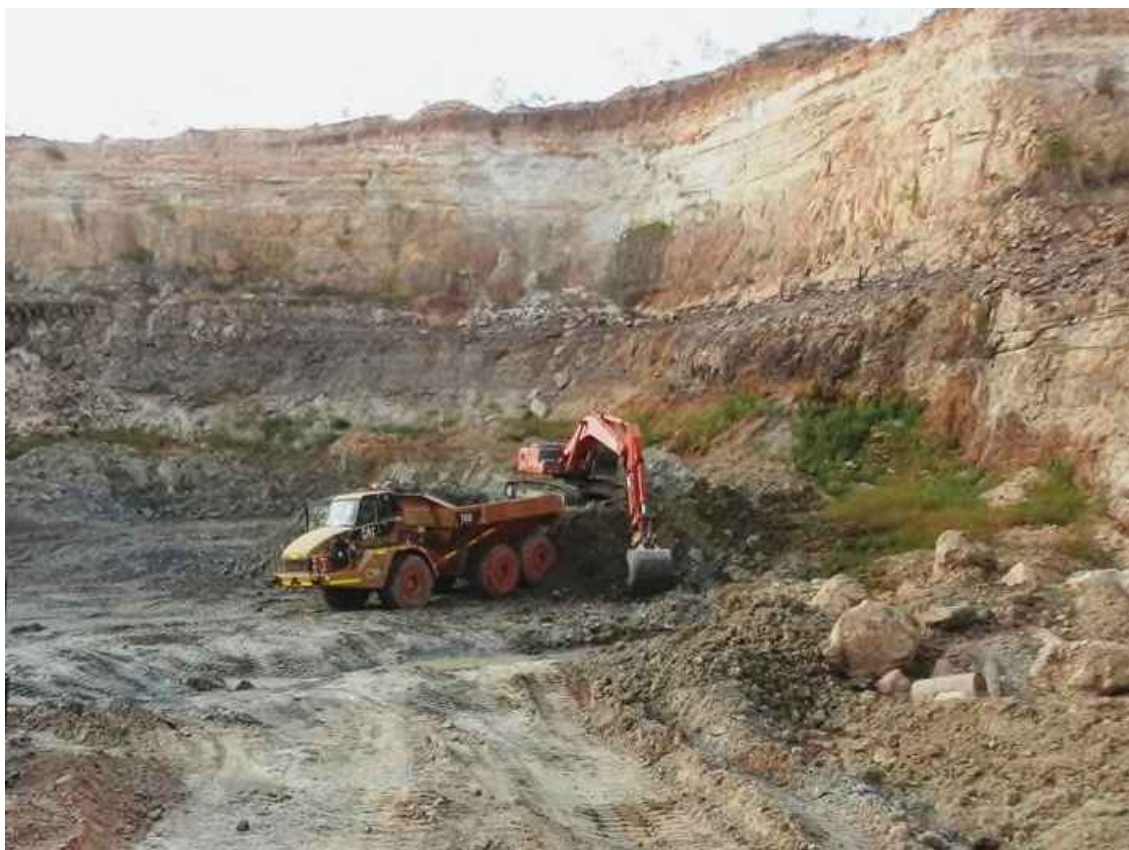
PHOTO 7: Loading haul-truck in Kay Pit

Following on from operations in November and December 2016, mining of kimberlite ore from Kay Pit continued during January and February. A Cat D10 bulldozer was used to rip the floor of the pit and push the broken kimberlite into piles. A 30-tonne excavator loaded the ore into a Cat D400 or Cat 740 six-wheeled articulated truck that hauled the ore to an ore pad sited at the top of the pit.

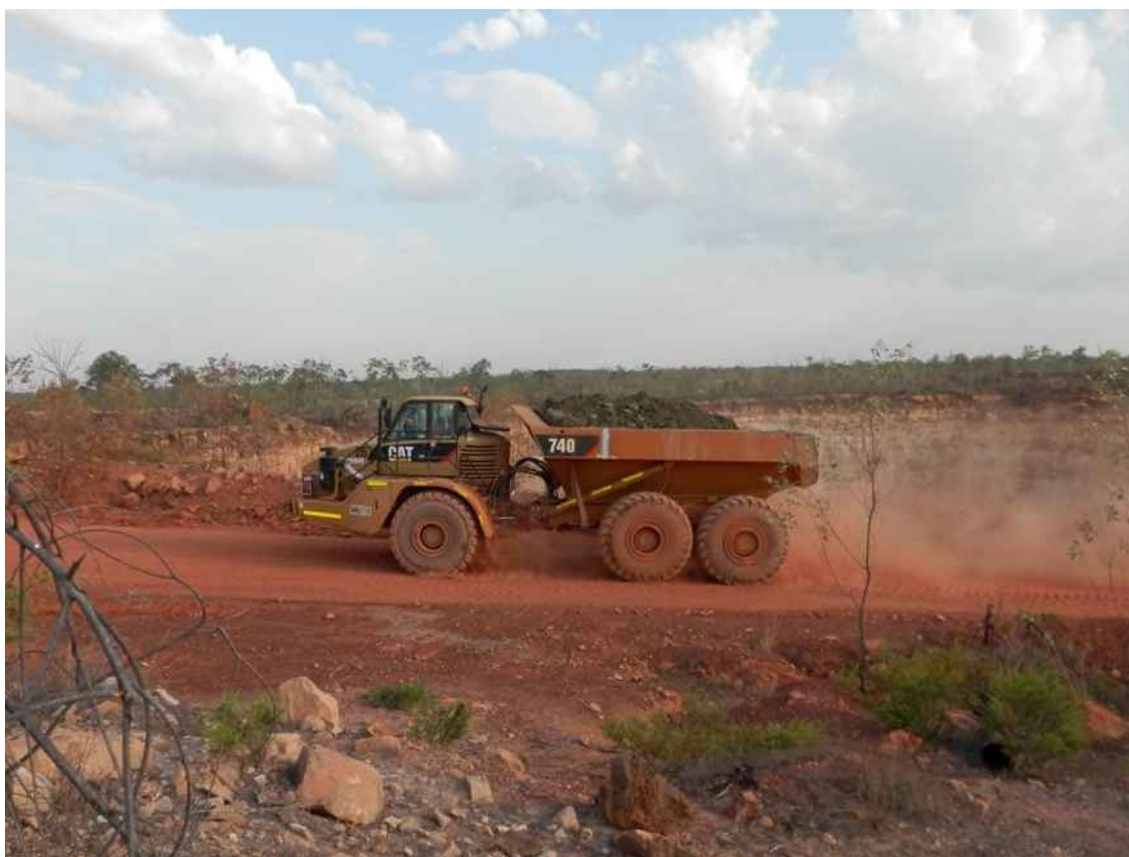
PHOTO 8: Hauling from Kay Pit to ore pad

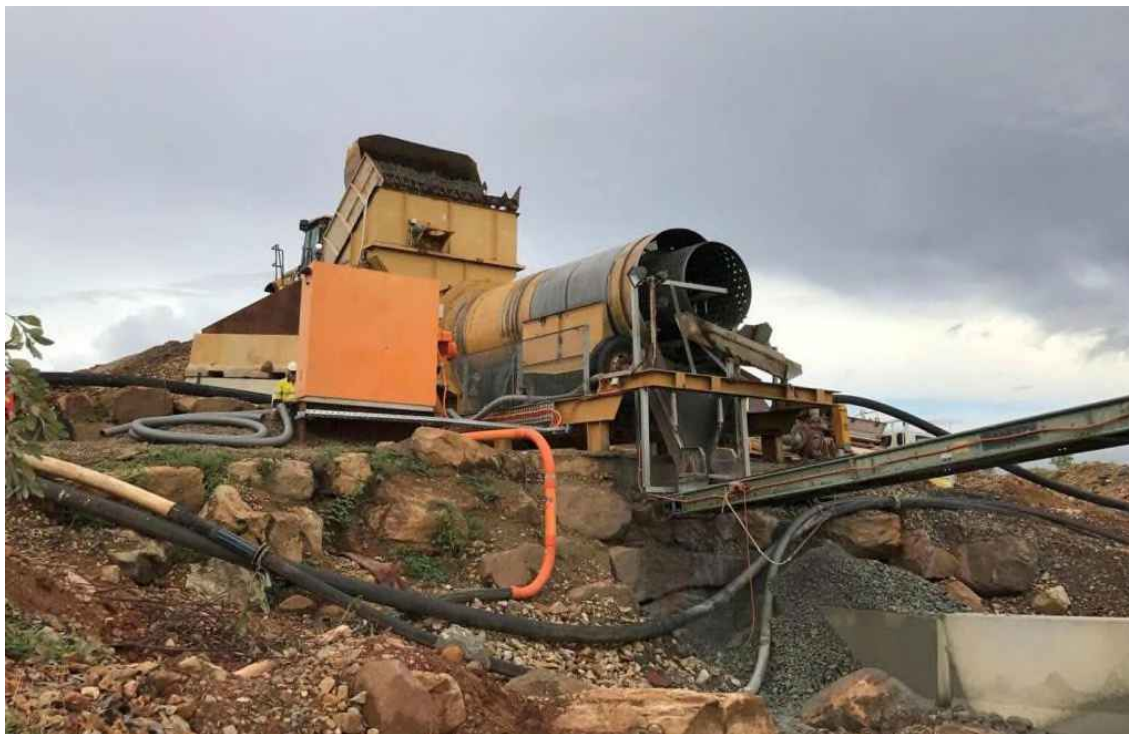
PHOTO 9: Scrubber commissioned in January 2017

Processing of kimberlite ore was using a dense media separation (DMS) plant. A simplified front-end format, introduced in late 2016, utilised cone crushing and wet-screening to produce a 1.5mm to 20mm feed for the DMS plant. This format worked well for treating the dry oversize stockpiles, but

was less effective for the more 'sticky' kimberlite ore. Hence, in mid January, a scrubber was installed to replace the wet-screen. This significantly improved the quality and suitability of the sized feed to the DMS and increased through-put.

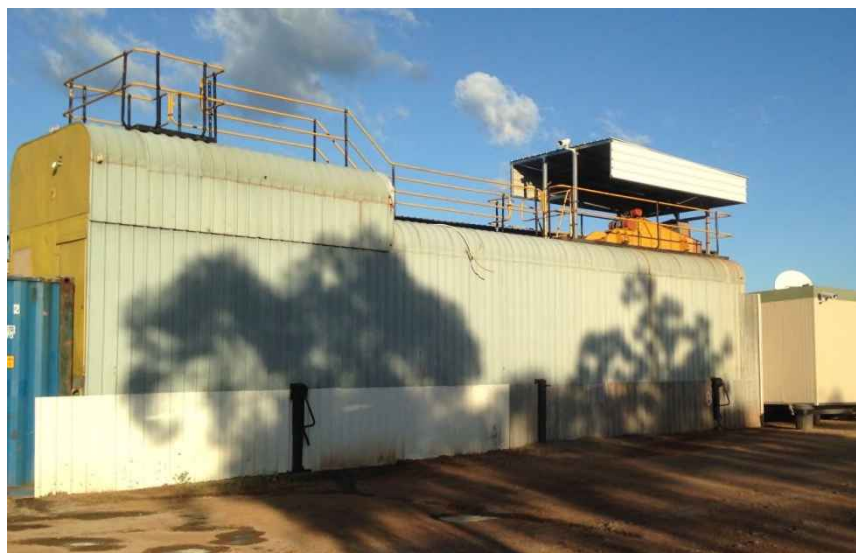
PHOTO 10: Modular Flowsort X-ray Sorter housed in a mobile caravan

During the January to June period, final recovery was undertaken using a Flowsort recovery system. The two twin-stage x-ray sorting machines housed in a mobile caravan were purchased from Ellendale diamond mine in the West Kimberley, transported to Merlin, and commissioned in October 2016.

Concentrate from the DMS is screened into three size fractions: +1.5 to -3.5mm, +3.5 to -8mm, and +8 to -16mm. Each size fraction is then passed separately through the twin-stage x-ray sorting machines. Most diamonds fluoresce under x-rays, and this emitted light triggers a detector which diverts that portion of the concentrate stream to a recovery bin. The Flowsort concentrate from each size fraction was then dried and hand-sorted in a secure area with the diamonds separated manually from the gangue minerals.

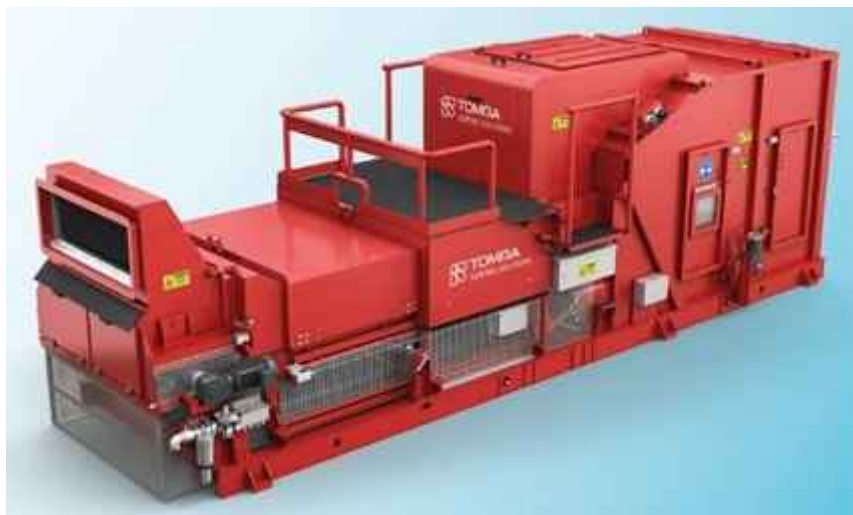
PHOTO 14: TOMRA XRT Sorting Machine

Following consultation with leading diamond industry experts, installation of a TOMRA XRT machine was strongly recommended. The TOMRA diamond recovery system replaces the conventional concentration and recovery process of the current DMS plant followed by the Flowsort X-ray sorting. The advanced x-ray transmission (XRT) technology reliably detects all diamonds, including coated, low luminescent, and Type II diamonds that are difficult to detect with traditional x-ray technology.

A suitable TOMRA unit was sourced, purchased and delivered to Merlin in November. The unit has been installed, and construction work for the feed bin and conveyors completed. The unit was successfully commissioned in late December, although no significant production work was undertaken during the remainder of December.

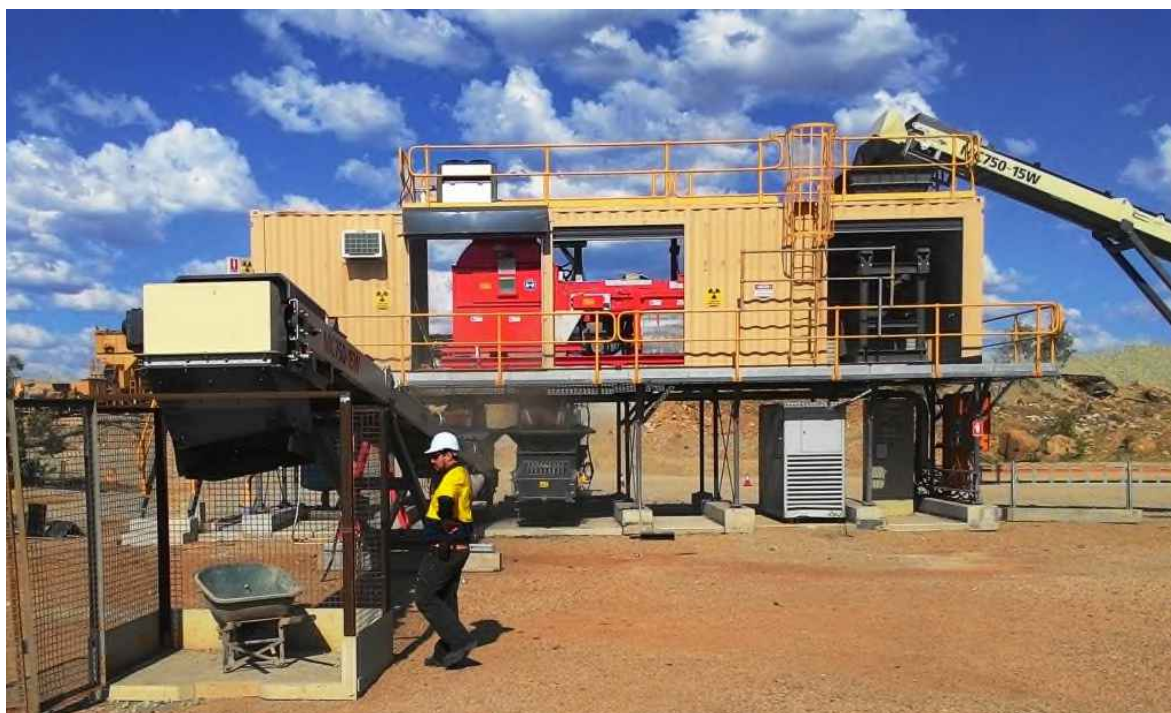
PHOTO 15: The Merlin TOMRA XRT is housed in a sea-container mounted on a raised platform
When fully operational, concentrate from the TOMRA will be delivered to a hopper housed in a secured cage

The TOMRA unit has been calibrated to process Merlin ore between +4mm to -40mm in size. The ore is screened into three fractions before each fraction is passed through the XRT. The size fractions are: +4 to -8mm, +8 to -18mm, and +18 to -40mm.

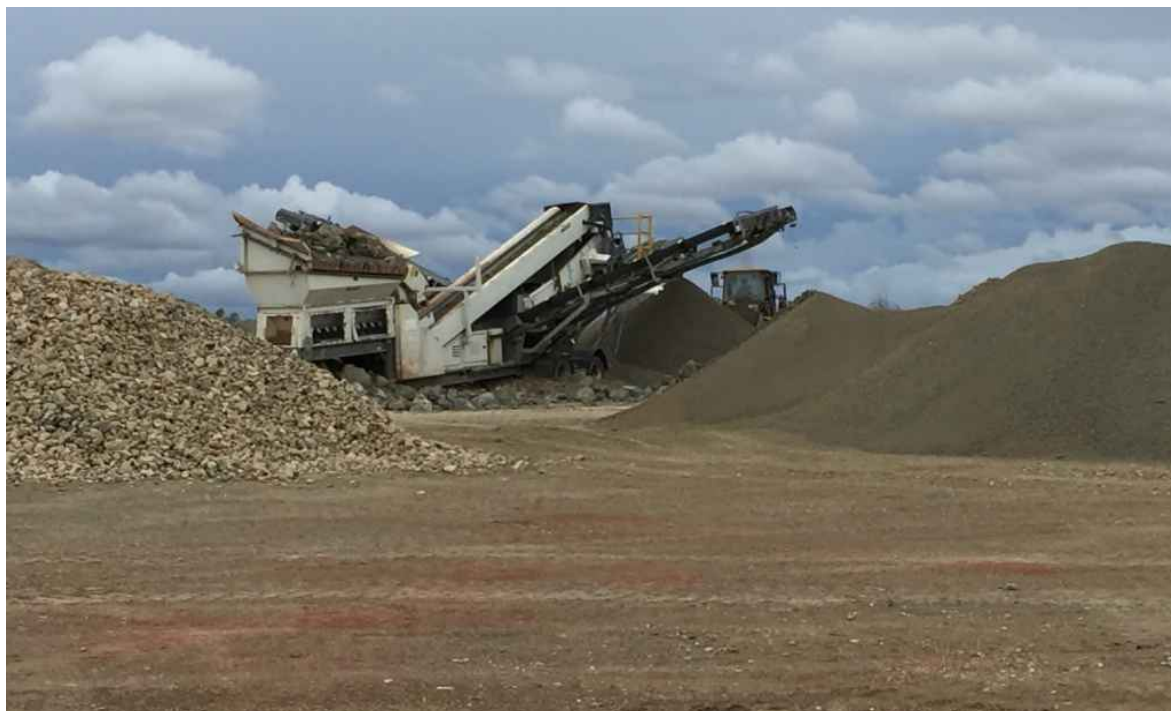
PHOTO 16: Mobile screening plant used to prepare the TOMRA feed into the three size fractions

During the commissioning phase, the TOMRA has processed screened scrubber oversize from the 2016-2017 processing of kimberlite from Kay Pit. The oversize was processed through a mobile screening plant into the required size fractions and stockpiled on the ROM for batch feeding. The minus 4mm fraction has been stockpiled for processing through the DMS plant at a later date. The +40mm material, which comprises mostly country rock clasts, is also stockpiled separately.

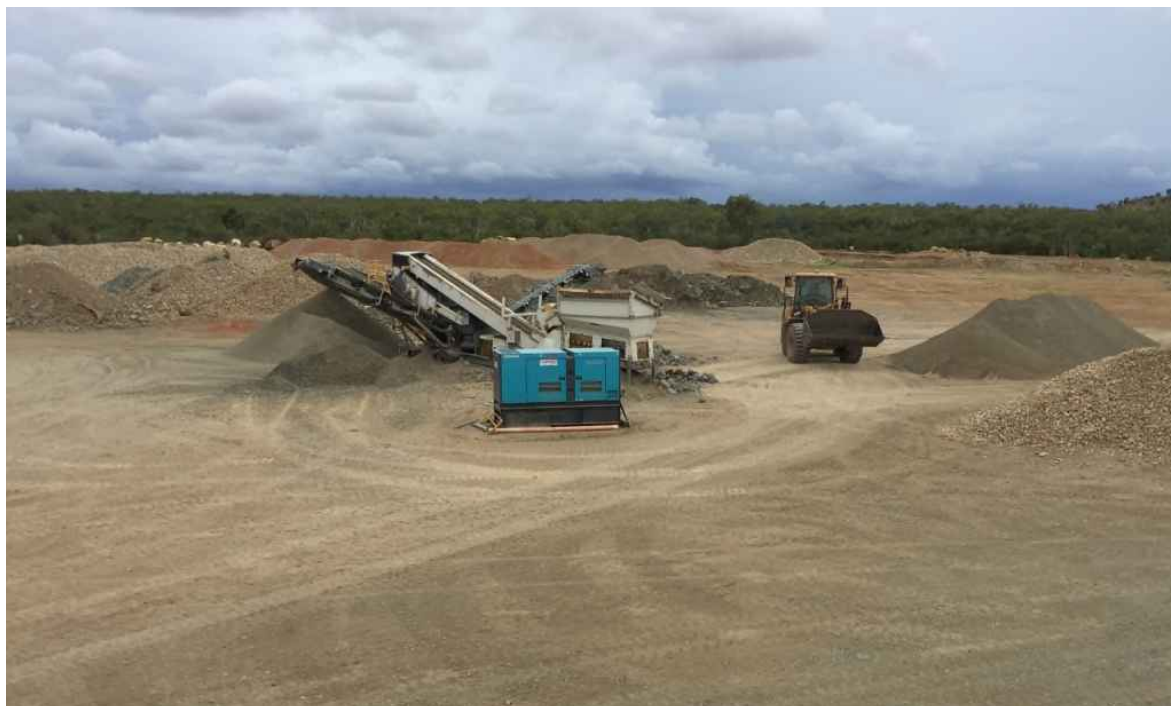
PHOTO 17: Much of the Merlin Rom is comprised of trommel oversize – a potential resource

Stockpiled trommel and scrubber oversize from Ashton and Rio Tinto production makes up much of the Merlin ROM and holds potential to carry stones larger than 20mm that would have been rejected as part of the oversize. Merlin is trialling this material through the TOMRA to establish economic potential as it is a readily available resource that will carry production through the first few months of 2018.

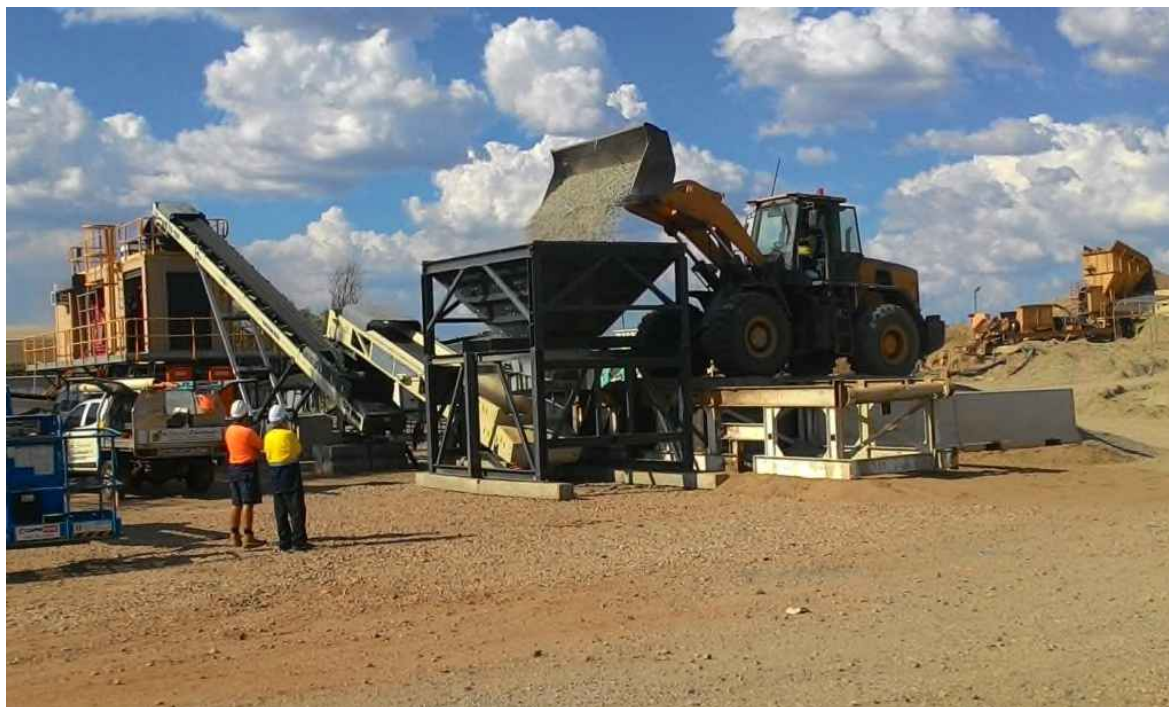
PHOTO 18: Batch feeding sized ore to TOMRA unit

Feed to the sorter is via a hopper, belt feeder and conveyor, with the rejects and accept products being conveyed from the sorter. The feed rate to the circuit is capable of being maintained at 60 tonnes per hour, with process water requirements estimated at 60 cubic meters per hour. In 2018, the ore feed preparation will be extended to utilise a jaw crusher, cone crusher, screens and conveyors with front-end loaders feeding the plant and removing the sized products. A new scrubber and trommel will be introduced once the plant moves on to mined kimberlite.

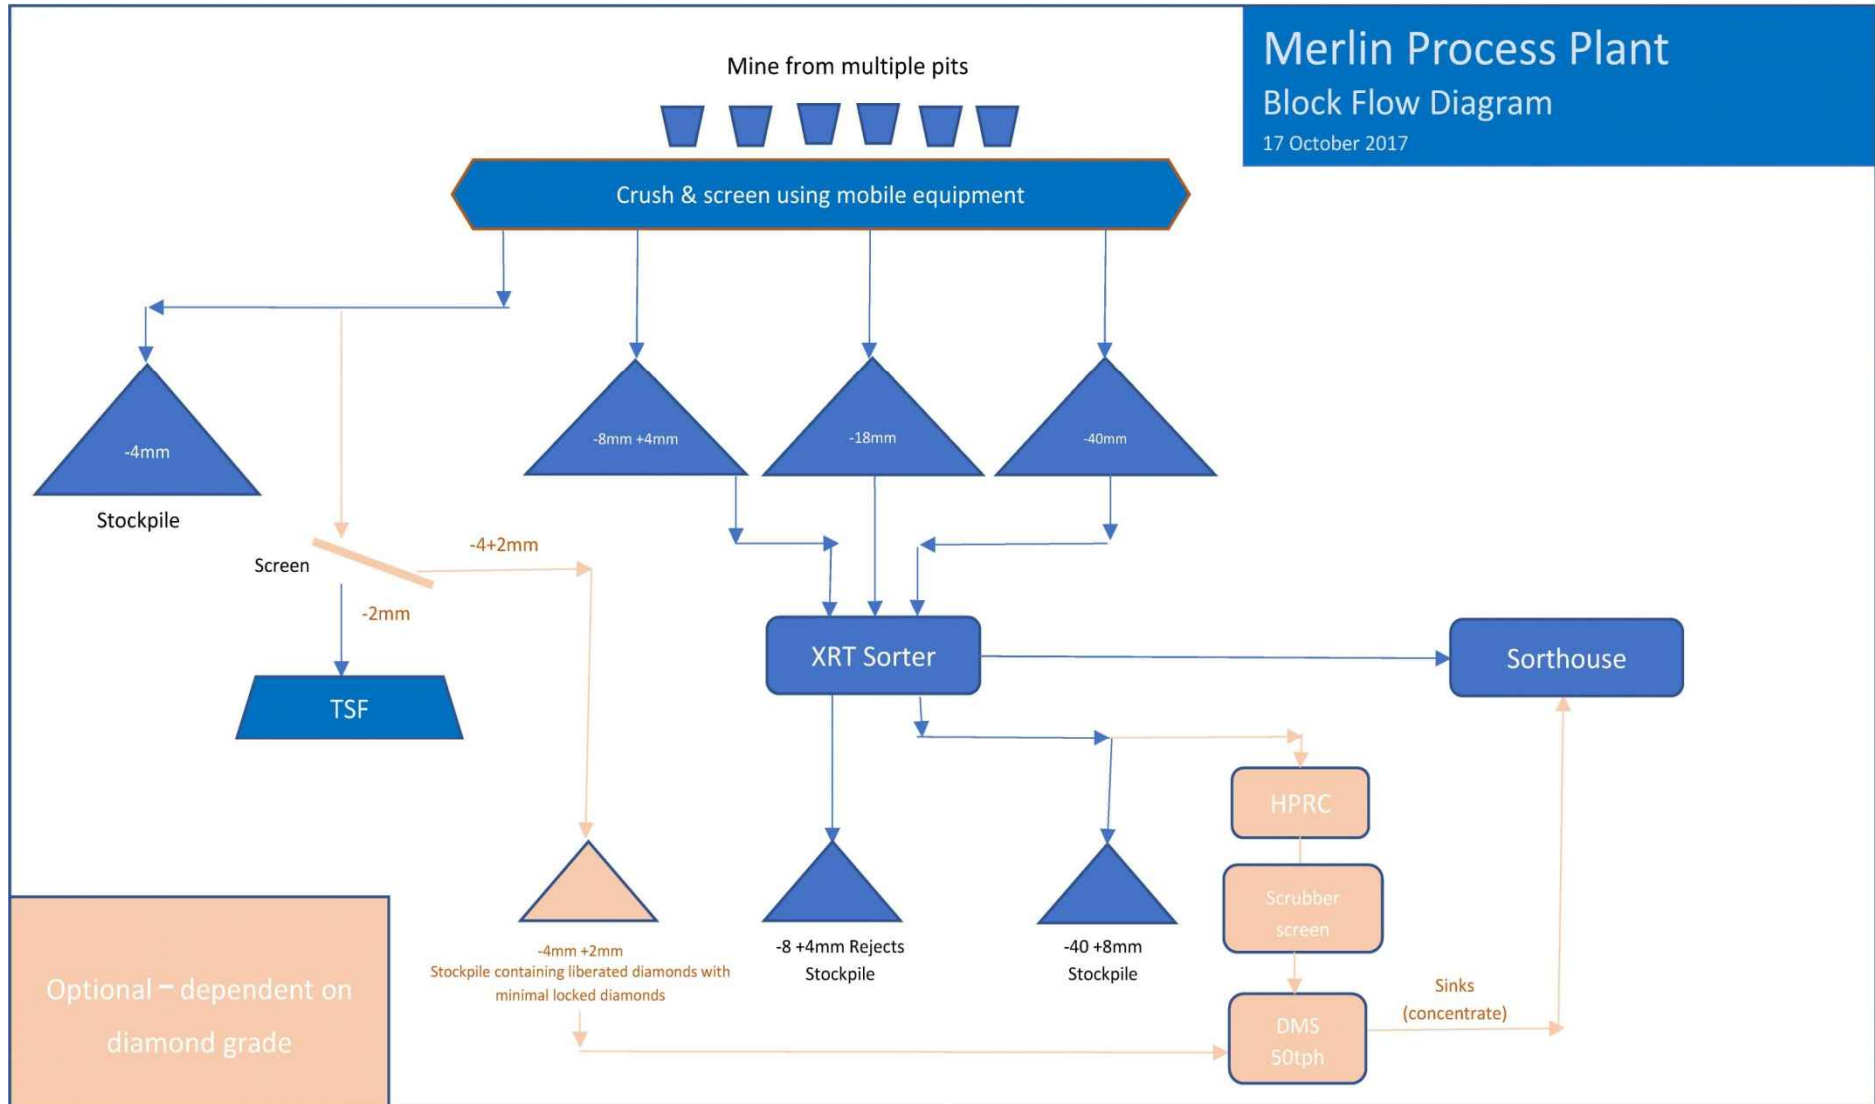
FIGURE 2: Process Flowchart for TOMRA XRT

Figure 2 shows the planned Process Flowchart for the plant.

The TOMRA XRT ore sorting machine uses advanced x-ray technology to ‘look’ for carbon, so it can detect coated diamonds and diamonds still trapped in kimberlite rock. The downside is that it also detects pieces of wood and plant roots, as well as carbonate minerals. Pieces of wood are a challenge whilst re-processing stockpiled trommel oversize, however when the ore feed reverts to mined kimberlite, this problem will be eliminated. Carbonate can be minimised by the use of filters and further calibration.
