# **Merlin Diamonds Limited**

## **ANNUAL REPORT Year 21 MINERAL LEASE MLN1154 “MERLIN DIAMOND PROJECT”**

**Annual Report For The Period  
1<sup>st</sup> January 2018 to 31<sup>st</sup> December 2018**

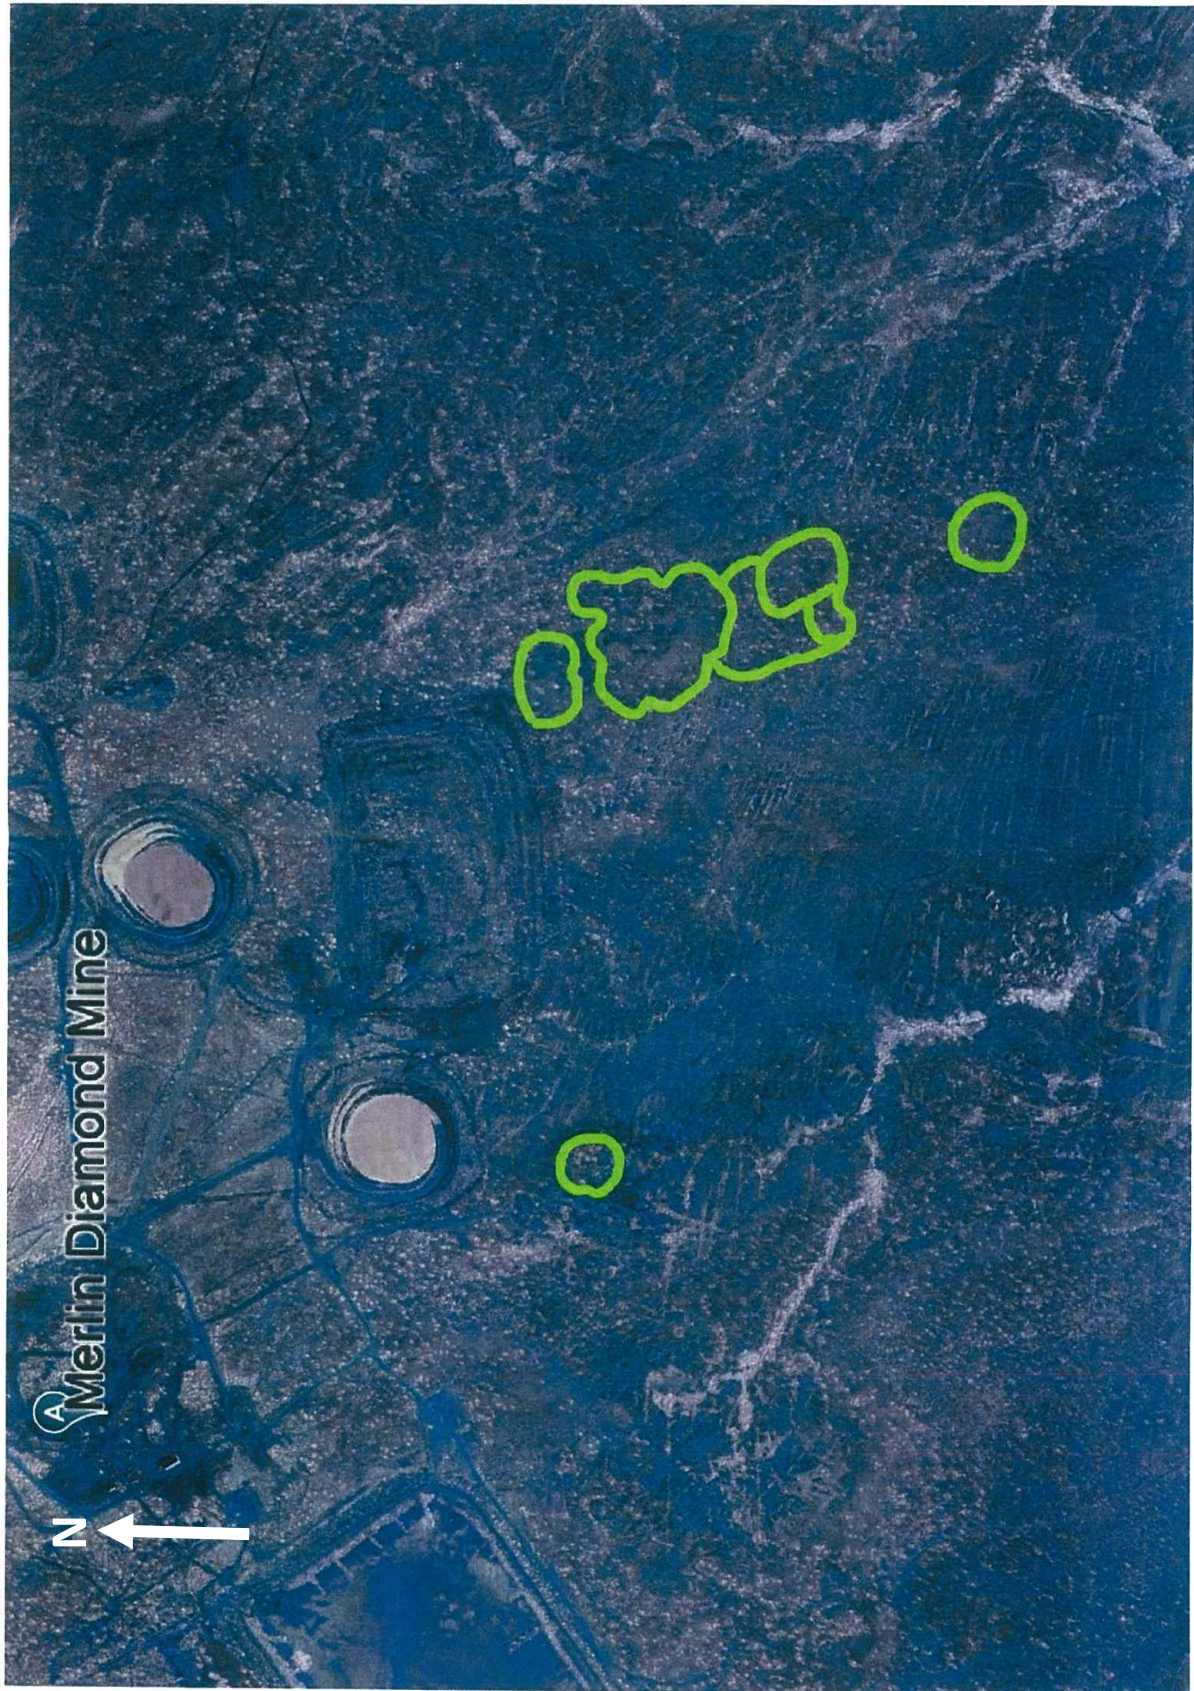
**Figure 1:** A satellite image of Merlin diamond mine showing location of circular topographic feature located south of Excalibur pipe.

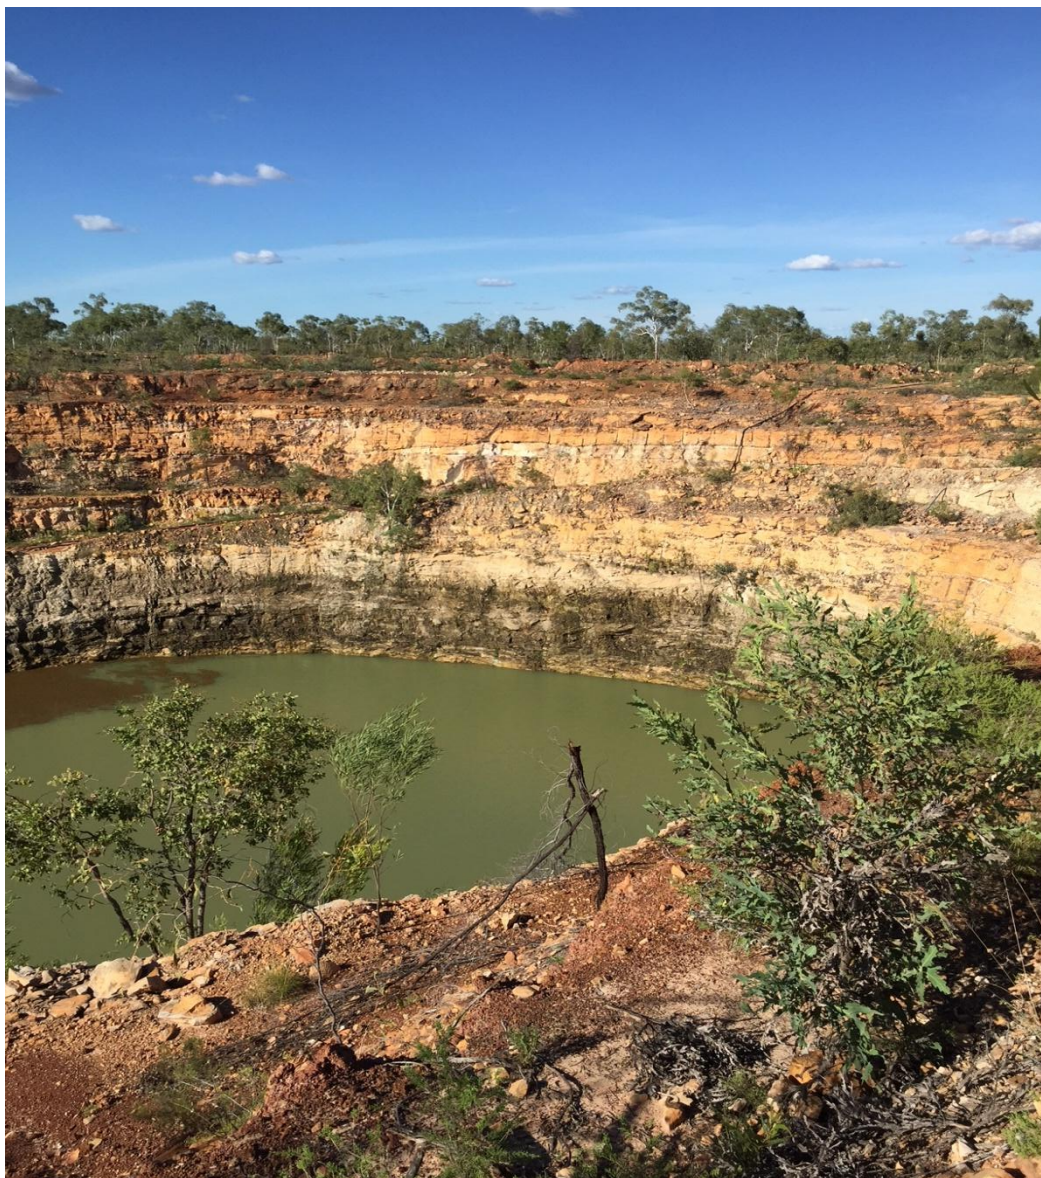
**PHOTO 1:** Gawain pit being de-watered (February 2018)

During the year, Merlin has completed dewatering of Ector, Excalibur, and Ywain Pits. Prior to that, Company has almost dewatered high grade Gawain Pit which likely to return significant profitability (PHOTO 1, 2). With the success of the 2017 mining campaign, Merlin has continued to utilise conventional mining methods during 2018.

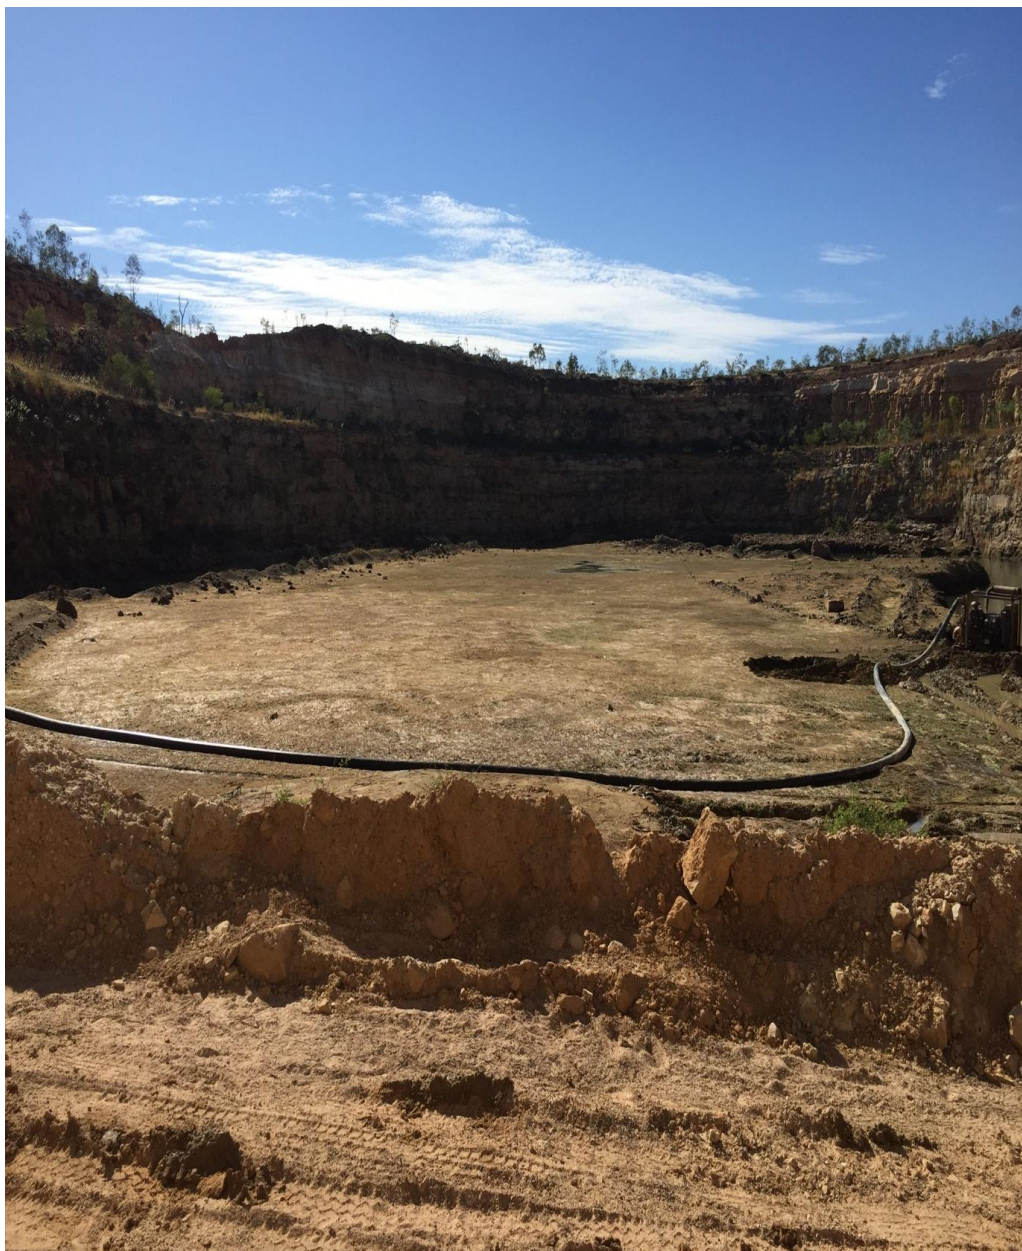
**PHOTO 2:** Dewatered Ector Pit.

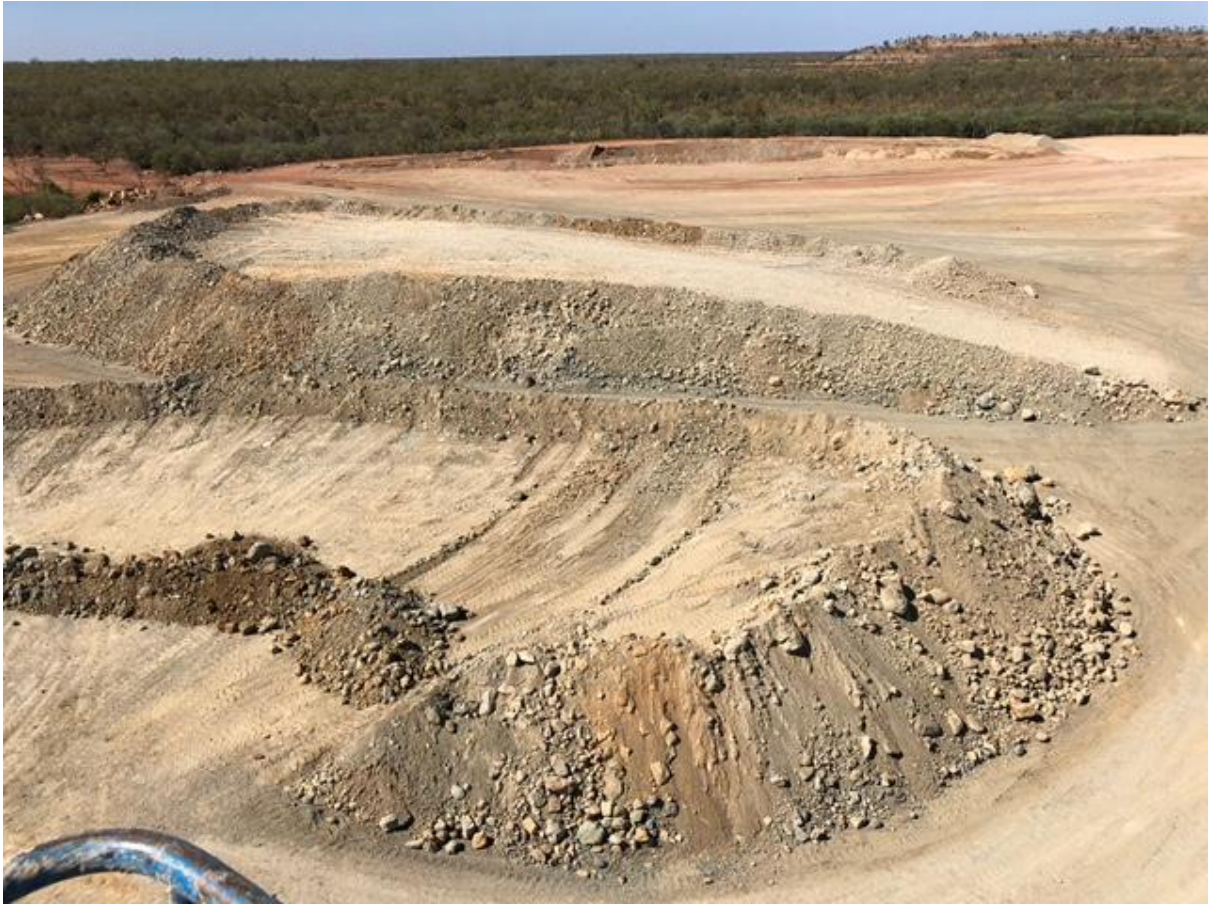
**PHOTO 3:** Part of stockpile from Ector pit on the ROM pad.

During the year, fresh kimberlite ore was mined from the Ector Pit. Mining contract was awarded to Rusca Bros Services. Rusca Bros mobilised to the site in late June 2018 and commenced mining of Ector pit. By the end of July, approximately 60,000 tonnes of ore was recovered from Ector pit and hauled to ROM pad (PHOTO 3). Ector is a large kimberlite pipe that has one of the highest proportions of large diamonds compared to other pipes at the Merlin Kimberlite Field and has had little mining in the past. Ease of Mining has allowed plenty of ore being hauled to the ROM pad in a short time frame and facilitated processing of the ore by the state of the art XRT machine at an increased feed rate.

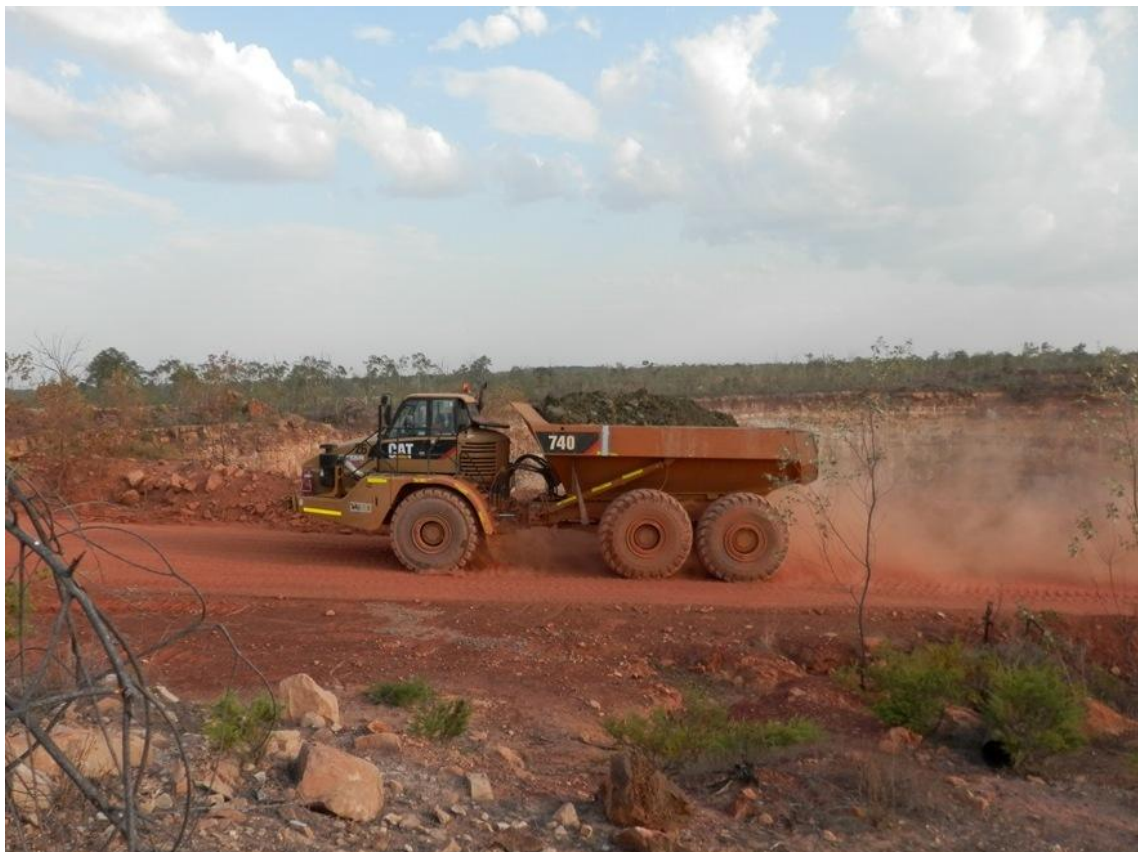
**PHOTO 4:** Hauling from Kay Pit to ore pad

During the mining a Cat D10 bulldozer was used to rip the floor of the pit and push the broken kimberlite into piles. A 30-tonne excavator loaded the ore into a Cat D400 or Cat 740 six-wheeled articulated truck that hauled the ore to an ore pad sited at the top of the pit (PHOTO 4).

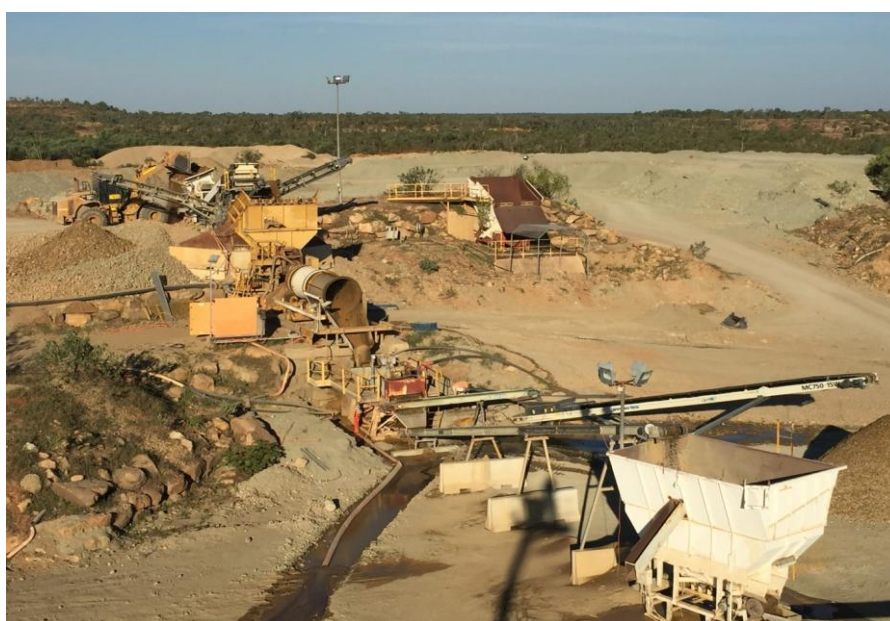
**PHOTO 5:** View of refurbished scrubber

In early 2018, the old DMS plant and scrubber were put back into production and previously mined stockpiles were processed to ensure it was working properly. Whilst it worked, it was breaking down and parts were constantly required for repairs. Merlin, therefore, decided to complete onsite refurbishment of scrubber and DMS Plant (PHOTO 5, 6). Furthermore, the Company needed to bring in more hired equipments to assist preparing head feed for the DMS plant and for the new TOMRA XRT Sorter.

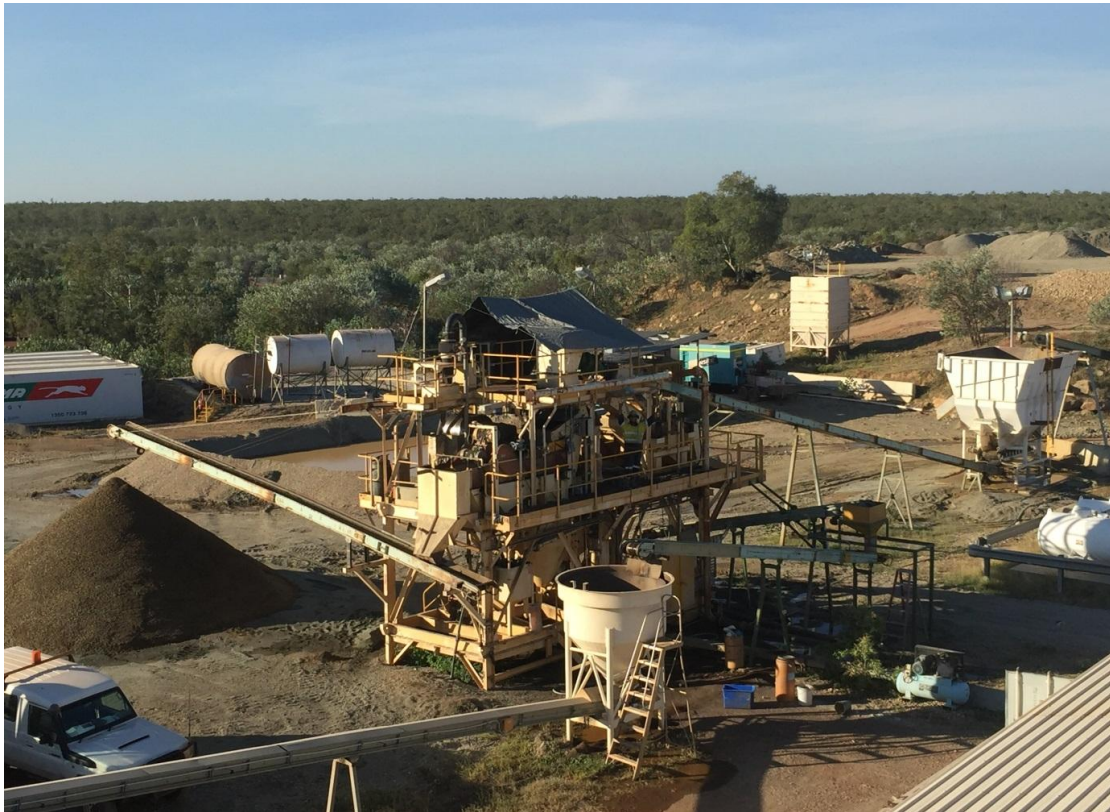
**PHOTO 6:** View of refurbished DMS Plant

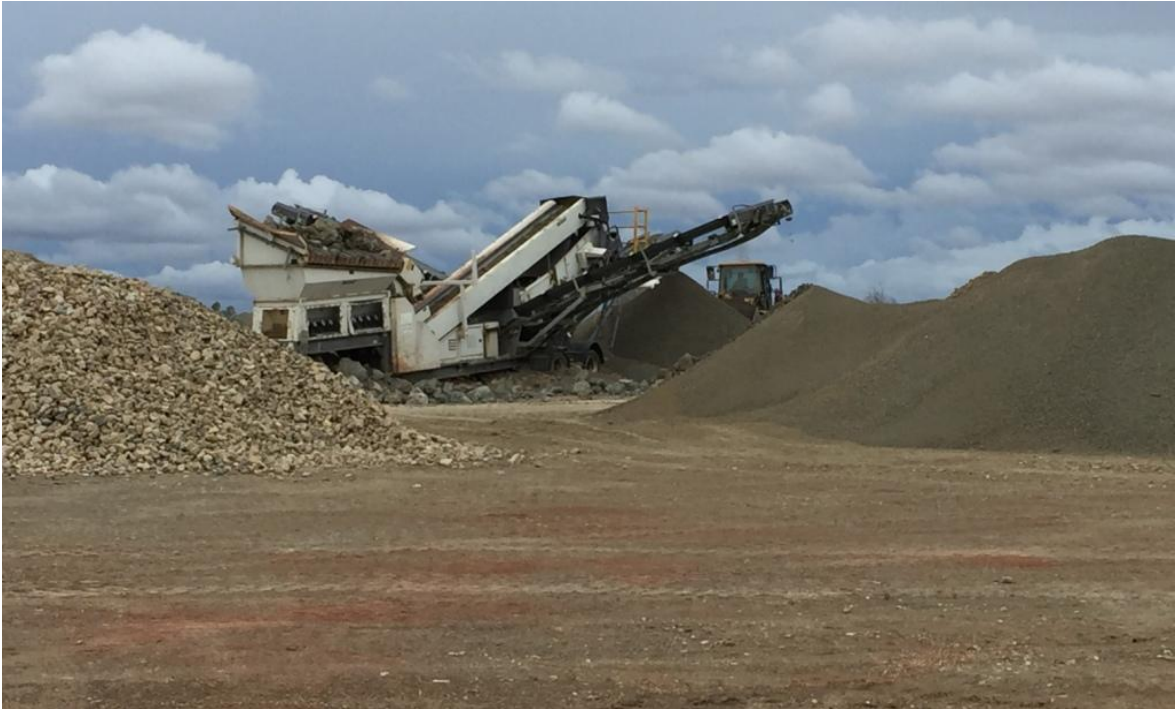
**PHOTO 7:** Mobile screening plant used to prepare feed for TOMRA. Feed for TOMRA was screened in three size fractions +4 to -8mm, +8 to -18mm, and +18 to -40mm.

In March 2018, Merlin introduced mobile screening plant into new circuit to remove oversize material before entering scrubber (PHOTO 7). The new mobile screening unit removes oversize +40mm to -200mm material; preventing it to pass through the processing plant. Oversized material is stockpiled on the ROM pad for further crushing to -40mm. Merlin has purchased a new jaw crusher which will be introduced into the processing circuit to treat oversize material (PHOTO 8).

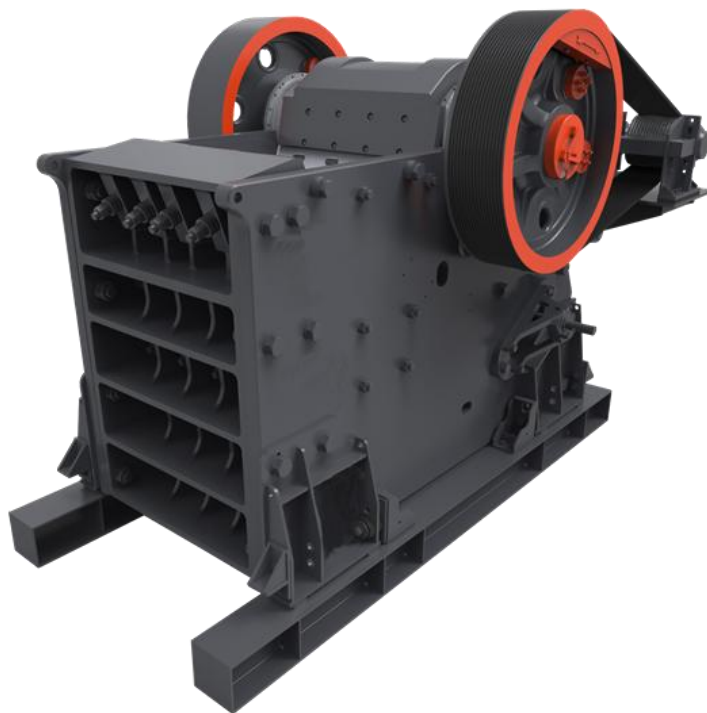
**PHOTO 8:** New Jaw crusher to be installed at Merlin Mine

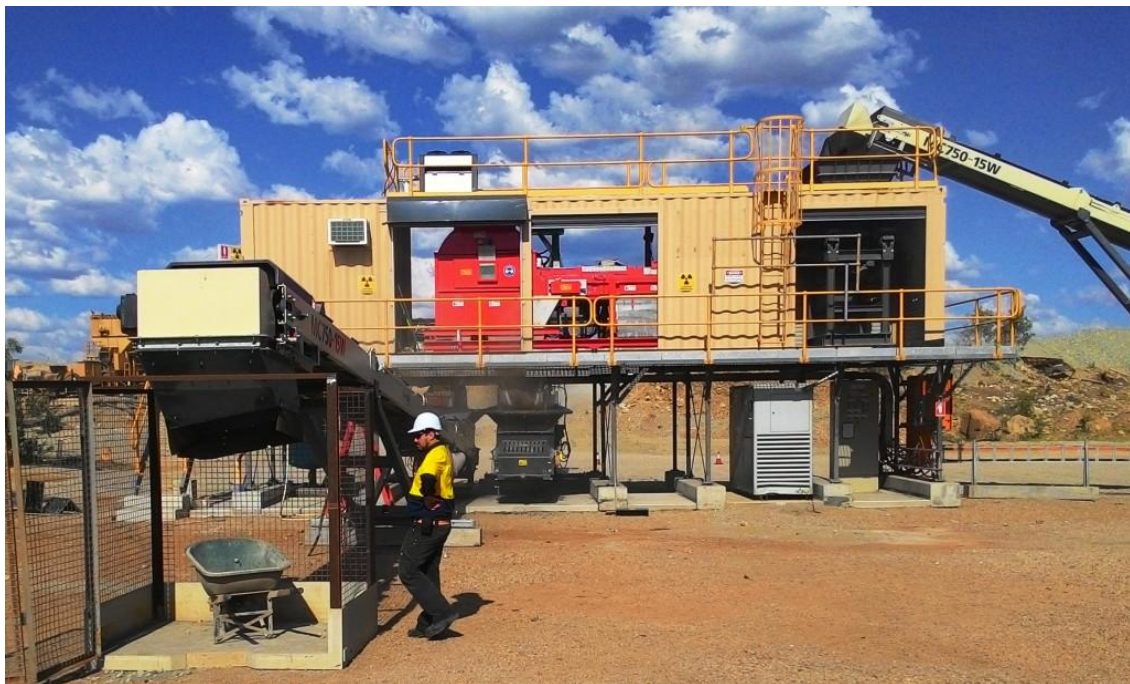
**PHOTO 9:** The Merlin TOMRA XRT is housed in a sea-container mounted on a raised platform when fully operational; concentrate from the TOMRA will be delivered to a hopper housed in a secured cage

Mobile crushing and screening equipments were brought in and were added to the front of the existing circuit to prepare feed for a TOMRA XRT sorter. The TOMRA unit has been calibrated to process Merlin ore between +4mm to -40mm size fraction. The ore was screened into three size fractions before each size fraction was passed through the XRT sorter. These size fractions were: +4 to -8mm, +8 to -18mm, and +18 to -40mm. The -4mm fraction has been stockpiled for processing through the DMS plant at a later date. The +40mm material, which comprises mostly country rock clasts, is also stockpiled separately.

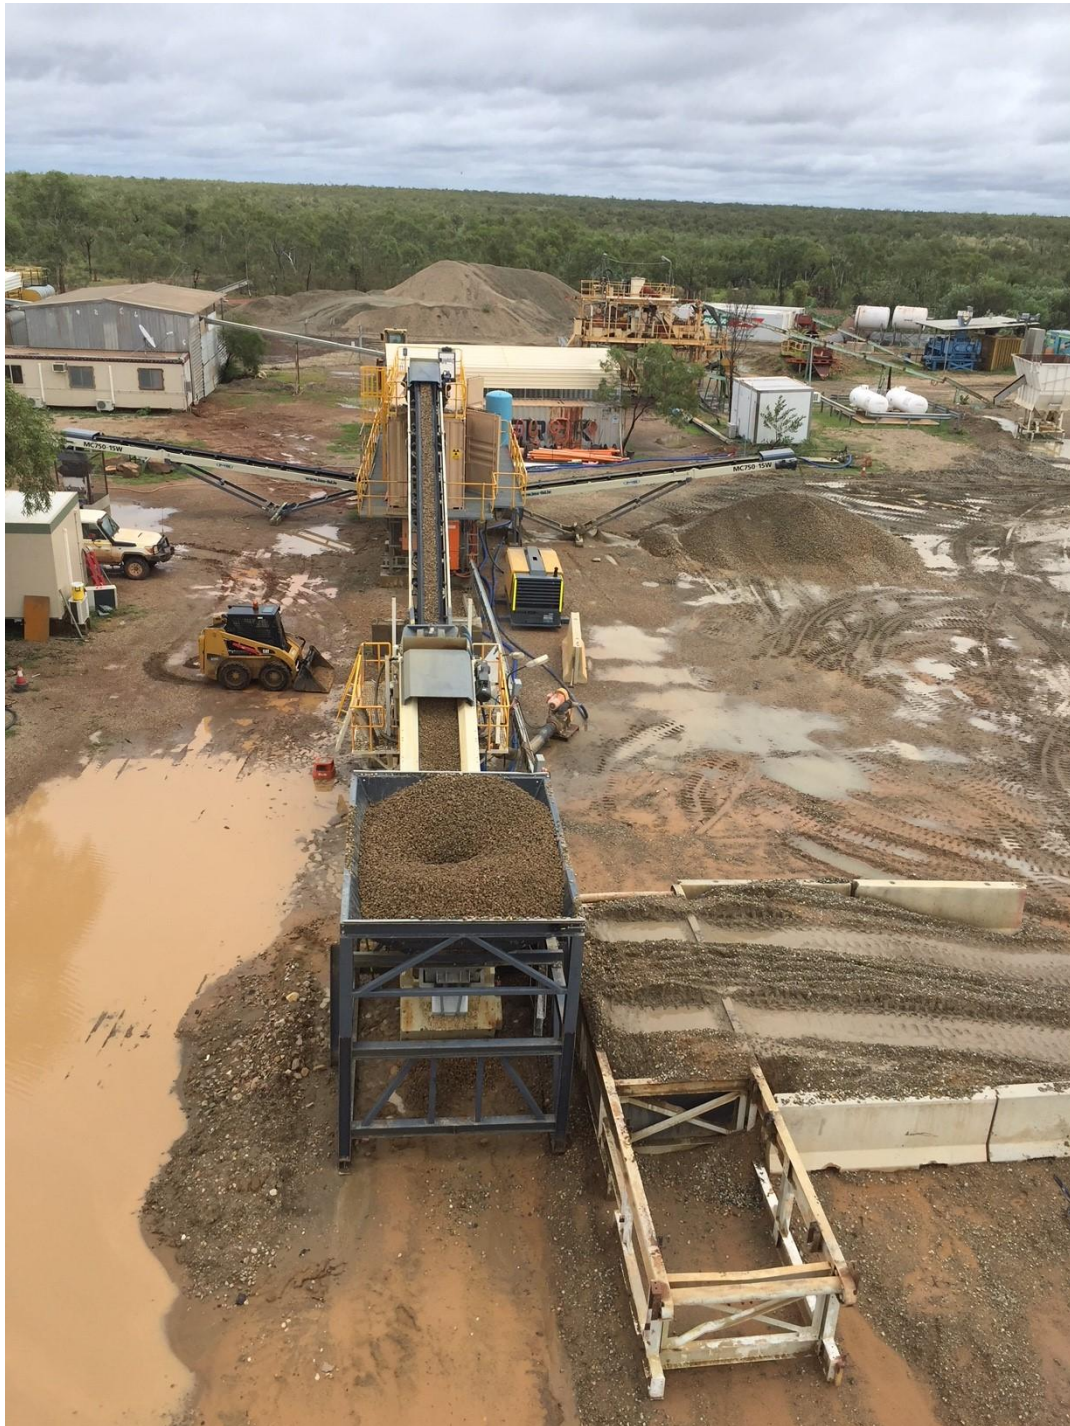
**PHOTO 10:** View of TOMRA XRT processing circuit.

During the year, TOMRA has processed approximately 20,000 tonnes of ore (mainly from Ector and very little from other pits) from January to September period. Feed to the XRT sorter was via a hopper, belt feeder and conveyor, with the rejects and accept products being conveyed from the sorter (PHOTO 10, 11). The feed rate to the circuit was maintained at 100 tonnes per hour. Recovery of diamonds was disappointing. Merlin recovered just one diamond from +8 to -18mm size fraction and no diamond was produced from +4 to -8mm and +18 to -40mm size fractions. The cause of poor yield of diamonds was due to XRT unit 'not functioning fully'.

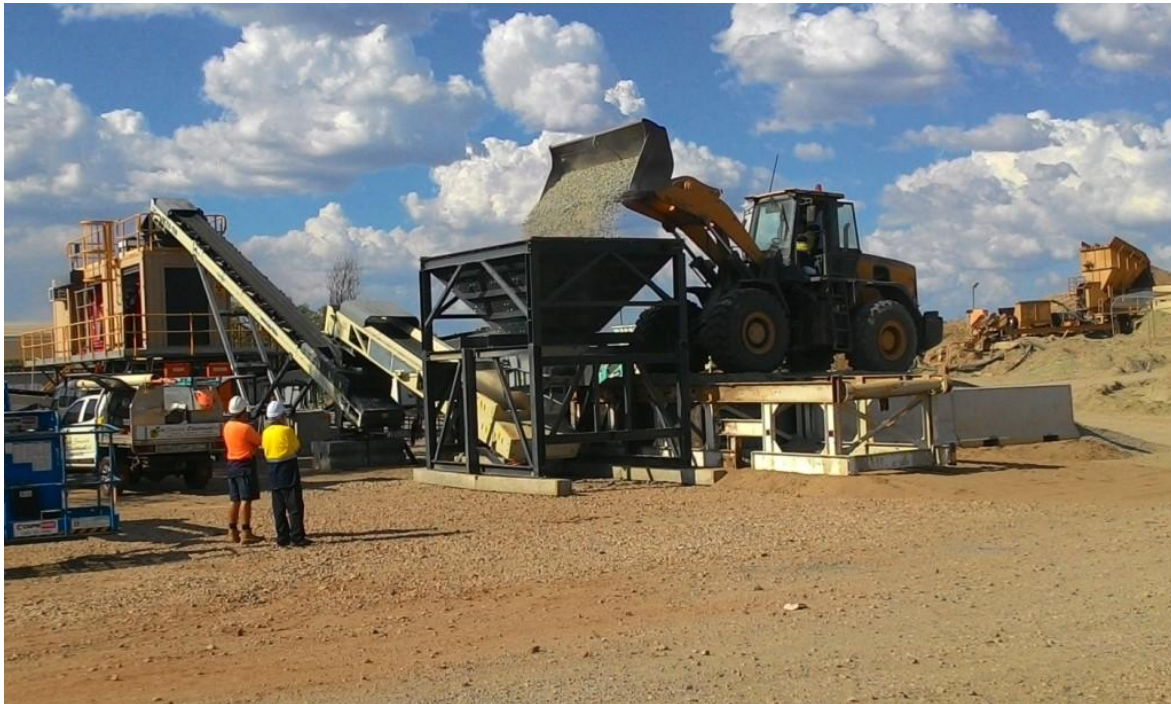
**PHOTO 11:** Batch feeding sized ore to TOMRA unit

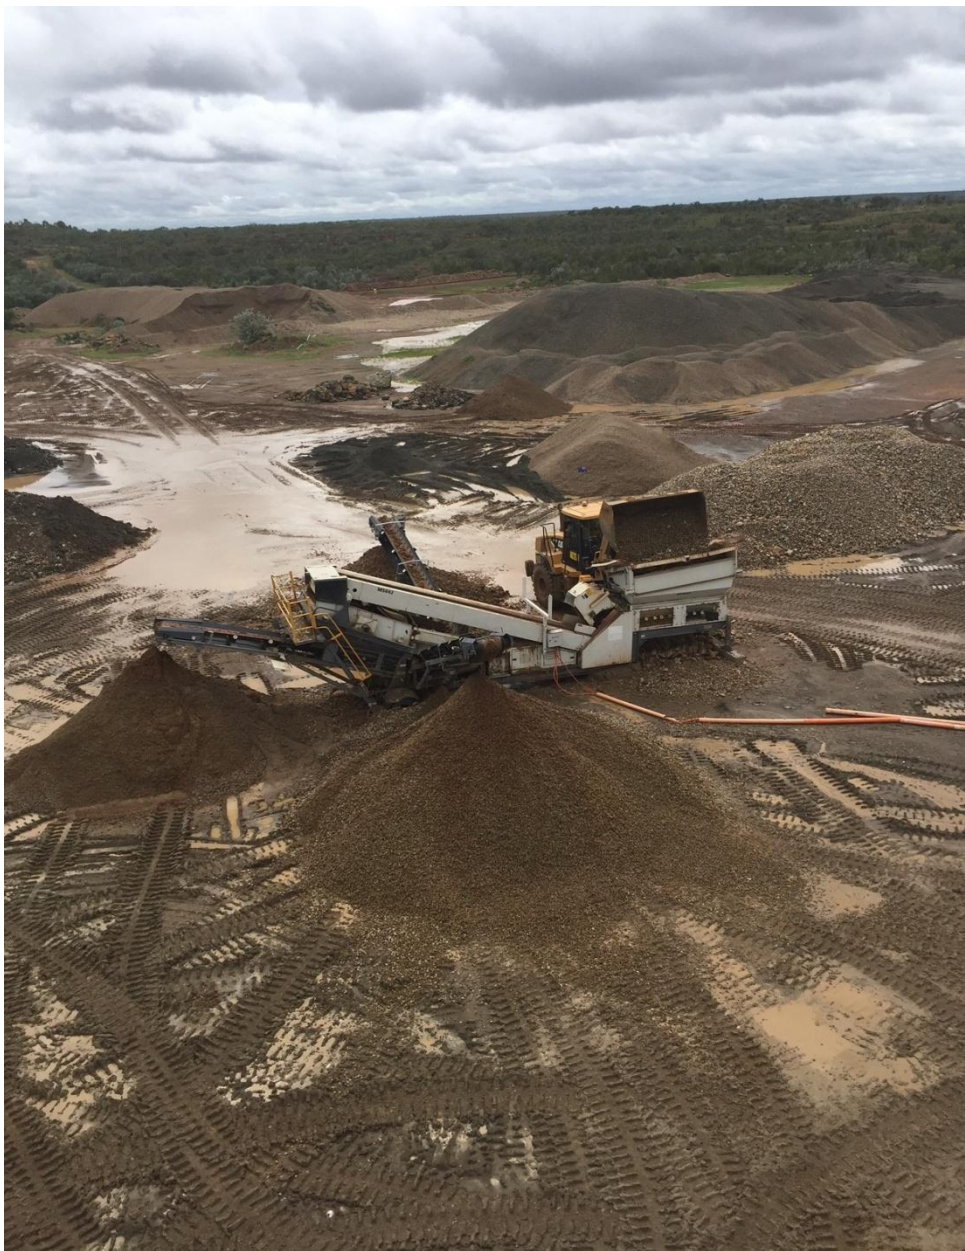
**PHOTO 12:** Mobile screening unit.

The previously screened -4mm size fraction which was stockpiled at ROM was reprocessed to recover +2mm to -4mm size fraction (PHOTO 12). This size fraction was combined with +4mm to -8mm and +8mm to -18mm size fractions retrieved from XRT sorter reject bins. The resulting +2mm - 18/20mm size fraction was then fed directly into the DMS plant at a head rate of approximately 40 tonnes per hour. The recovered heavy concentrate product was sent to the final recovery unit - Flowsort X-Ray Machine.

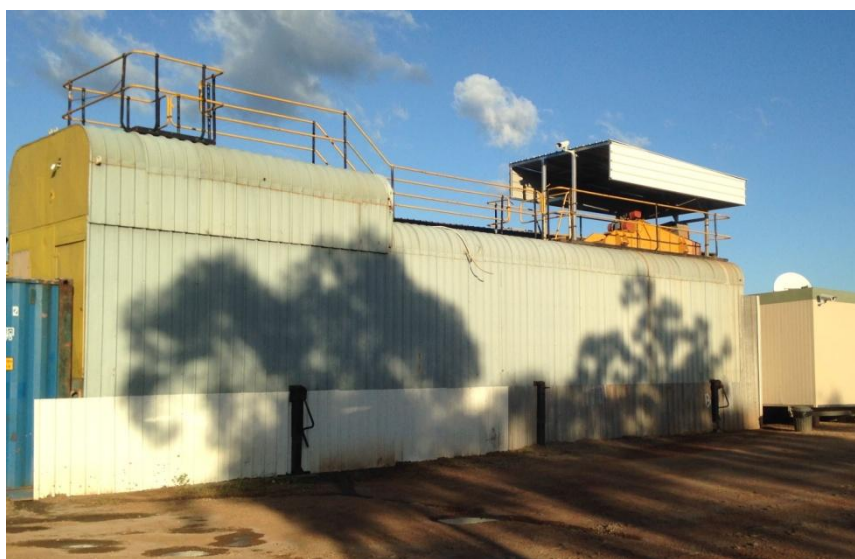
**PHOTO 13:** Modular Flowsort X-ray Sorter housed in a mobile caravan

During the January to June period, final recovery was conducted using a Flowsort recovery system (PHOTO 13). The two twin-stage x-ray sorting machines housed in a mobile caravan were purchased from Ellendale diamond mine in the West Kimberley, transported to Merlin mine site, and commissioned in October 2016.

Recovered concentrate from the DMS plant is screened into three size fractions: +2 to -4mm, +4 to -8mm, and +8 to -18mm. Each size fraction is then passed separately through the twin-stage x-ray sorting machines. Most diamonds fluoresce under x-rays, and this emitted light triggers a detector which diverts that portion of the concentrate stream to a recovery bin. The Flowsort concentrate from each size fraction was then dried and hand-sorted in a secure area with the diamonds separated manually from the gangue minerals.

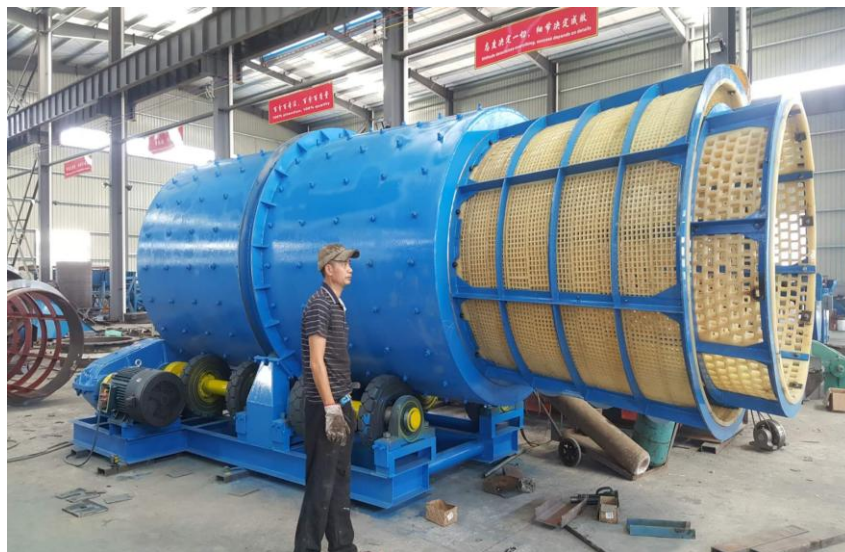
**PHOTO 14:** On order trommel scrubber unit

sizing trommel on to the end of it will result in streamlining the process. In turn reducing downtime and increasing throughput. Merlin has placed order for trommel scrubber wash plant which is being sourced from China. The new scrubber, screen and conveyor belts are being prepared for shipment and are expected to arrive sometime in 2019. Merlin anticipates by incorporating this new trommel scrubber in the processing plant, head feed will increase from 50 tonnes per hour to 100 tonnes per hour which translate directly into doubling the production of diamonds. Furthermore, scrubber will significantly reduce the recirculation of oversize material and give Merlin the ability to feed damp ore directly from pit.

Screened material from mobile screening unit will be transferred to the scrubber. Scrubber will discharge material on to Merlin's new high-performance screening and sizing trommel unit, which will separate material into three different size fractions; -1mm, +2mm -18mm and +18mm -40mm. The -1mm material will be transported to the tailing dam, the +2mm -18mm will be processed in DMS module and +18mm -40mm material will be conveyed to the XRT machine for screening.

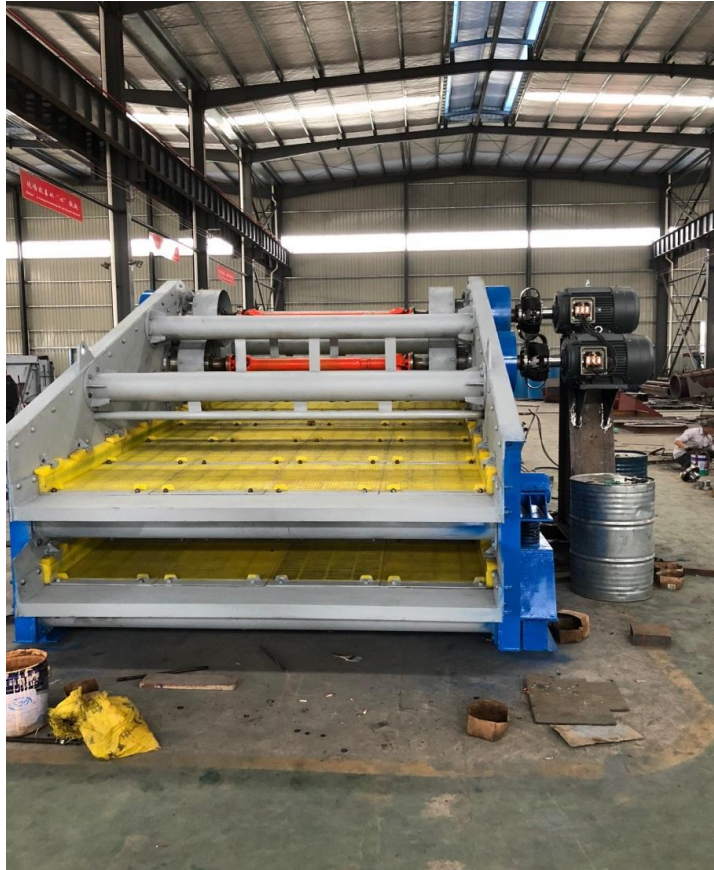
**PHOTO 15:** On order high frequency vibrating screen

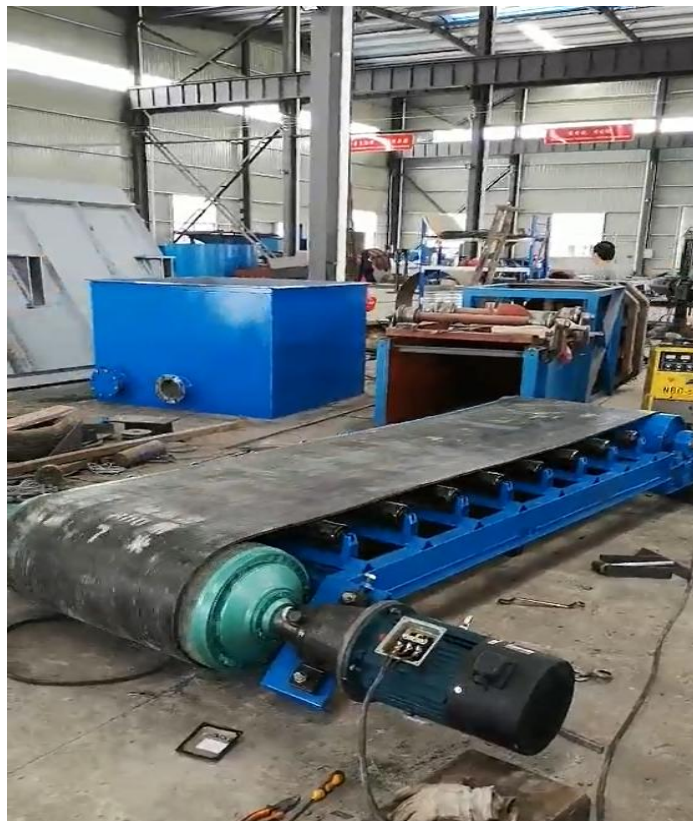
**Figure 16:** On order conveyor belt
