NORTHERN TERRITORY GEOLOGICAL SURVEY

REPORT GS 79/9

REPORT ON THE FEASIBILITY OF A DAM
ON THE TODD RIVER

B. WEBER & C. HORSFALL

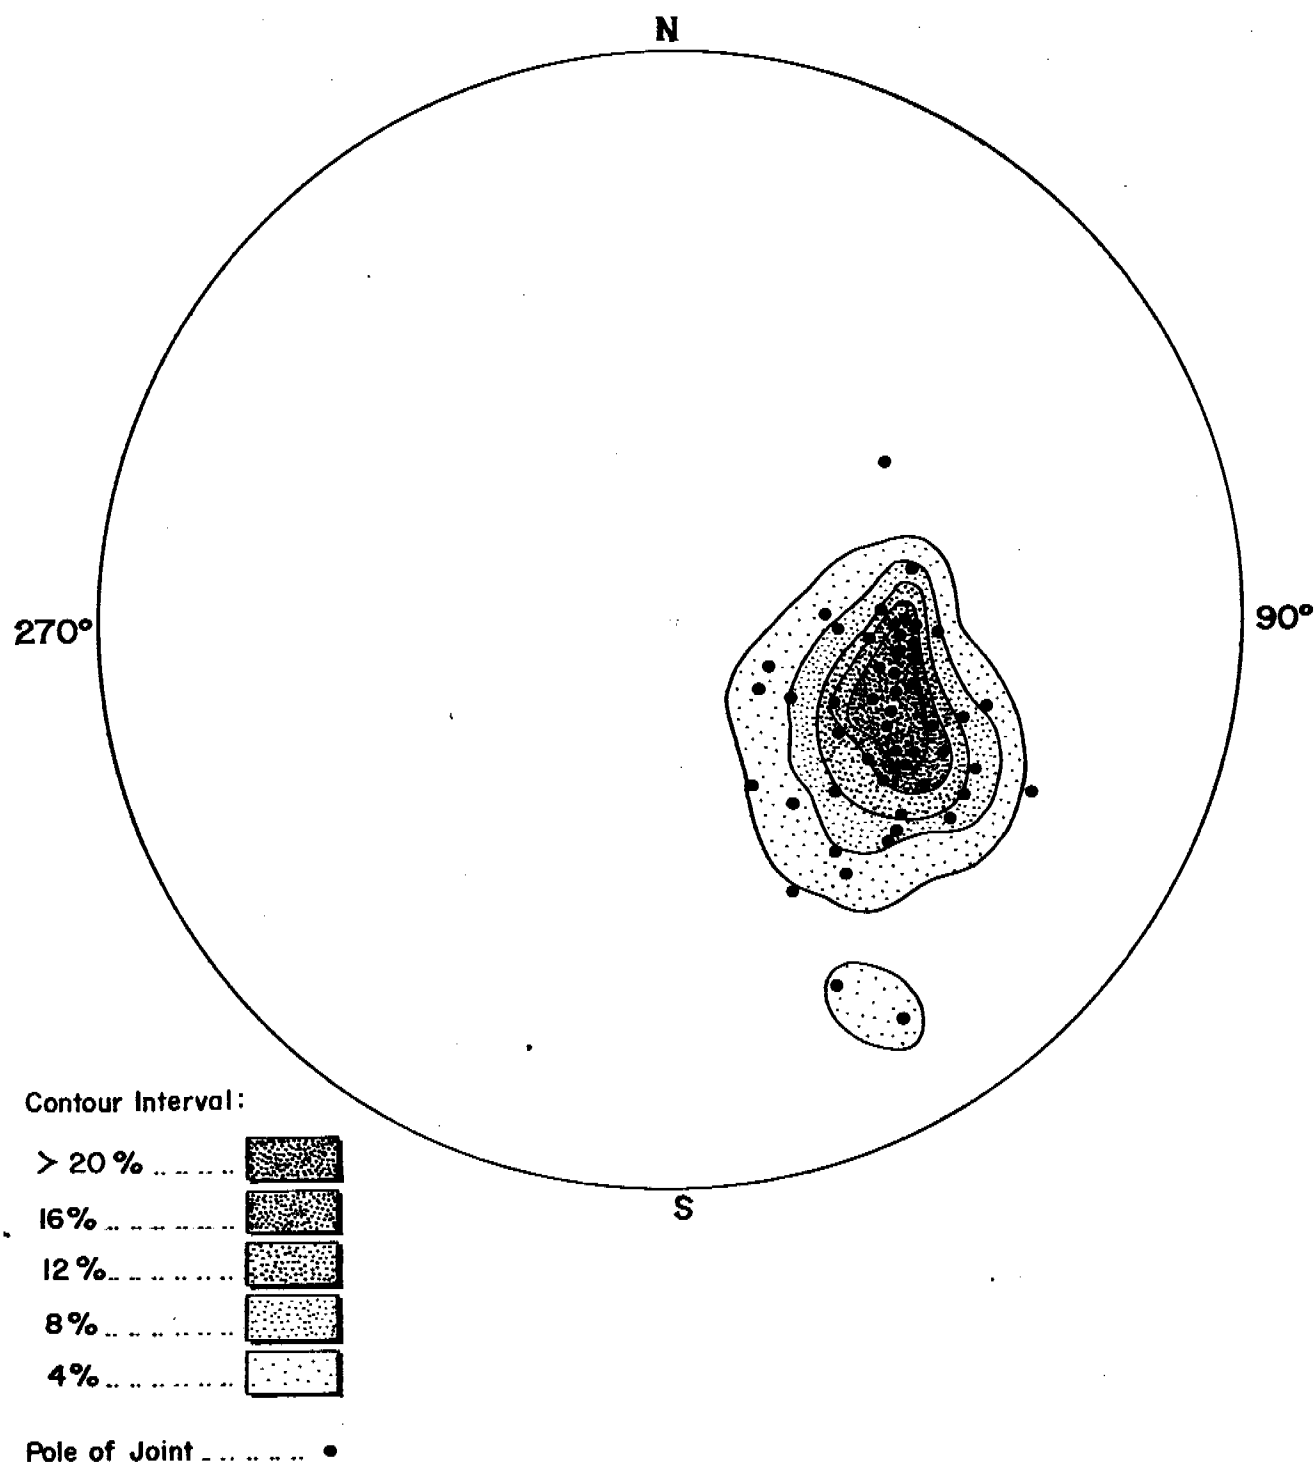
CONTOURED POLES TO FOLIATION
DAM SITE, SPILLWAY & RESERVOIR
(Equatorial Equal Area Net)

Foliation over the entire area forms a well-defined pole point maximum which indicates simple large-scale low-angle folding in the area (Plate 11).

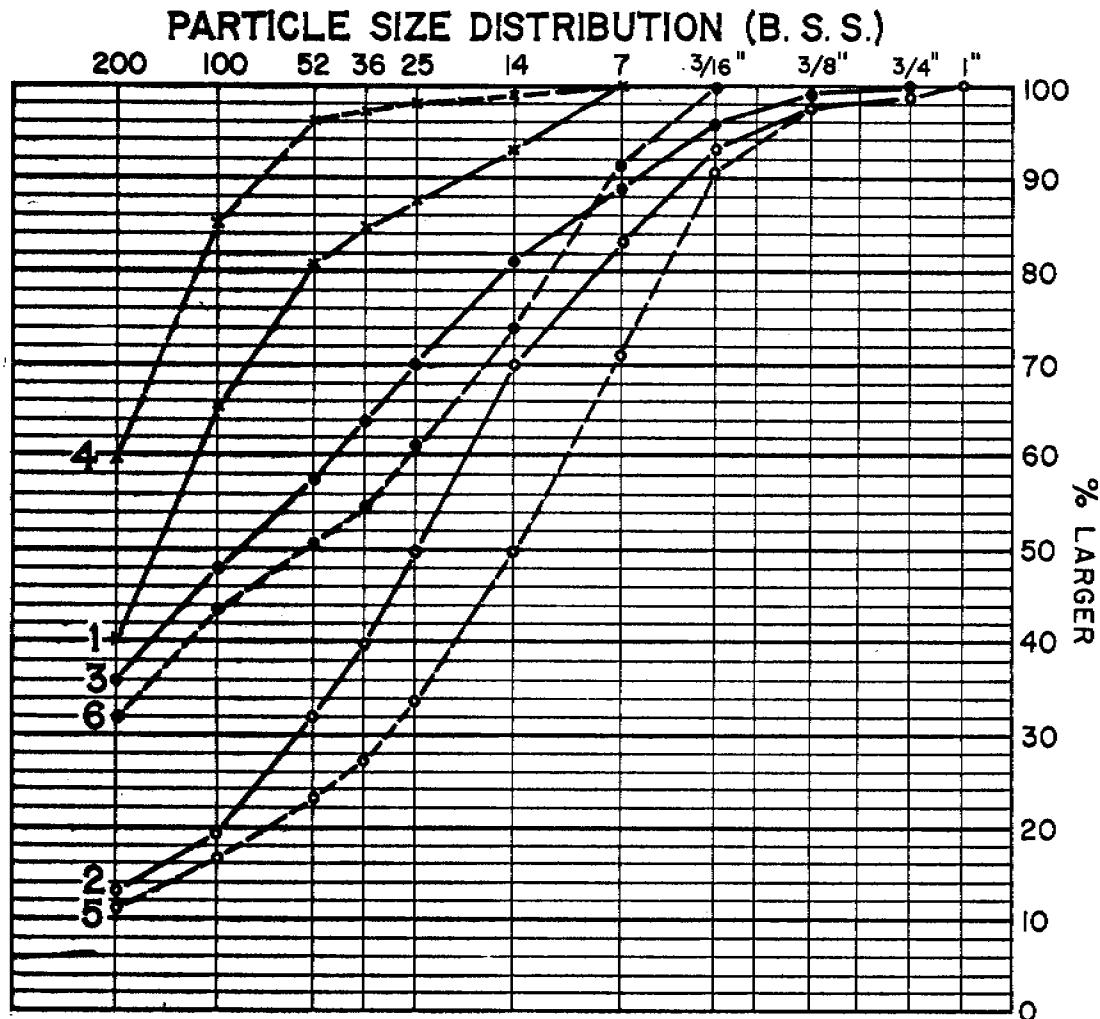
Although clay materials are generally scarce within the Arunta Complex, a brief reconnaissance soil sampling programme was undertaken to locate potential core material for possible use within the saddle dams. Six samples were collected from the locations shown on Plate 17 and tested for grading and plasticity. Of the tested samples only two (Nos. 2 and 3) warrant further interest and detailed laboratory testing.

- x—x Sample 1 (SM) Non-plastic. Alluvial soil (Floodplain)
- Sample 2 (SC) LL = 29, PI = 7. Residual soil (Schist)
- Sample 3 (SC) LL = 26, PI = 12. Alluvial soil
- x—x Sample 4 (ML) Non-plastic. Alluvial soil (Floodplain)
- Sample 5 (SW-SM) Non plastic. Residual soil (Granite)
- Sample 6 (SM) Non plastic. Alluvial soil (Floodplain)

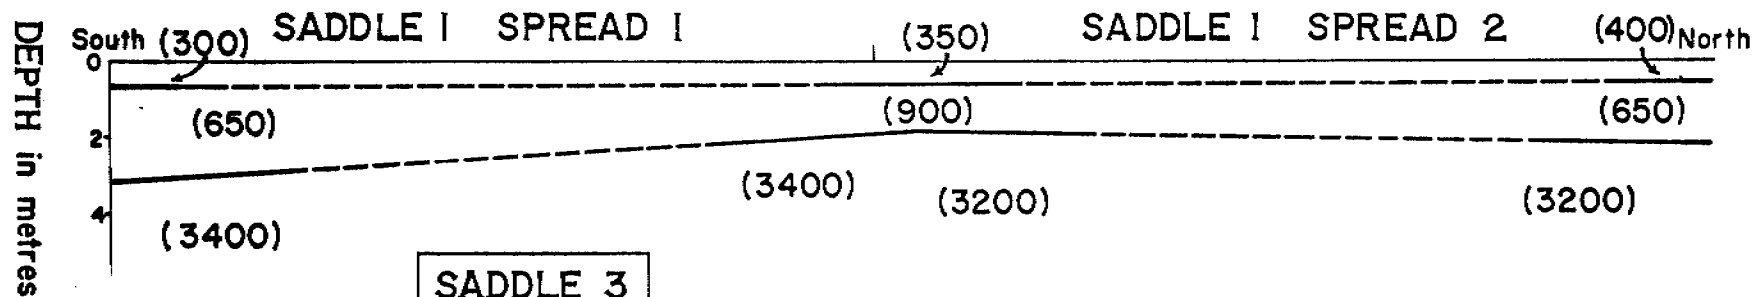
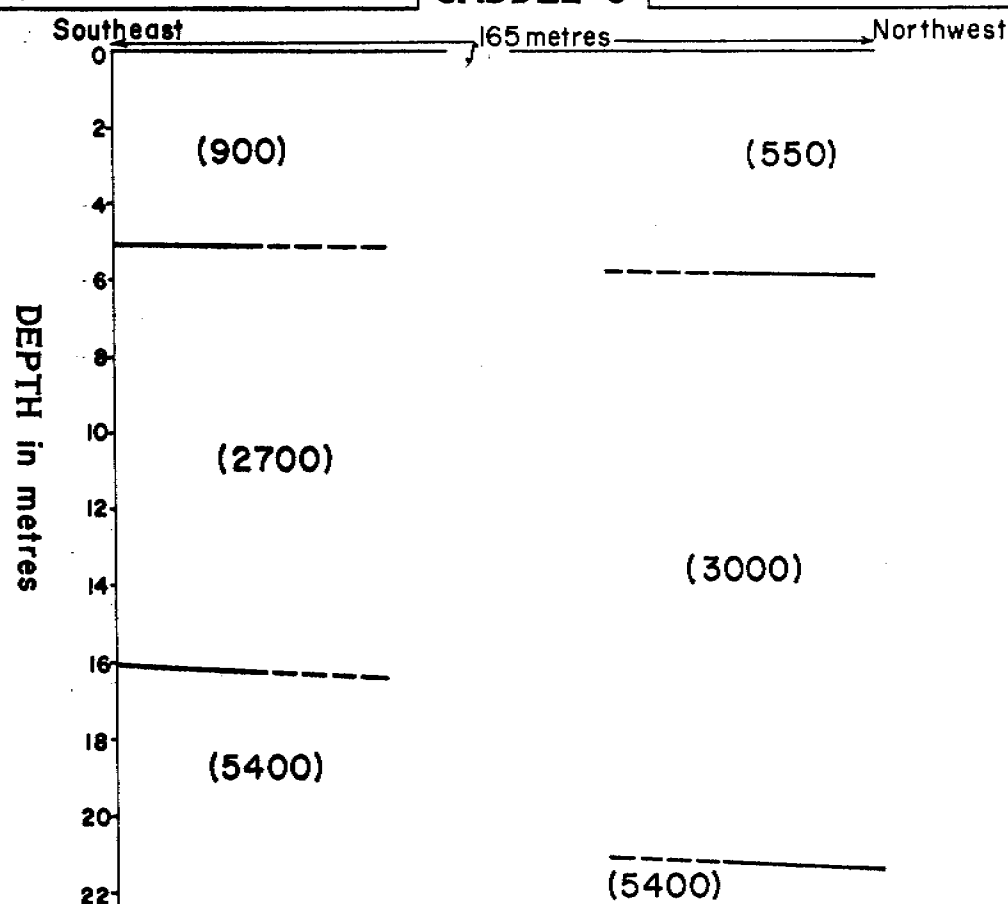
Plate 20

The near surface seismic record is of poor quality. The section (Plate 20) indicates fresh rock with few defects (seismic at a depth of 16 to 20m. velocity 5400 m/s).

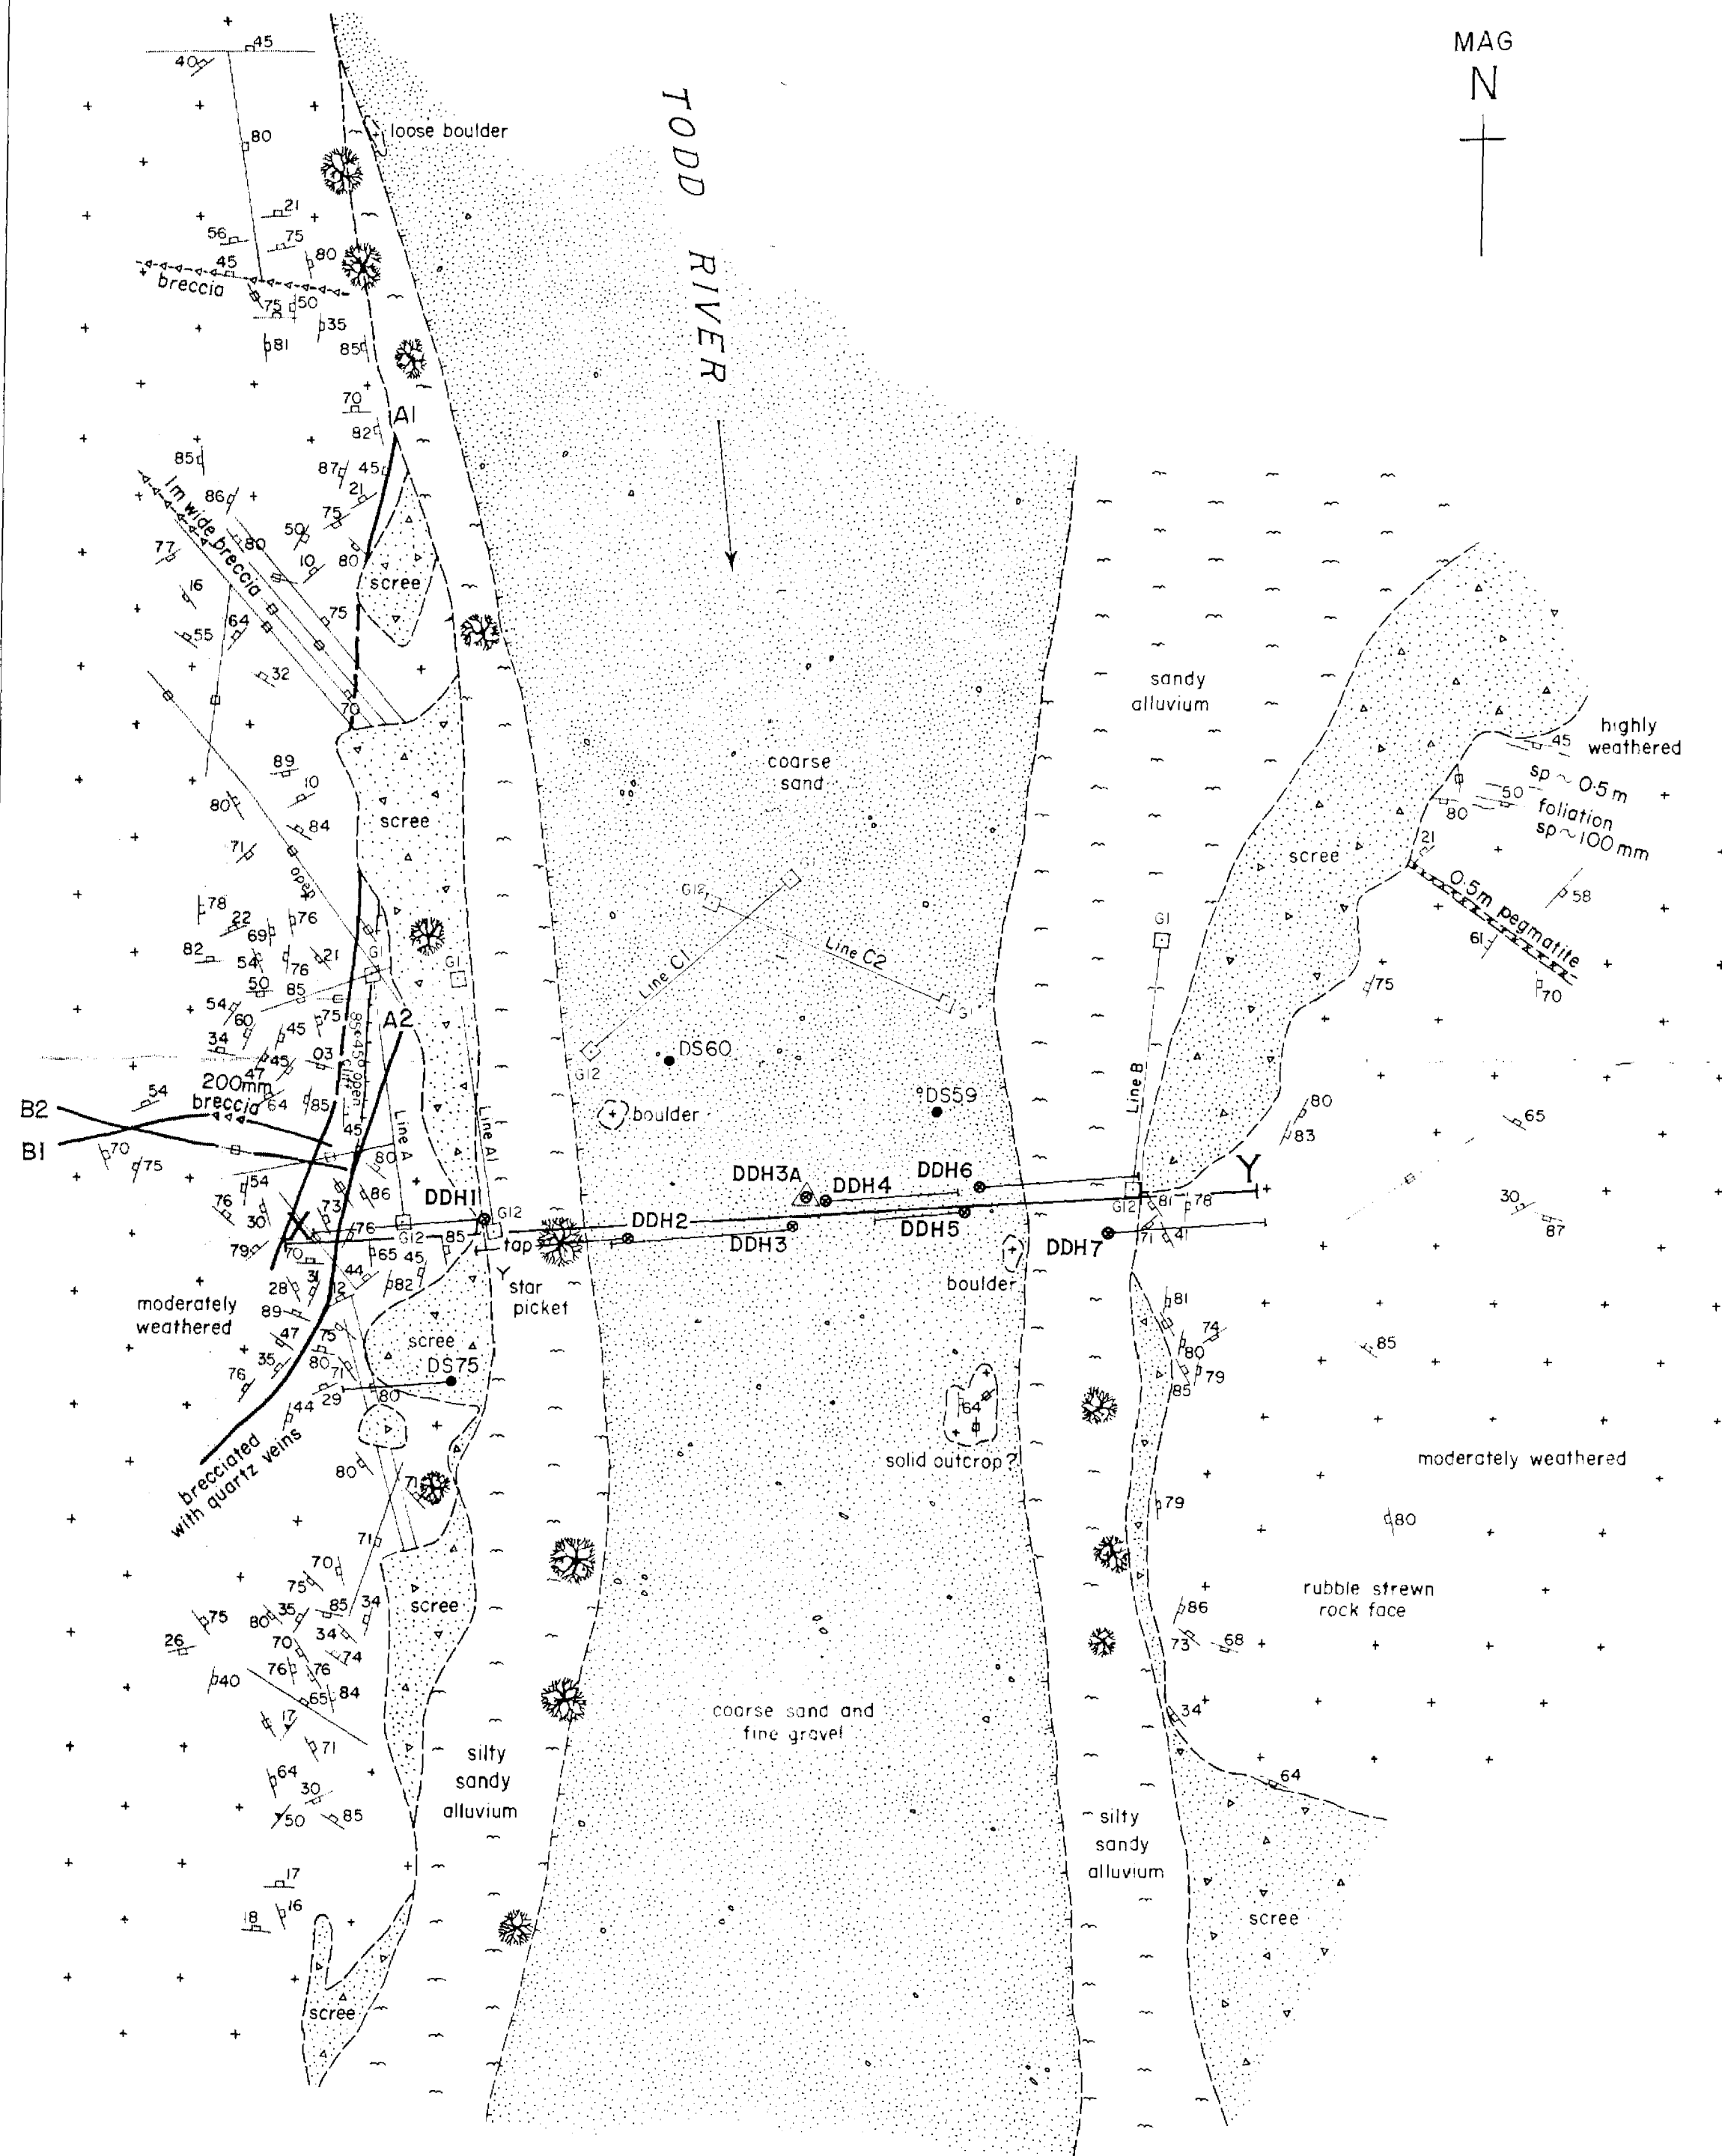
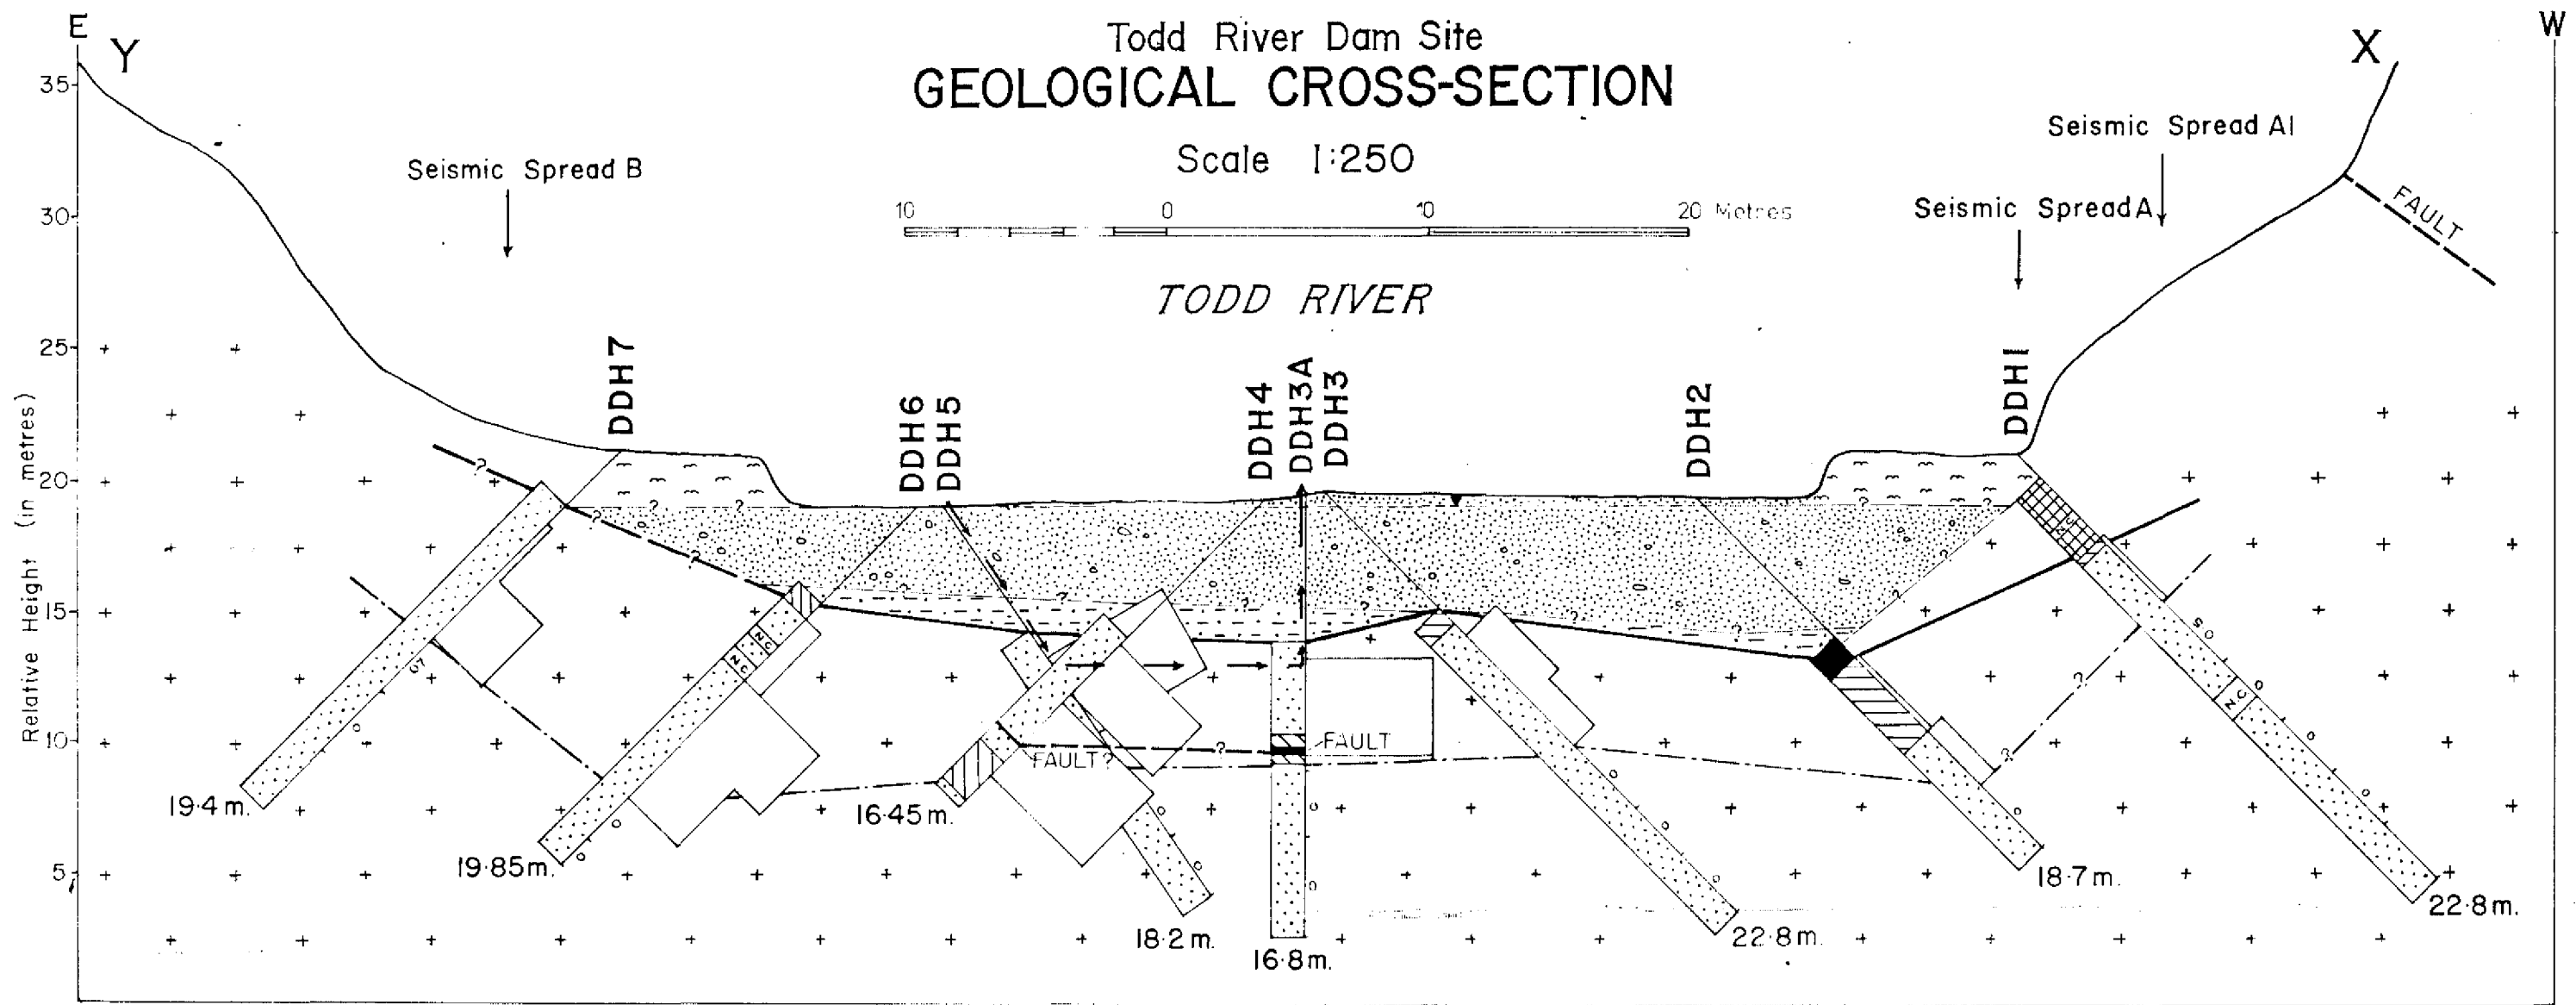
Todd River Dam Site DETAILED GEOLOGY

At least four faults (A1, A2, B1, B2, on Plate 12) intersect the right abutment; of the faults B1 and B2 may be continuous with faults observed in boreholes DDH 3A and DDH 7. In DDH 3A the fault cuts a thin dolerite dyke. Their intersection with master joints could explain the high permeability (>100 Lugeons over the fault in DDH 3A) recorded in this area.

The absence of a deeper higher velocity refractor
in line A suggests that moderately to slightly
weathered rock is a depth greater than 6 m there.
This may be a result of shearing and deeper weathering
associated with faults A1 and A2 (Plate 12).

The greater depth of the 2000 m/s refractor at
the northern end of line A1 is similarly likely to
be related to these faults. This suggests that at
6 m depth the rock is likely to be highly weathered
within 7 m of the indicated positions of the faults.
Faults B1 and B2 do not appear to extend further
eastwards than indicated in Plate 12. The depth
to fresh rock of 4.9 m encountered in DDH 1
(Plates 12 and 13) compares with the depth of
5.7 m to the 3700 m/s refractor in line A1.

This compares with a depth to fresh rock of 3 m in nearby DDH 7 (Plates 12 and 13).

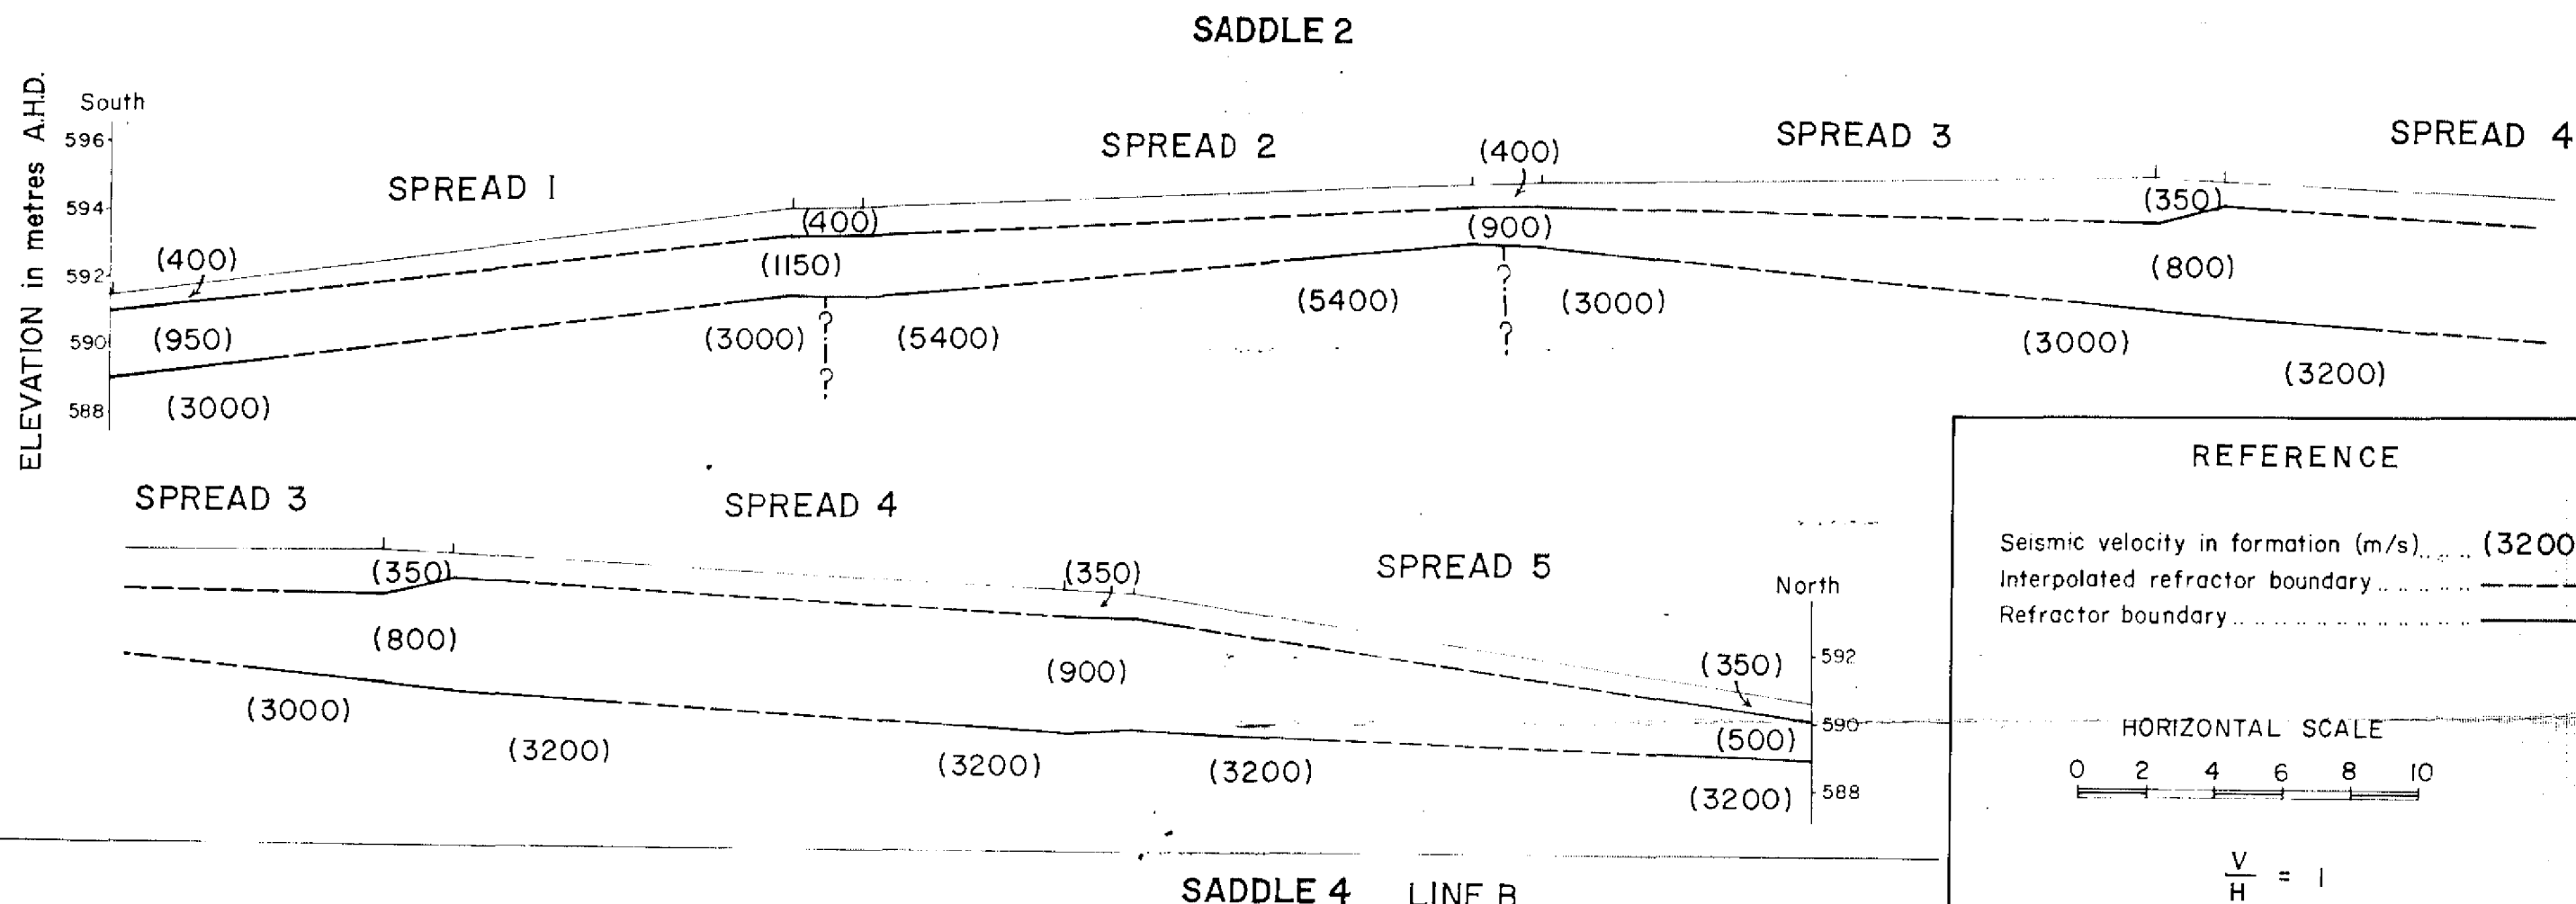
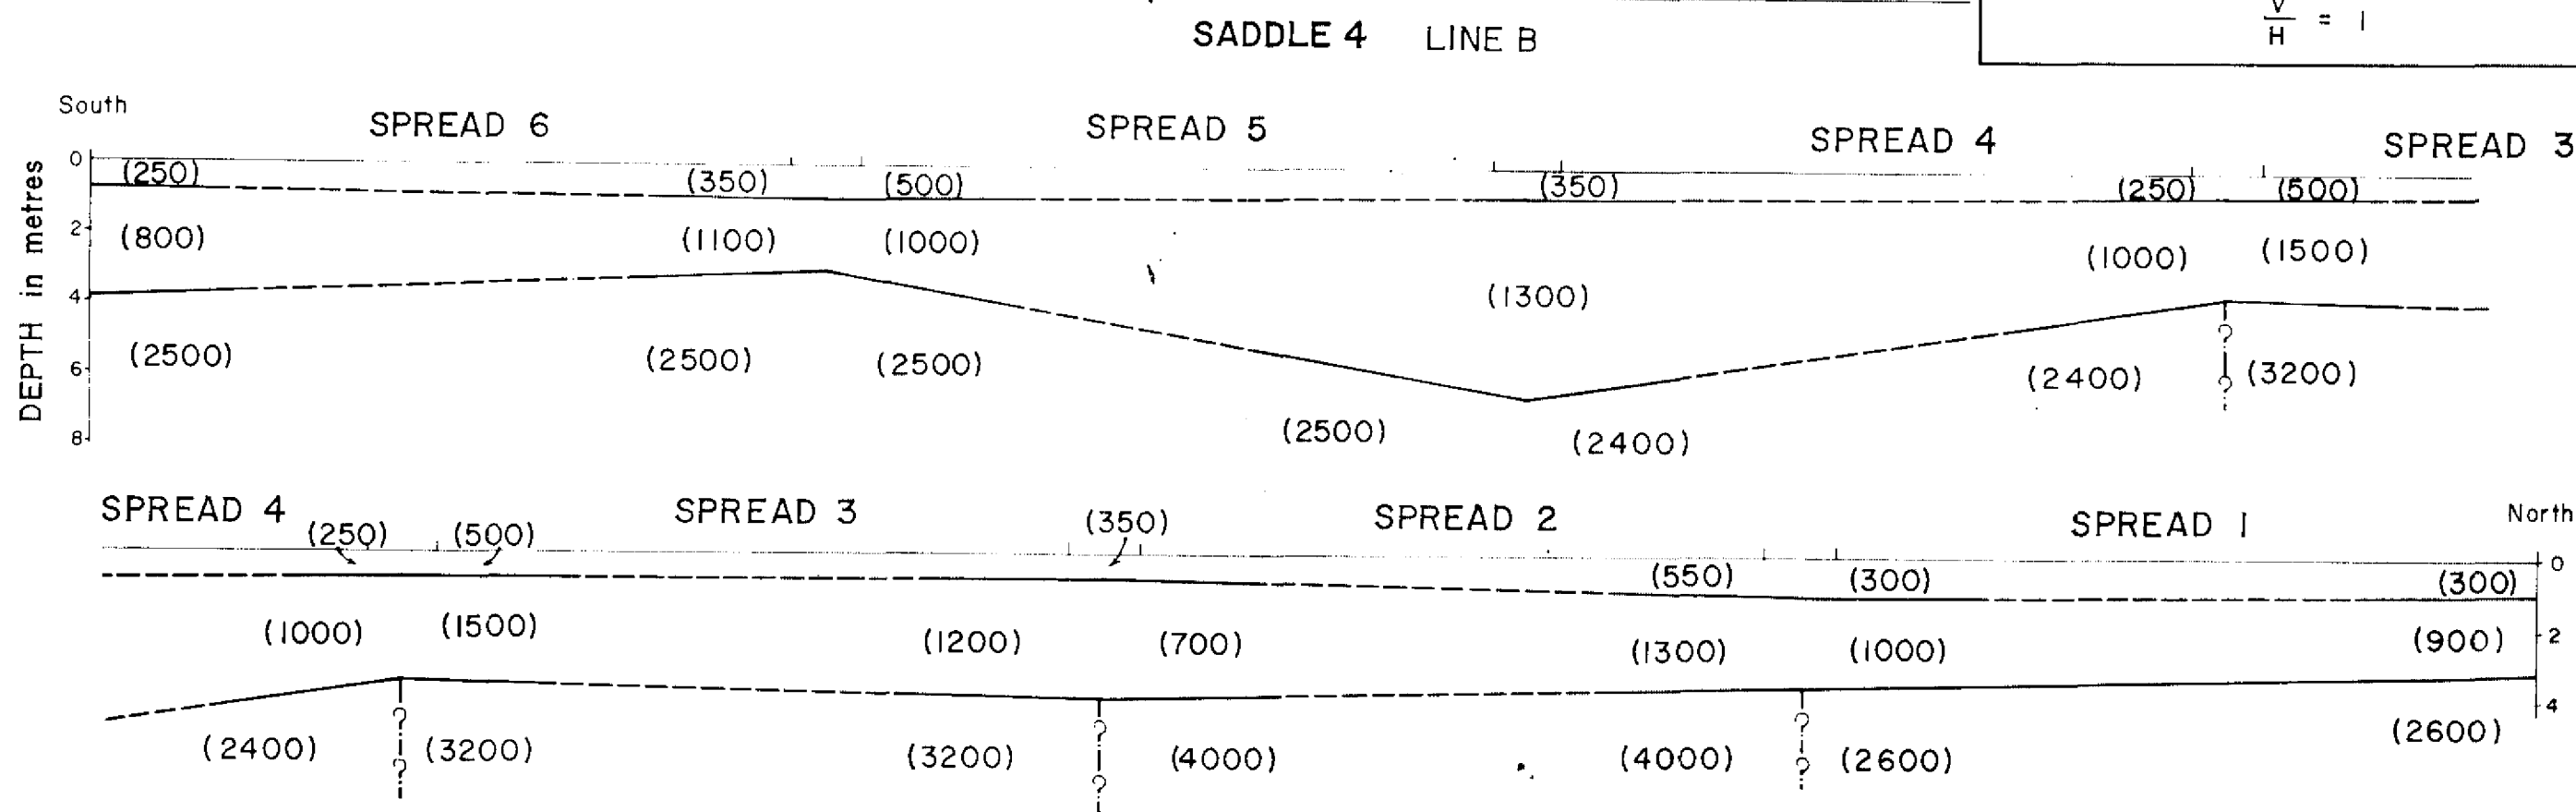
Plate 21

The seismic spreads (Plate 18) were shot with a 2 m overlap. The sections (Plate 21) indicate a depth to slightly weathered rock of 2 to 4 m. The bedrock seismic weathered rock of 2 to 4 m. The bedrock seismic velocity of 5400 m/s shown in spread 2 is considered too high for a depth of 3 m; it is probably caused by a topographic effect on the path of travel of the shock waves; the material A seismic velocity of about 3400 m/s is considered more likely.
