NORTHERN TERRITORY GEOLOGICAL SURVEY

REPORT GS 79/10

GEOLOGICAL REPORT ON THE FEASIBILITY OF A DAM ON THE HUGH RIVER AT BIRTHDAY GAP (Hermannsburg 1:250 000 Sheet SF 53-13)

DEPARTMENT OF MINES & ENERGY (October 1979)

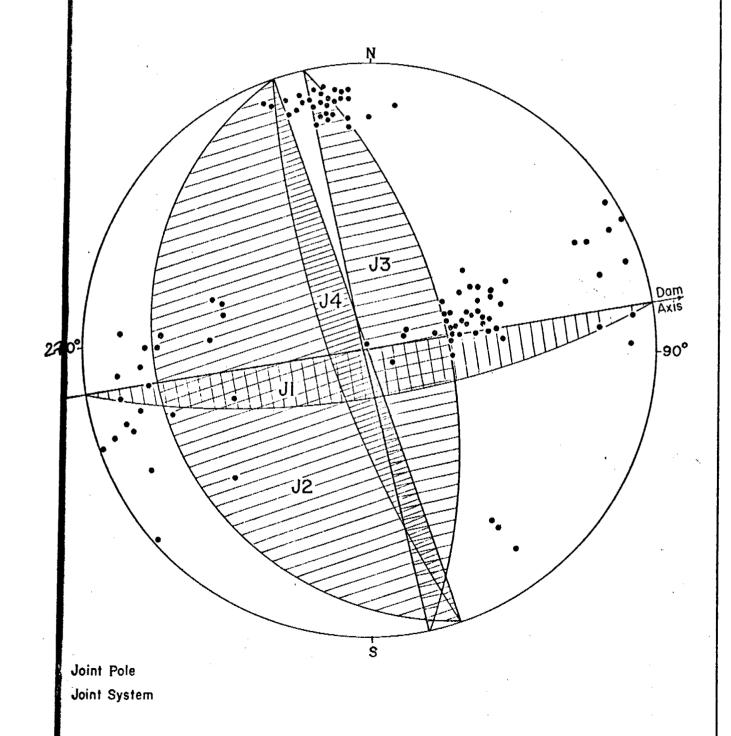
LEFT ABUTMENT

The principal joint sets as defined by Weber are as below (refer Figs. 3,4 & 5 for equatorial projections).

TABLE	1	× ,
		Strike	Dip	Direction
Left	set J1	080°	76 ⁰	S
Bank	set J2	162 ⁰	27 ⁰	E
	set J3	168 ⁰	64 ⁰	W
	set J4	162°	80°	E
Centre	set J1	080°	73 ⁰	S
	set J2	161 ⁰	64 ⁰	E
	set J3	179 ⁰	46 ⁰	W
	set J4	161 ⁰	80°	E
	set J5	044 ^O	54 ⁰	SE (very minor)
Right	set Jl	080°	75 ⁰	S
Bank	set J2	161 ⁰	270	E
	set J3	169 ⁰	65 ⁰	W
•	set J4	161 ⁰	80°	E

Of the above sets J1 is the foliation direction that is also typical of the gneiss and schist. Sets J2, J3 and J4 all are nearly perpendicular to the dam axis and therefore are all potential leakage paths with set J2 being the most common. (Refer to contour lower hemisphere polar projection Fig. 2).
