**PINE CREEK GOLDFIELDS
LIMITED**

**ANNUAL REPORT
MLN 13**

1 JULY 1993 - 30 JUNE 1994

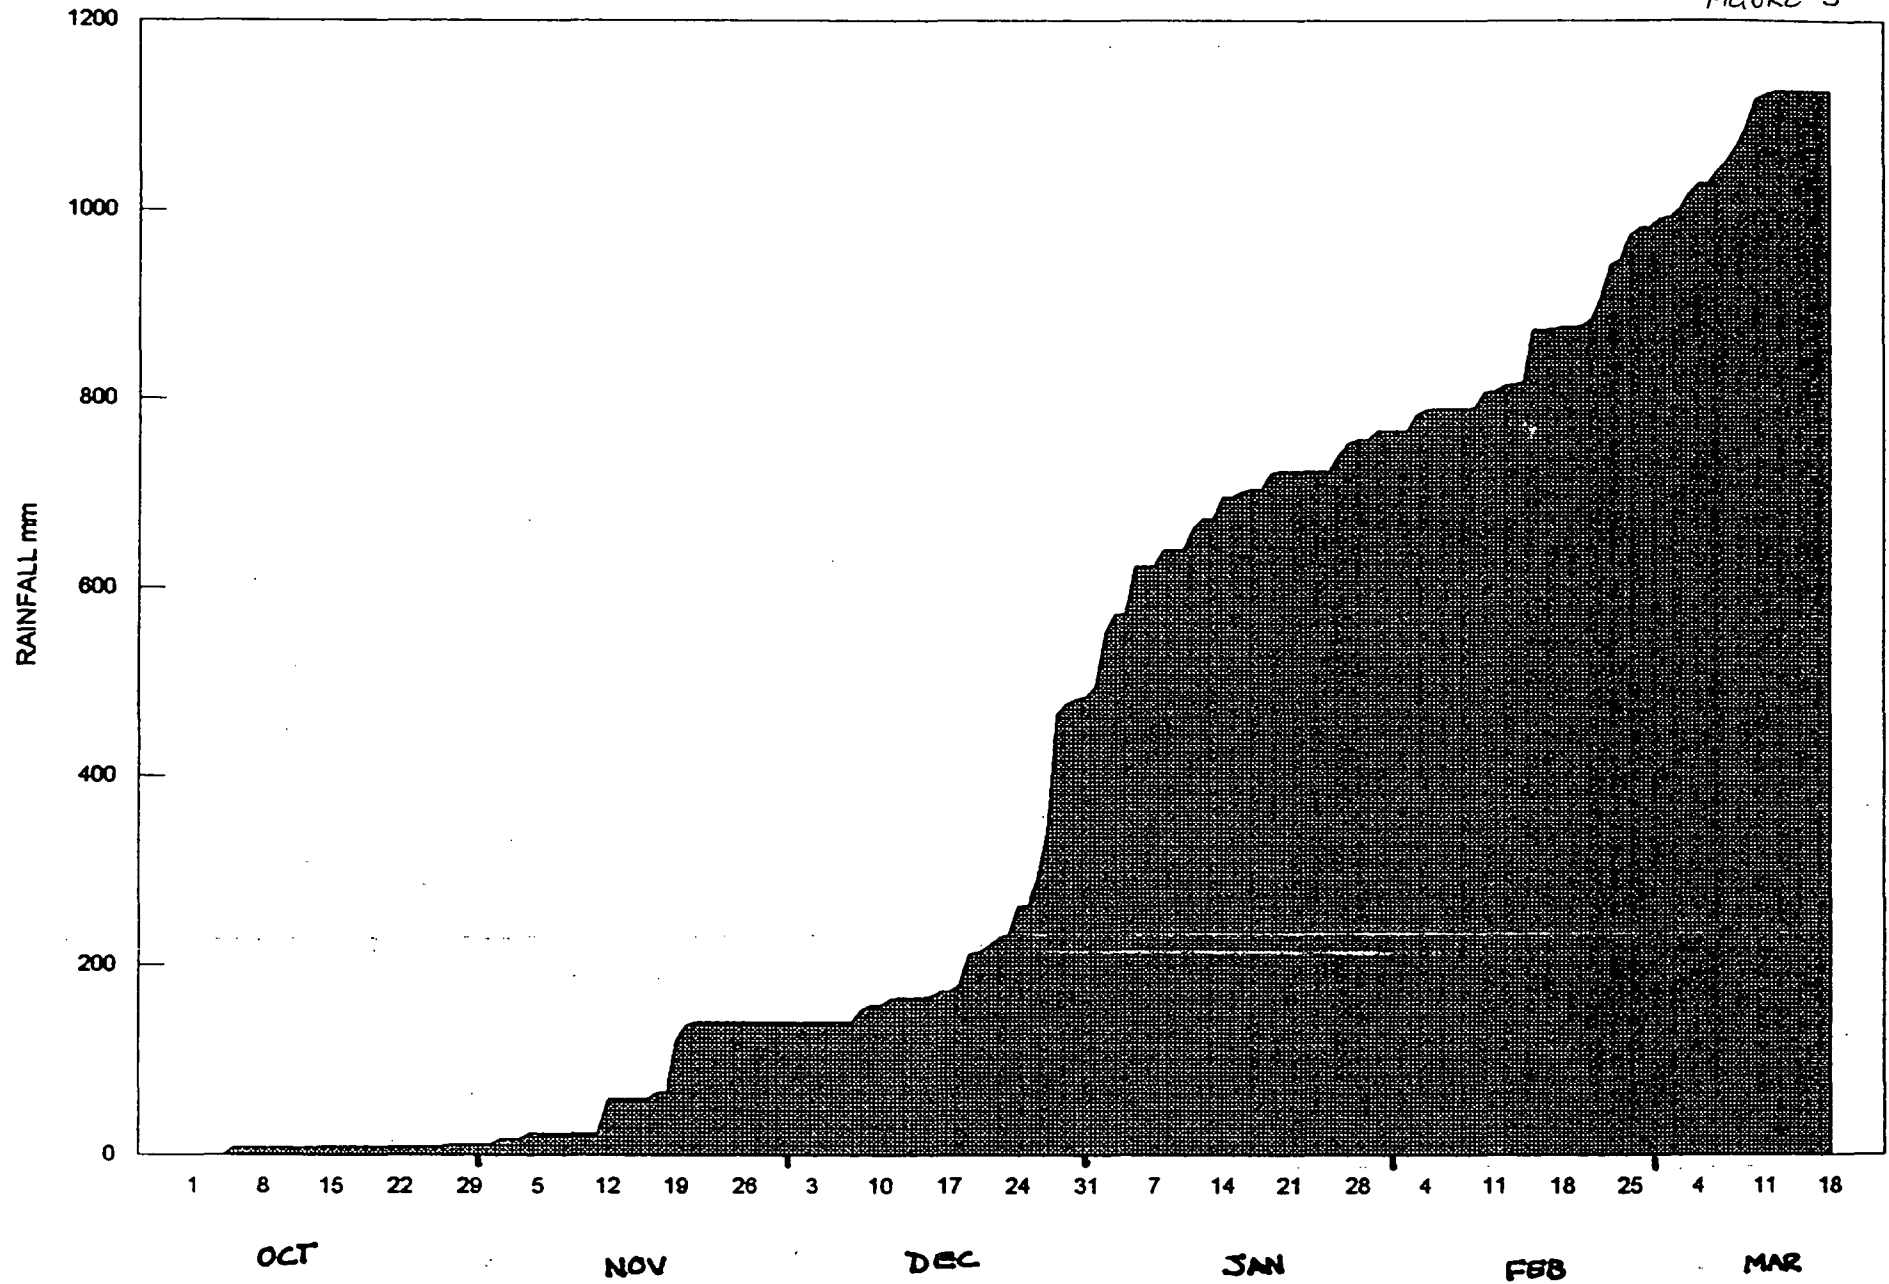
FIGURE 3

1993/94 CUMULATIVE RAINFALL

The rainfall recorded for the 1993/94 year was 1202.2 mm. This compares with an average annual rainfall of 1157.6 mm since operations began in 1985. Figure 3 shows rainfall data collected through the year as a cumulative graph.
