SURPRISE-1

WELL COMPLETION REPORT
(Basic)

EP 115
Amadeus Basin
Northern Territory

Central Petroleum Limited

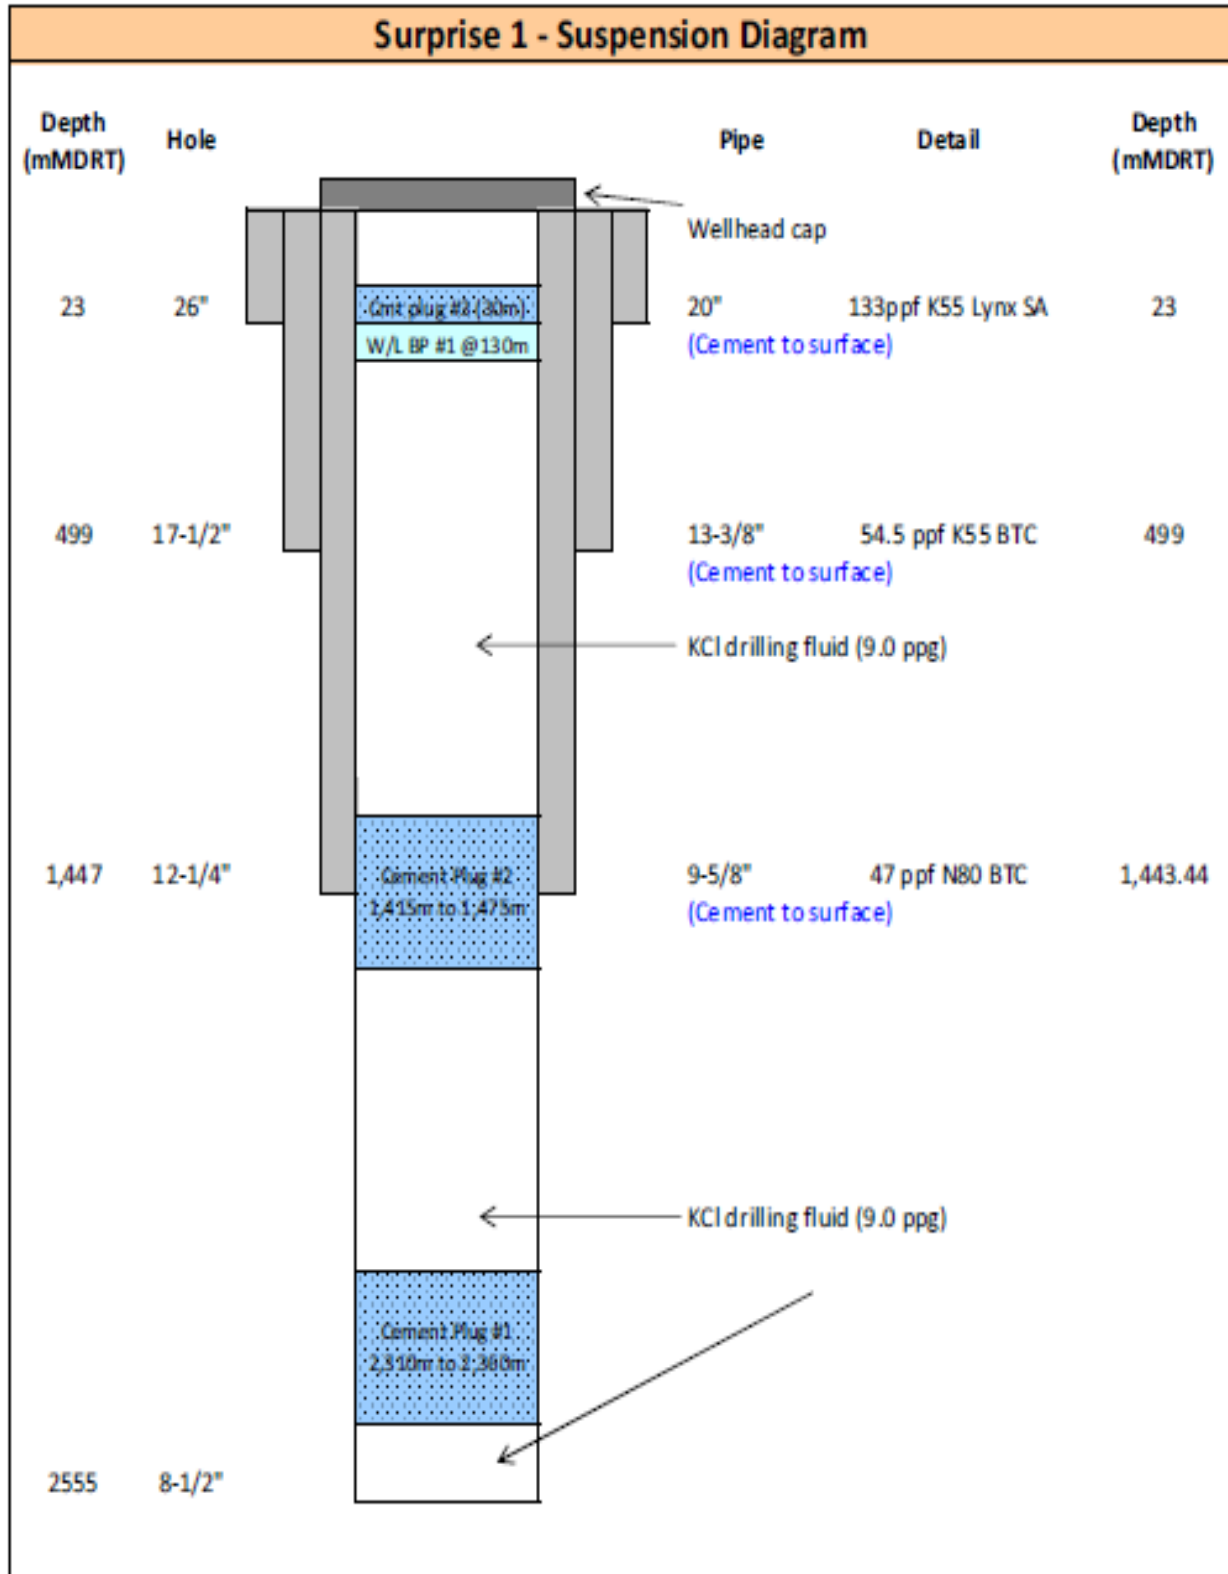
Figure 3: Surprise-1 Suspension Diagram

The well was suspended with the setting of 3 cement plugs (2,310m – 2,360m MDRT, 1,415m – 1,475m MDRT, 100m – 130m MDRT) and a wireline bridge plug at 130m MDRT. 9.0ppg KCl weighted fluid has been set between the plugs. A suspension flange has also been installed on the wellhead at surface.

The crane was used to pick up the drill pipe to be used as a cement stinger. The first cement plug was set at 2,370m MDRT. This plug consisted of 11.5bbbls of 15.8ppg Class G cement. The next cement plug was set at 1,473m MDRT. This plug consisted of 14.2bbbls of 15.8ppg Class G cement. The cement plug was tagged and the cementing string was pulled out to the surface.

The Halliburton 9 ⁵/₈" EZSV bridge plug was made up with the casing collar locator (CCL) and correlated on depth to 130m MDRT. With the CCL log giving inconclusive data, the assembly was tripped out to change the CCL sonde. The assembly was tripped in again and the bridge plug set on depth at 128m MDRT on 18th December 2010. 7.3bbbls of 15.8ppg Class G cement was dumped on top of the bridge plug. Rig down operations began and the rig was released at 0900 hours on 19th December 2010.

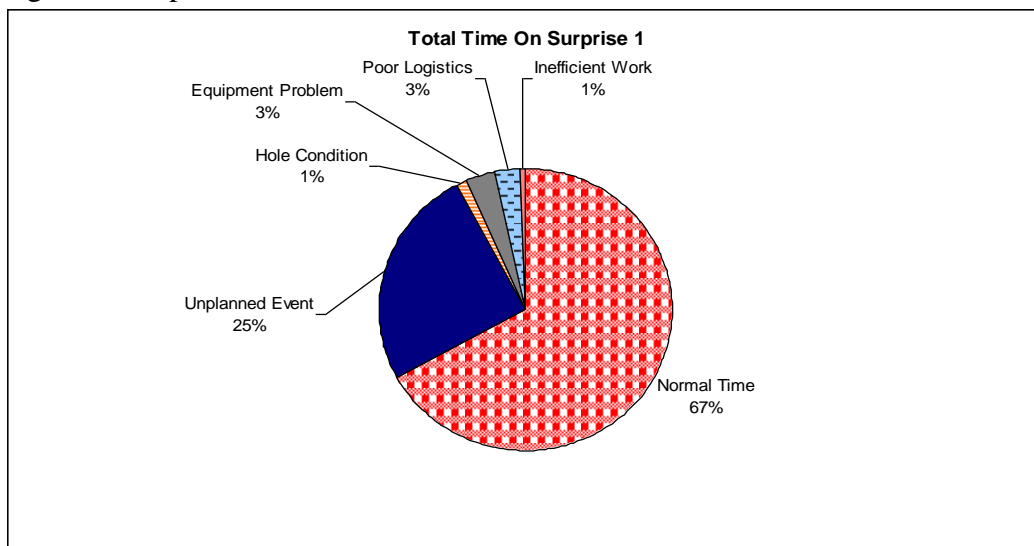
Figure 4: Surprise-1 Time breakdown

A total of 433.5 hours were summed as actual lost time. The big items that contributed to the lost time were the damage of the monkey board and mast amounting to 238 hours. The next big item would be the time taken to fish out the stuck FRT tool amounting to 57.5 hours. The third big item would be time taken waiting on the 26” hole opener to arrive on site amounting to 45.5 hours. This is graphically illustrated on the following pie chart.
