MANBARRUN PROJECT

WEED and DRILL COLLAR EROSION ASSESSMENT REPORT

September 2013

Report Date: October 2013

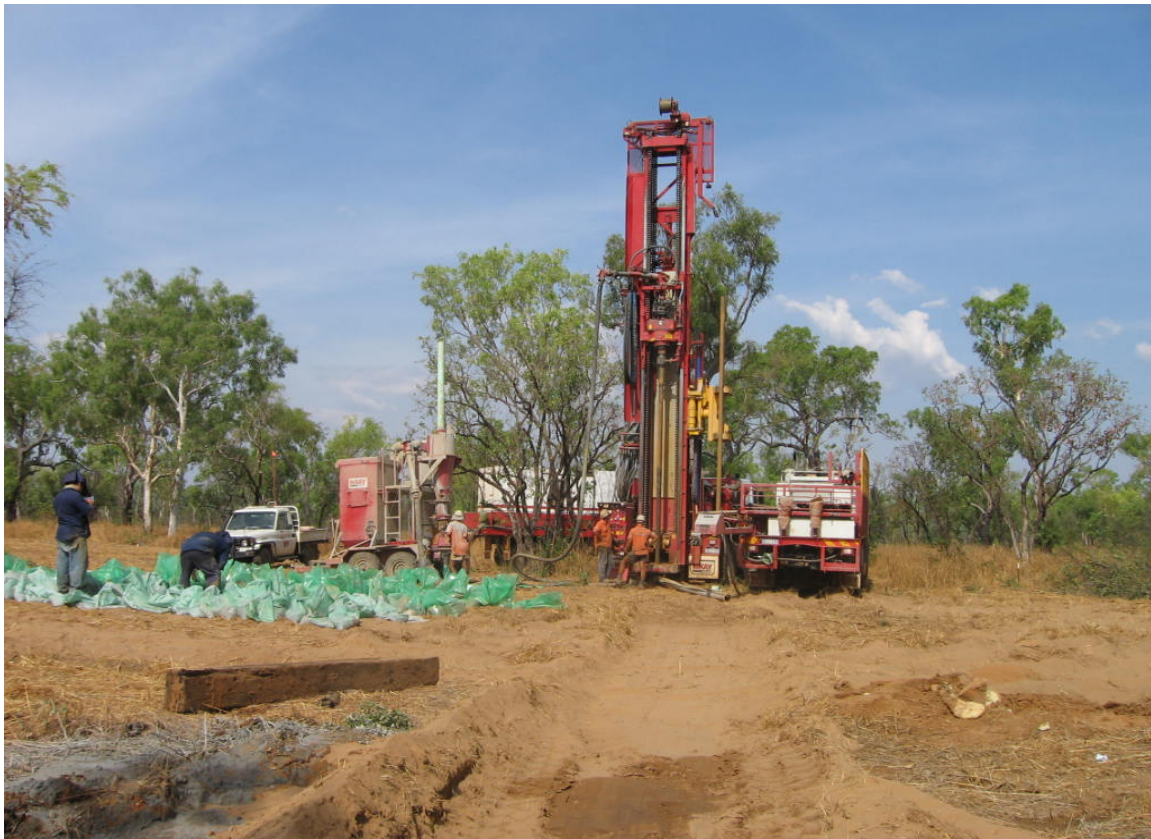
Plate 1. Photograph of drill site 06MRC008 on Eastern Side of Sandy Creek
Photograph taken October 2006

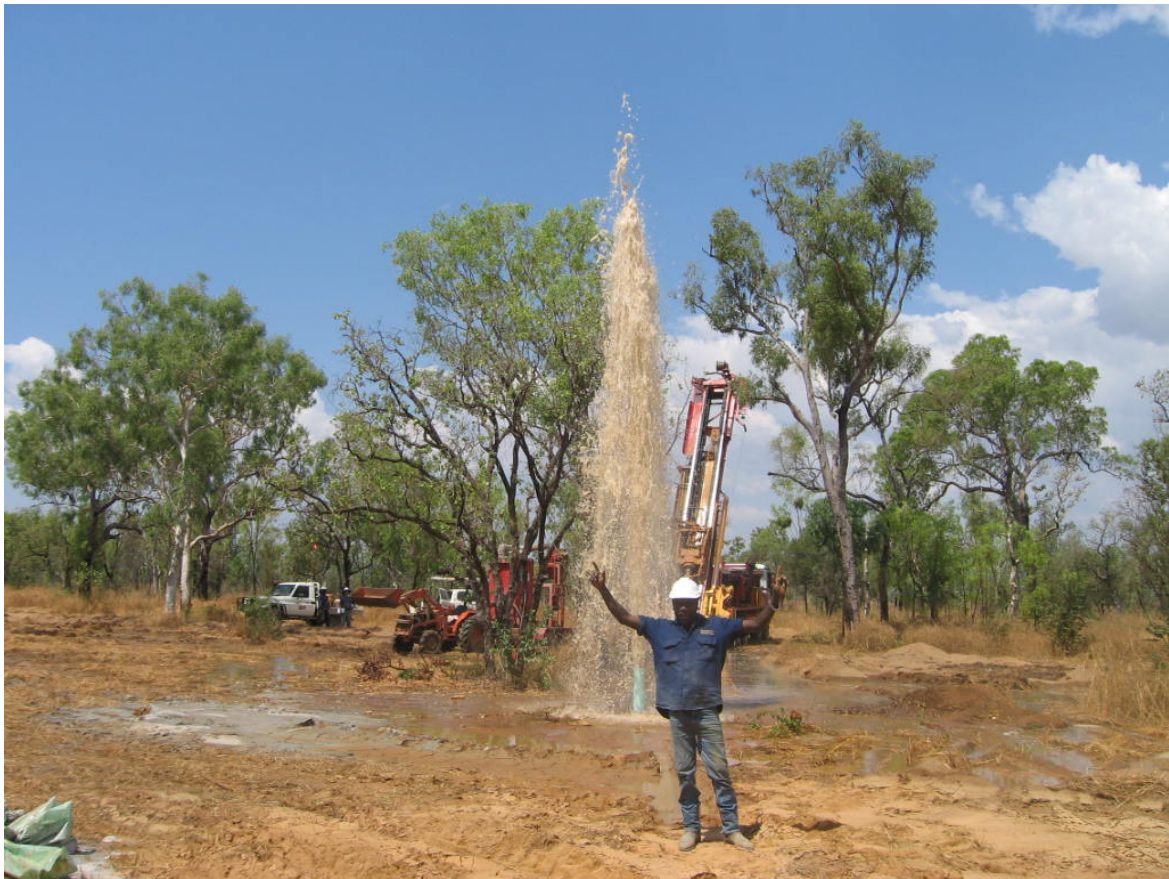
Plate 2. Photograph of drill site 06MRC008 on Eastern Side of Sandy Creek showing sandy conditions. Photograph taken October 2006

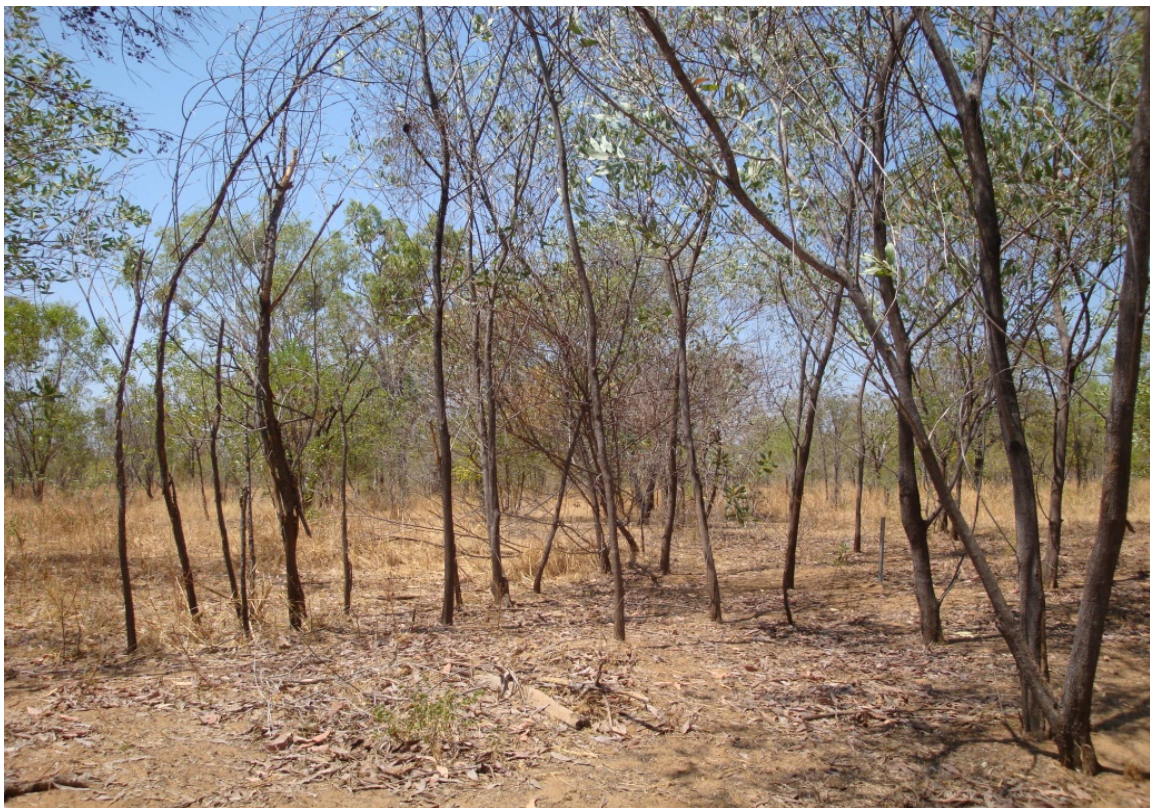
Plate 3. Photograph taken 30m South of drill site 06MRC008 on Eastern Side of Sandy. Photograph taken August 2012. Some evidence of Hyptis growing on right of photo.

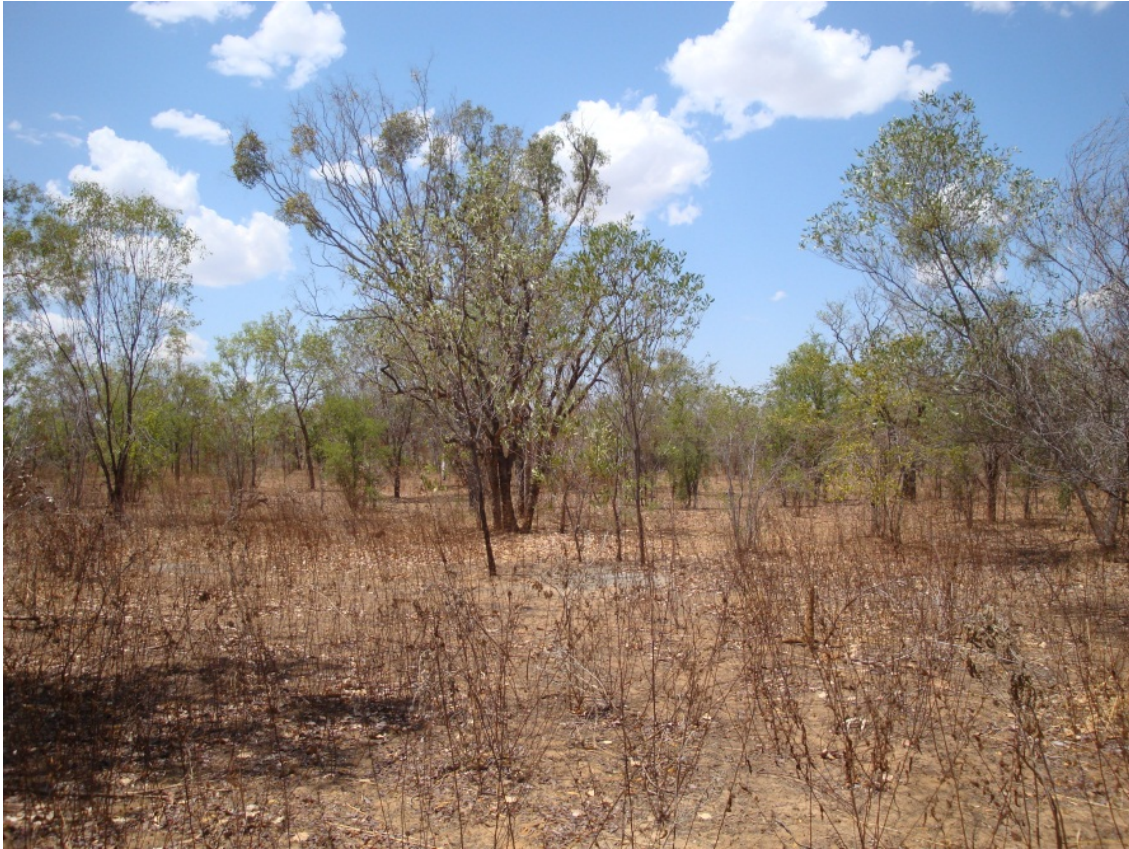
Hyptis (Hyptis suaveolens); which was not identified in the survey plots during the 2007 baseline survey but observed on the verges of the roads around the drilling operations and along the banks of Sandy Creek is still evident along the western bank of Sandy Creek. There is no sign of the weed growing around the drill sites away from the creek. The weed is more evident on the eastern side of Sandy Creek where it is very sandy and had recently been burnt.

Plate 1. Photograph of drill site 06MRC008 on Eastern Side of Sandy Creek showing burnt conditions and *Hyptis suaveolens*. Photograph taken September 2013

The low density and species richness of weeds within the Authorisation should be maintained. There are areas of significantly higher weed densities and species richness in other areas of Legune station (Freeland 2004). Additional weed species are present along the road from Kununurra to the project area. Monitoring of the eastern side of Sandy Creek will continue and a site inspection is planned as soon as the site can be accessed after the 2014 wet season.

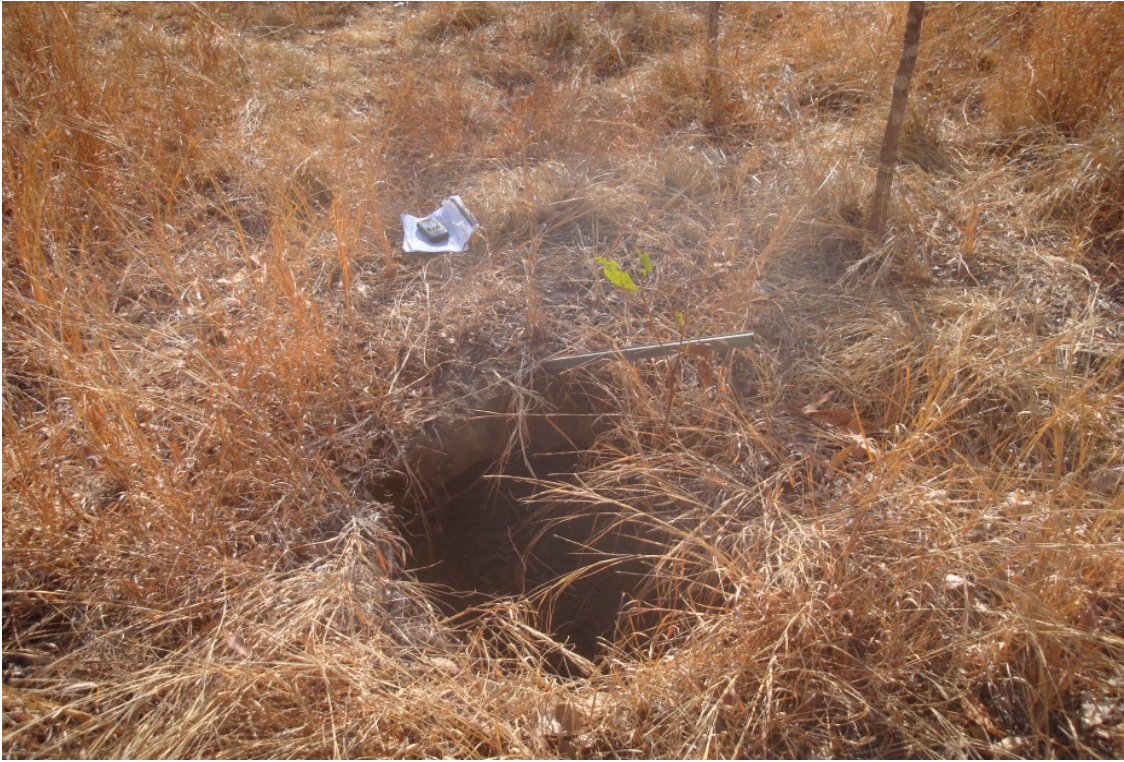
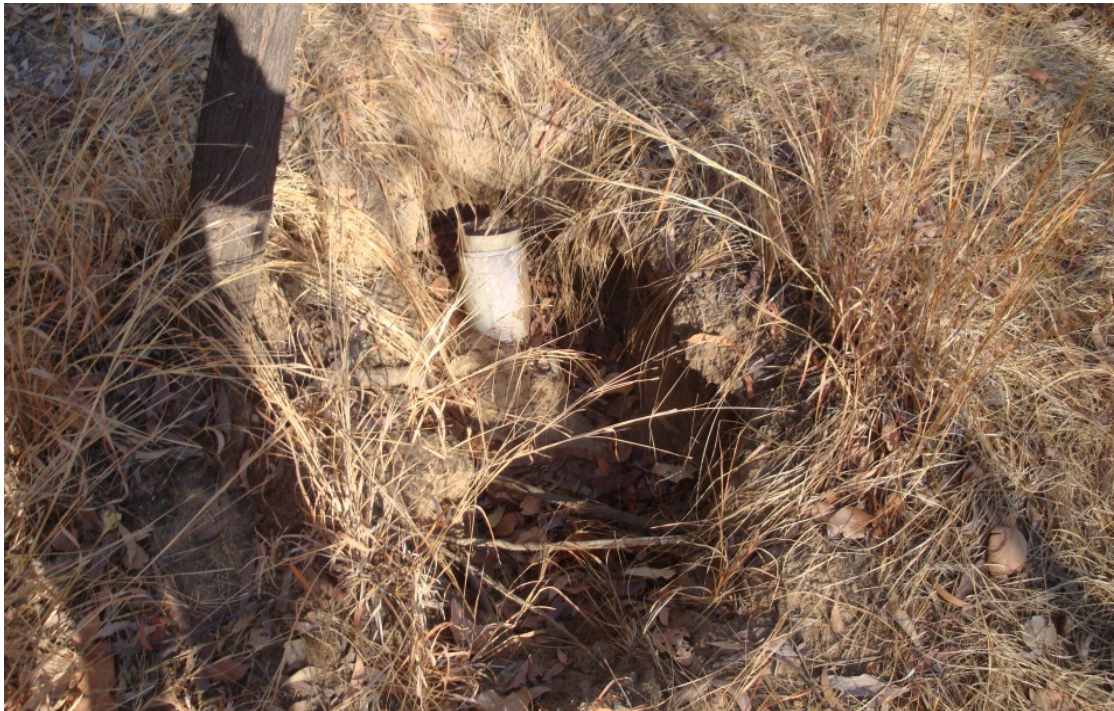
Drill hole collar erosion was noted and photographed at 8 sites listed below.

EXAMPLES OF DRILL COLLAR EROSION AT THE SANDY CREEK PROSPECT.

These drill hole collar failures will be rehabilitated at the start of the 2014 field season.
